St Marys Site Audit Report and Site Audit Statement for RAP

Sydney Metro Western Sydney Airport Station Boxes and Tunnelling Works

Project number	WSA-200-SBT
Document number	SMWSASBT-CPG-STM-SN100-EN-RPT-295367
Revision date	16 February 2024
Revision	00

SITE AUDIT REPORT REMEDIAL ACTION PLAN, ST MARYS STATION BOX AND TUNNELLING WORKS, SYDNEY METRO WESTERN SYDNEY AIRPORT

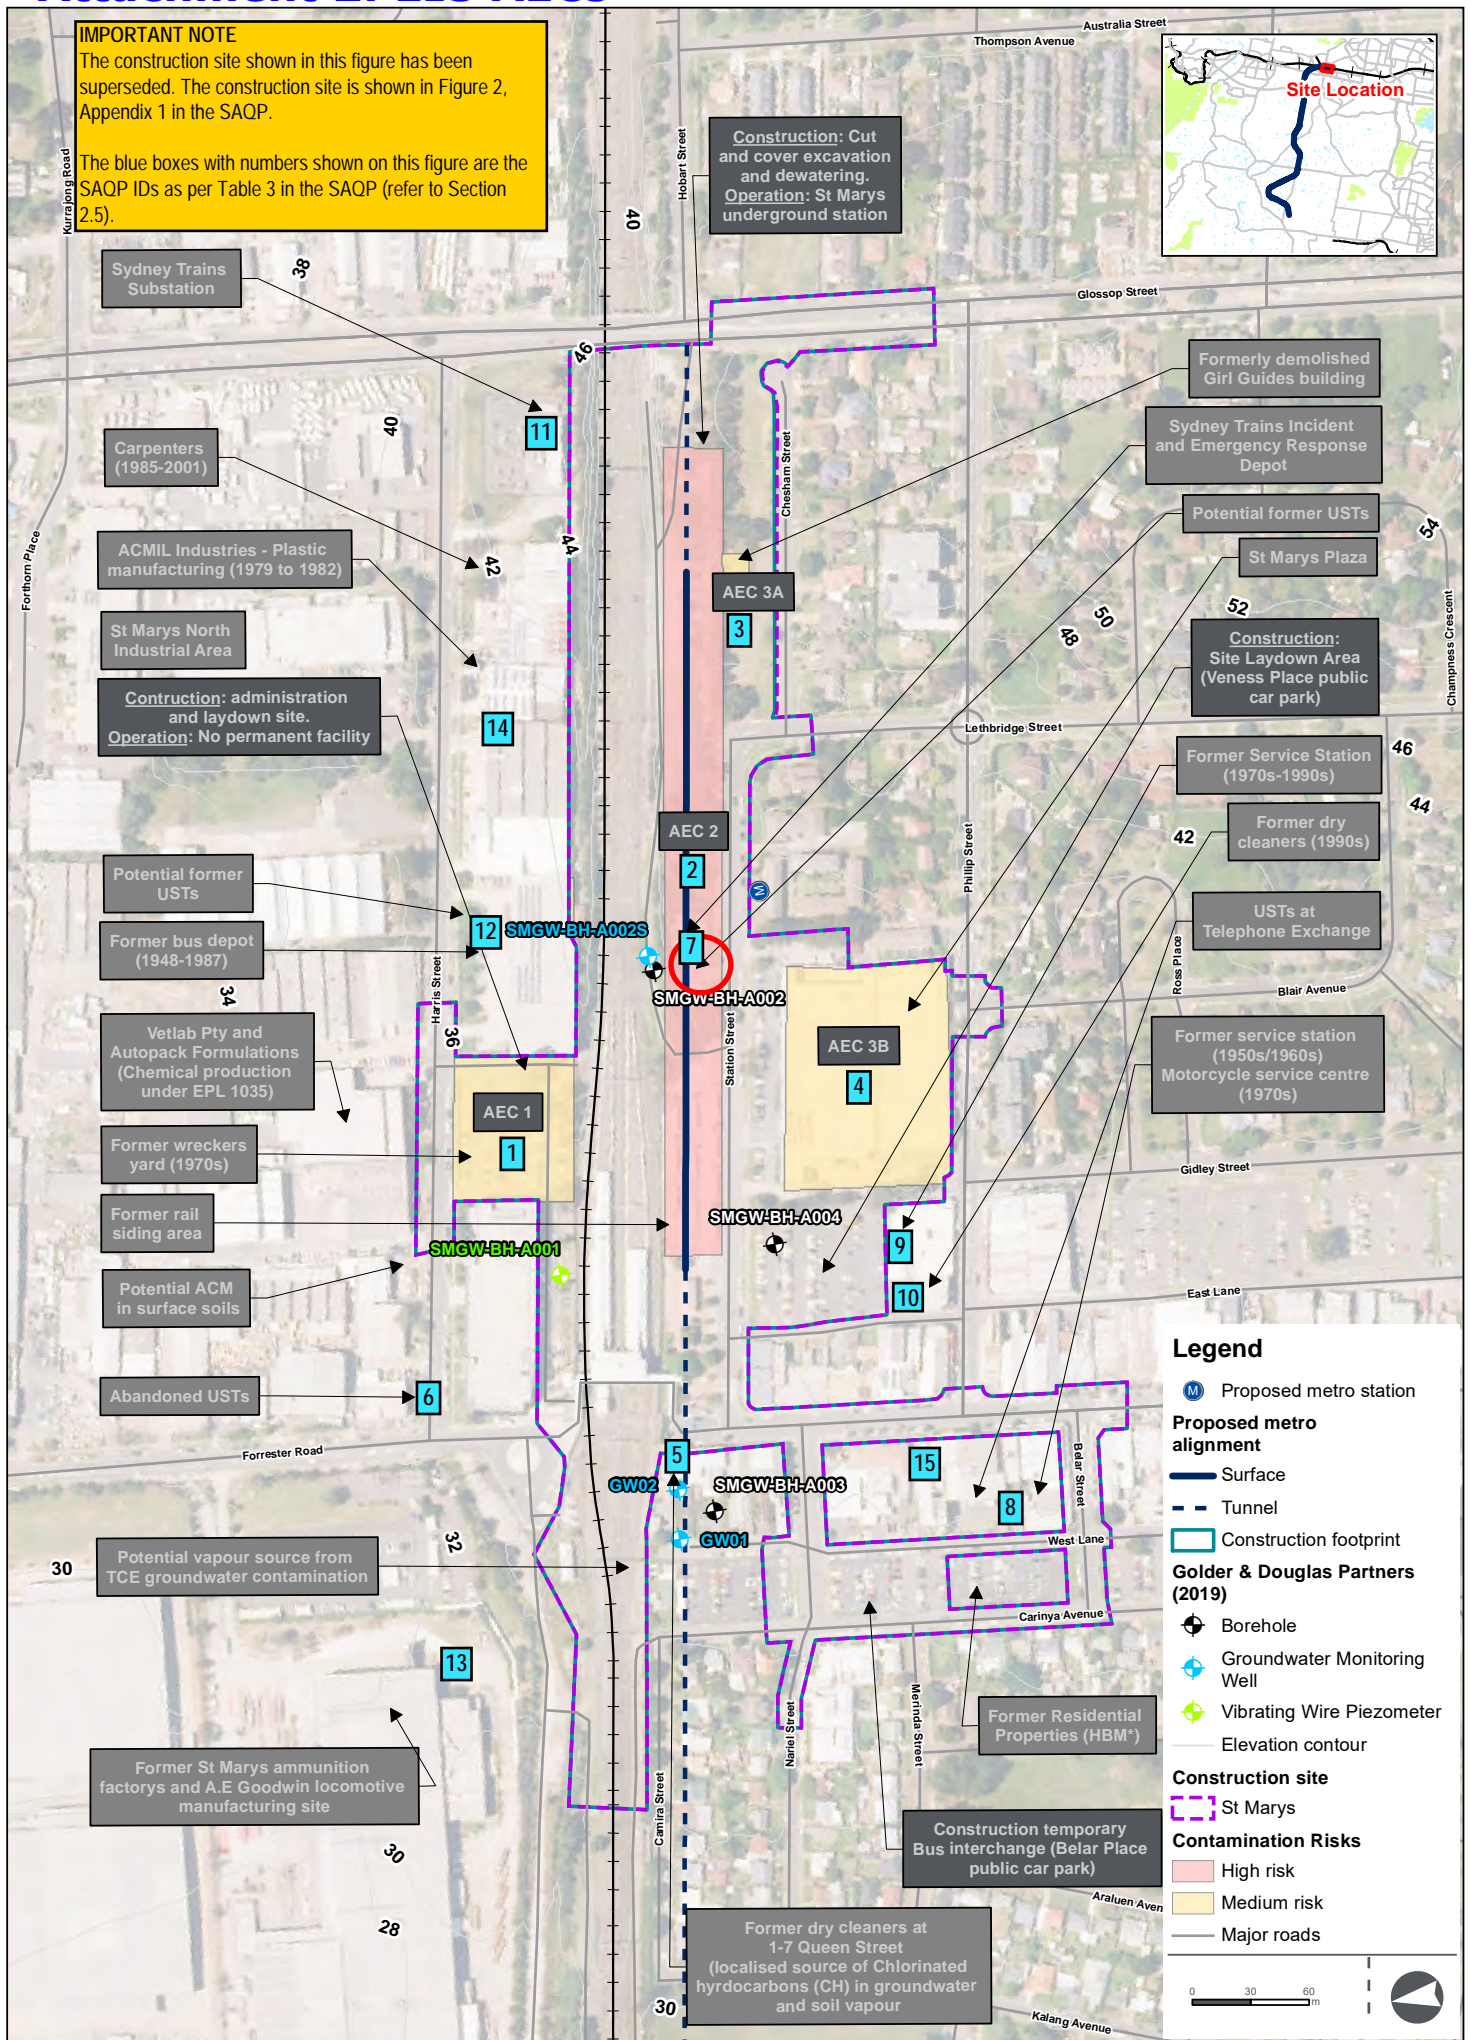
Attachment 2: EIS AECs

TTMP noted in the SAQP and DSI that historical activities with the potential for contamination (referred to as Areas of Environmental Concern (AEC)) were identified in the EIS. Fifteen AECs were identified and the location of the AECs are shown in Attachment 2, Appendix A. The summary provided by TTMP for these AECs is provided as Attachment 3, Appendix A.

St Marys contamination sources and risk ranking
