Removal of the Beatrice Bush Bridge for the Rozelle Interchange Project

Matt Hennessy, Structural Engineer, EIC Activities
Colin Edmonds, Technical Director - Structures, EIC Activities

ABSTRACT

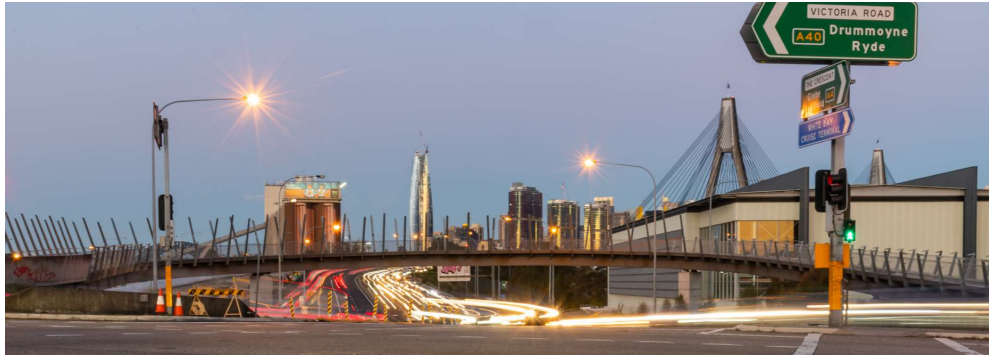
Figure 2- Beatrice Bush Bridge

Named after Beatrice Bush, who sold newspapers at the intersection which the bridge spans for over 25 years, the existing bridge was constructed in 2005 and consists of a four span steel box girder with a concrete deck and reinforced concrete substructure. The steel girder consisted of 4 spans, constructed in a span-by-span approach having lengths of 40.555m, 40m, 30.025m and 17.605m from north to south respectively. The bridge was horizontally curved in plan to meet the required grade specifications for pedestrian usage and was also provided with a vertical crest to meet the required vehicle clearance to Victoria Road. To resist torsion, the bridge utilised several 32mm diameter stressing bars, tying the steel box girder to the pier with 8 no. provided at Abutment A, 8 no. provided at Pier 1 and 2 no. provided at Pier 2.

The steel box girder was 1.7m wide by 1.064m deep consisting of a 20mm thick bottom flange, 16mm thick web plates and a 16mm thick top flange. The girder was stiffened both transversely and longitudinally. A minimum 170mm thick concrete decking was provided but was not made composite with the steel girder. To provide protection to pedestrians crossing the bridge and traffic passing below, the bridge was provided with a steel handrail and barrier complete with anti-throw mesh panels.

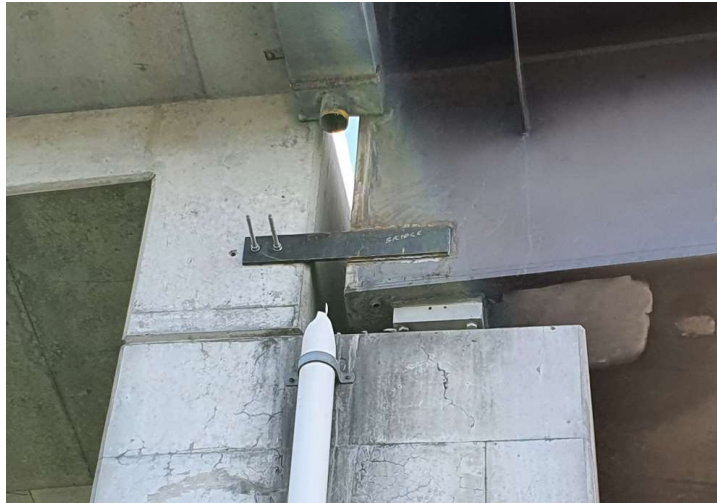
Figure 13- Temporary longitudinal restraint

Physical removal of the bridge began first with installing the required temporary works to facilitate the expected actions that would occur during the removal process. The temporary longitudinal restraint between Abutment B and Girder A was installed just prior to the removal of Girder B as shown in Figure 13 below to restrain the bridge following the removal of Girder B.

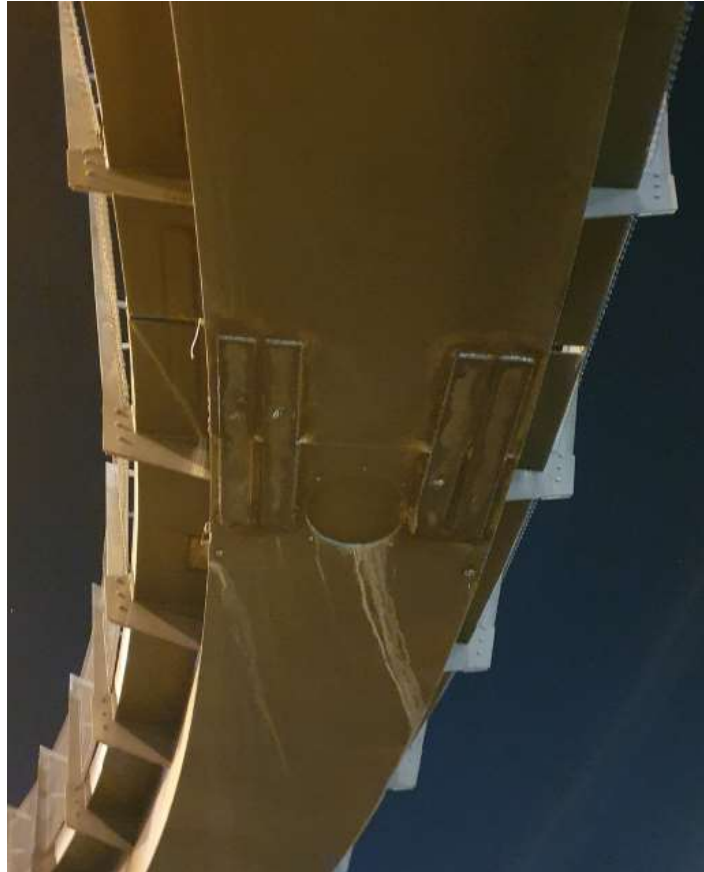
Figure 14- Hinging Restraint

To prevent a mechanism forming following the removal of Girder C, the temporary splicing plates were required to be installed to Splice C1. These plates were installed to the top and bottom flanges as shown in Figure 14 creating a longitudinal bending moment couple.

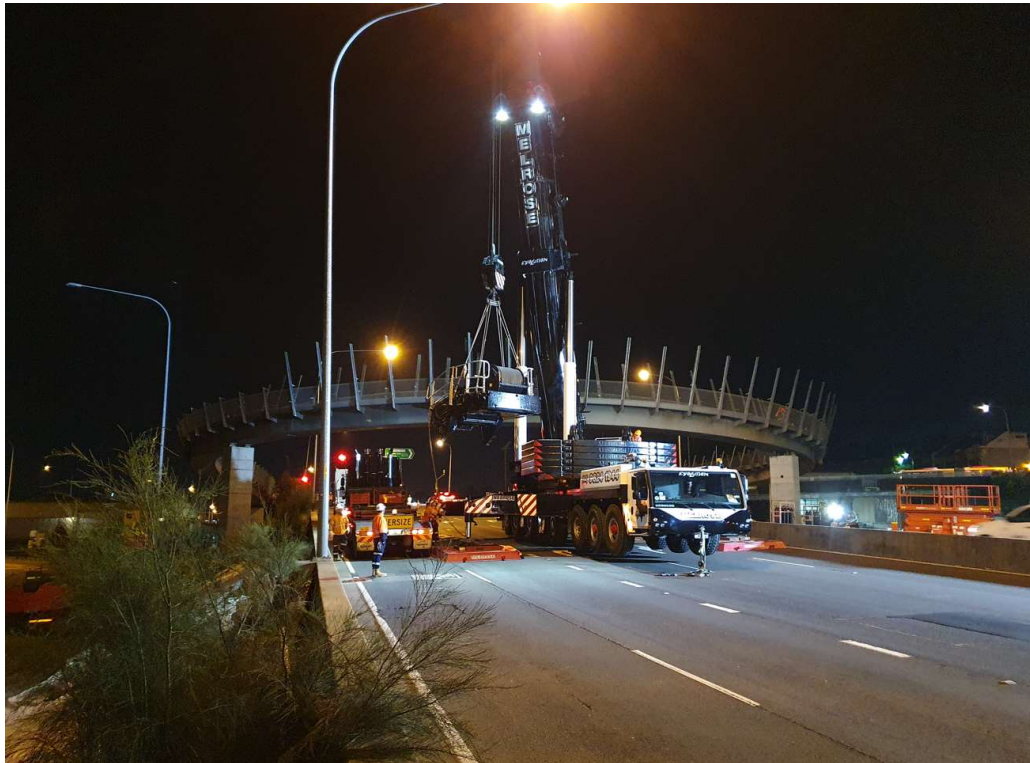
Figure 15- Mobile crane setting up on the Westbound side of Victoria Road

During the first closure, a mobile crane was chosen to remove Girder C as this crane did not require crane pad foundations to manage bearing pressures and was able to be setup and dismantled within the one overnight occupation. As shown in Figure 15 below, the crane was setup on the Westbound side of Victoria Road.

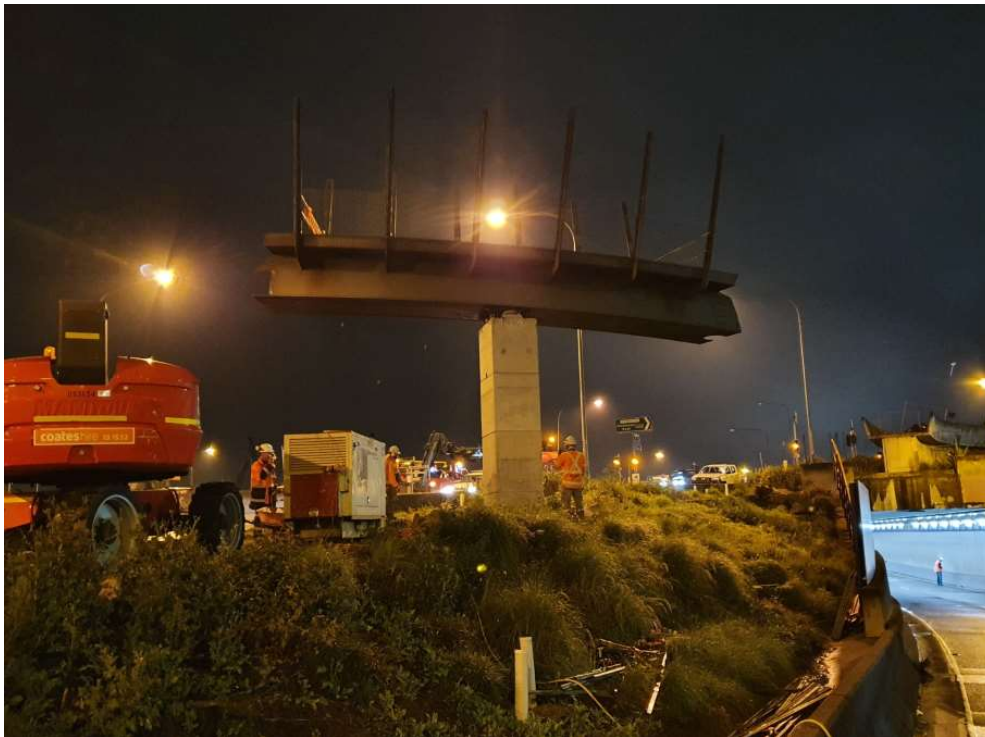
Figure 18- Leftover section above Pier 1

To remove the leftover girder portion located at Pier 1, cutting of the stress bars connecting the girder to Pier 1 was required. Firstly, the rigging to the crane was connected and the crane pre-loaded most of the girder weight. When the project staff were ready, the 8 no. stress bars were then cut underneath the soffit of girder. An audible popping noise was heard upon the cutting of each stressing bar and no visible debris was seen coming from the girder during cutting operations.

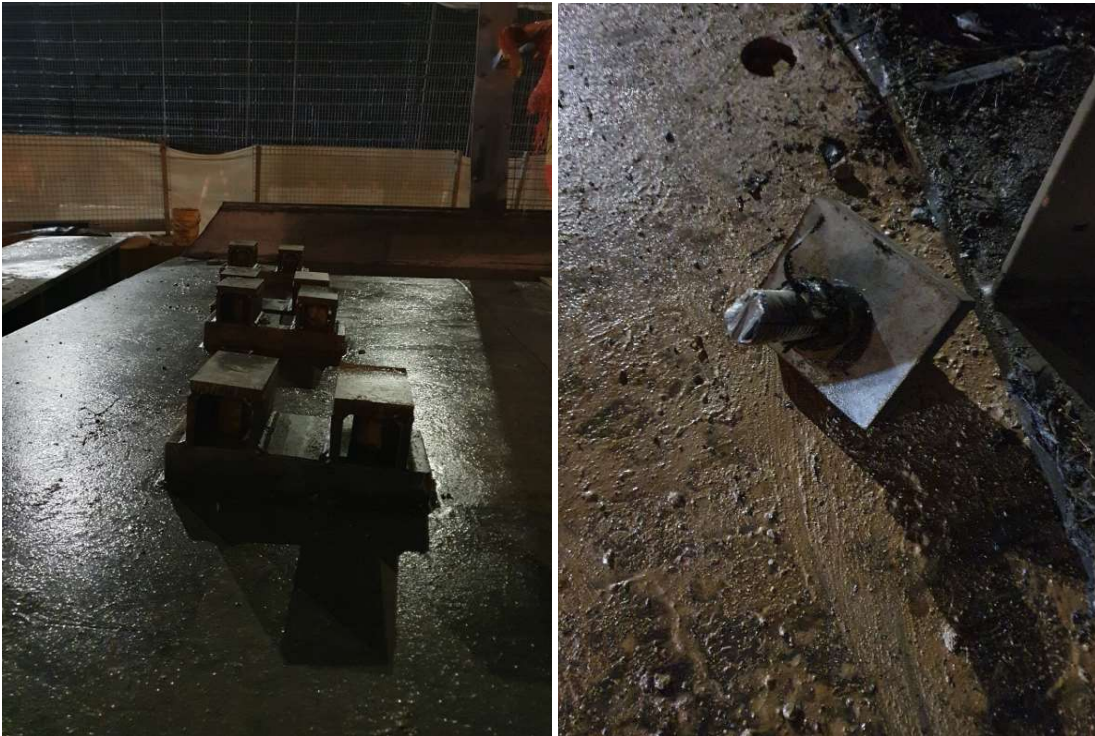
Figure 20- Inspection of stress bar brackets and cut stress bar

Once the girders had both landed in the storage yard, the condition of the brackets covering the top of the stressing bars were inspected. No evidence of failure or damage to the brackets was observed. The girder was then dismantled and taken off site.
