## **Final Report**

# **Investigating the influence of green infrastructure on demountable building performance**

GC16000

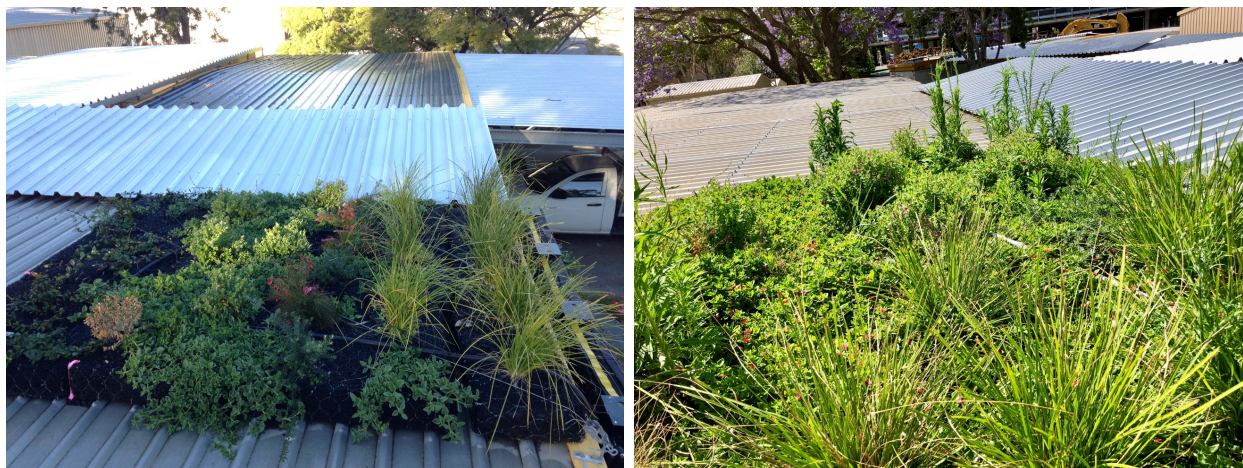
**Figures 3a** (left) and **3b** (right). Green roof growth from July 2017 – October 2017.

Plant growth on the green roof and green wall was highly successful. Species were chosen by Grow Collective that could grow in shallow inorganic systems, both vertically and horizontally under dry and extreme weather conditions. Species included *Aloe vera*, *Rosmarinus officinalis*, *Philodendron xanadu*, *Aptenia cordifolia*, *Russelia equisetiformis*, *Pennisetum* sp., *Jasminum* and *Metrosideros* sp. At the research forum in Sydney, QUT showcased the first set of progress photos from the site from July to October 2017 (Figures 3a,b and 4a,b).

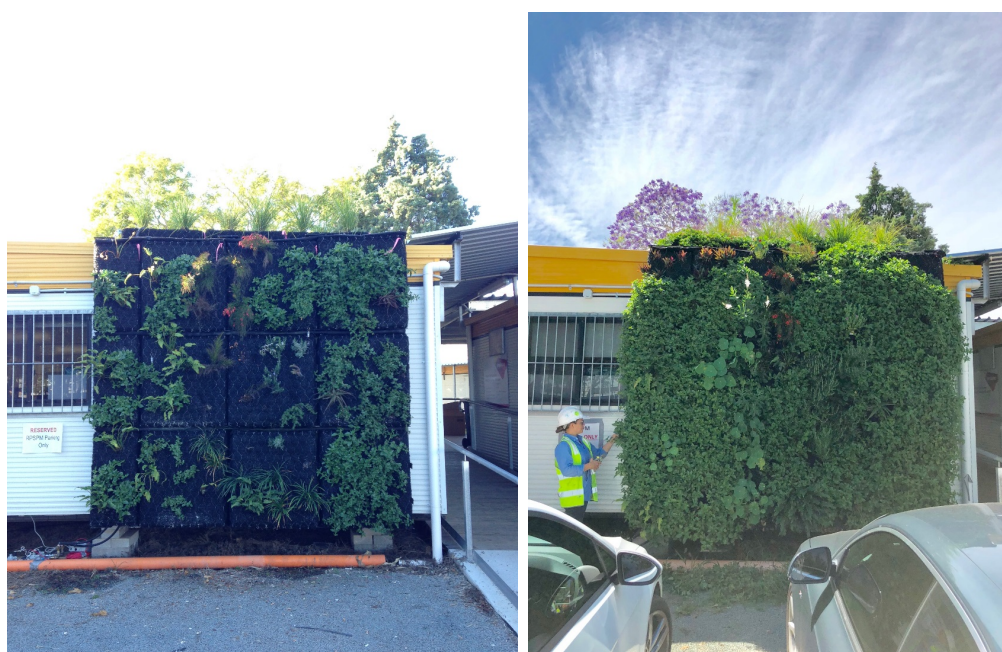
**Figures 4a** (left) and **4b** (right). Green wall growth from July 2017 – October 2017.
