## Aboriginal Objects Due Diligence Assessment Pedestrian/Cycleway Rail Overbridge, Station Street, Menangle NSW

Wollondilly Local Government Area  
Prepared for Calibre Group

Prepared by Niche Environment and Heritage | 5 August 2022

**Re: Updated Pedestrian/Cycleway Rail Overbridge, Station Street, Menangle NSW – Aboriginal Objects Due Diligence Assessment (Niche ref: #6570)**

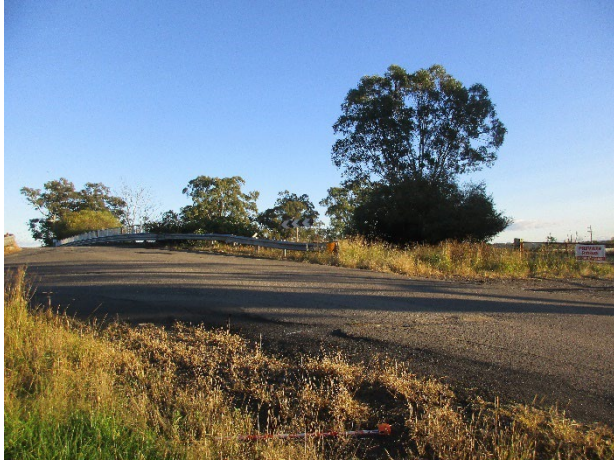
**Plate 1: General view of the Activity Area, looking north west.**

The remaining areas had a poor visibility of 30-40% due to vegetation coverage (Plate 1-Plate 4). The entire Activity Area was found to be extensively disturbed from vegetation removal, the construction of roads, bridges, railway corridor and associated infrastructure (i.e. subsurface utilities).

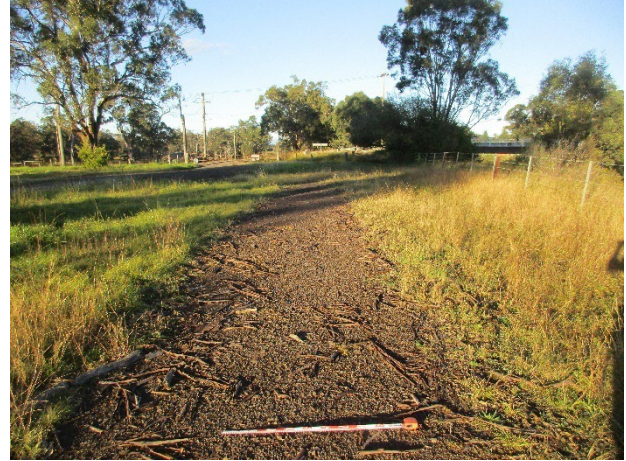
**Plate 2: General view of the Activity Area, looking south.**

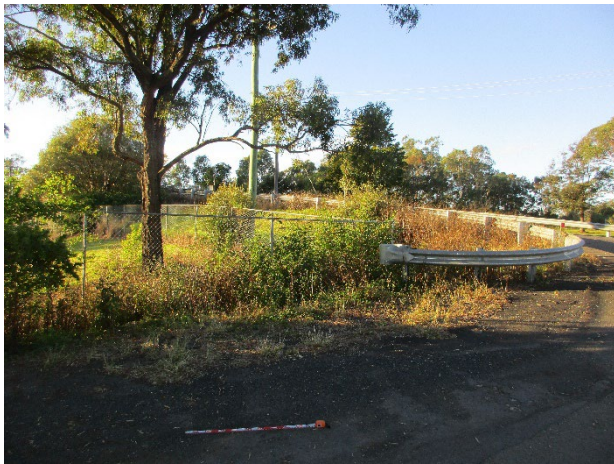
**Plate 3: General view the Activity Area, looking south east.**

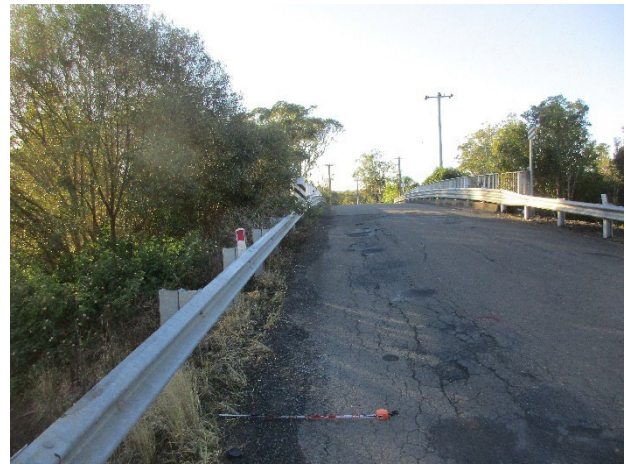
**Plate 4: General view of the Activity Area, looking east.**
