## APPENDIX A

UPSTATE FLOOD MITIGATION TASK FORCE

# **Mohawk River Basin Report Abstracts & Summaries**

FEBRUARY 2023

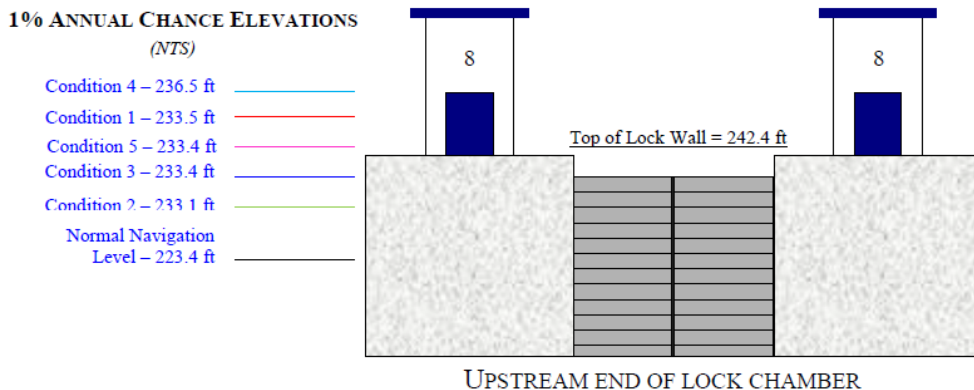
Water surface elevations were developed in tables and diagrams for each Lock and each operation condition, for each flow analyzed. Below is the WSEL diagram for Lock E-9 at the 1% annual chance (100-year) flood event.

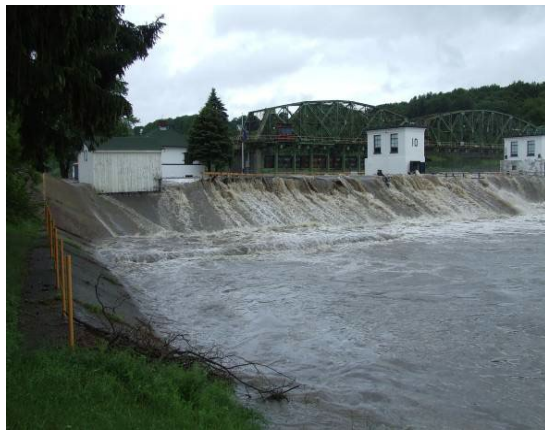
The original concrete Spillway abutted the downstream end of the lower guide wall of Lock E-10 and extended 100 feet south, perpendicular to the lock chamber. The apron and spillway slabs were constructed of 12" thick concrete, lightly reinforced with 6" square wire mesh reinforcement. During the June 2006 flood event, the Spillway was washed away. The loss of the E-10 spillway steepened the hydraulic gradient between the downstream and upstream ends of the E-10 lock chamber and increased flows and velocities in the southern overbank. This resulted in scouring of the surface materials and underlying fill and alluvial soils, the loss of the frame buildings, shifting and settlement of the Lock Office Building, and loss of miscellaneous New York State Canal Corporation (NYSCC) facilities.

**Figure 6: Flow over Spillway**

The replacement Spillway is integral with existing grade adjacent to Lock E-10, and functions only in the event that floodwaters flow overland around the lock structure. The Spillway is comprised of an upper concrete apron, 2H:1V sloping concrete slab, and lower concrete apron. The Spillway is oriented perpendicular to the landward lock wall, with the crest aligned just downstream of the lower miter gates and following the slope of the lower apron access

The replacement Spillway is hydraulically and structurally designed for a range of discharges and flow conditions. One of the Spillway design conditions uses 150% of the 100-year flood, consistent with recommendations for existing dams with Hazard Classification "B", from NYSDEC's *Guidelines for Design of Dams* (NYSDEC, 1989).

Therefore, the replacement Spillway includes designed (either buried or surface) stone filling at the upstream and downstream perimeter of the reinforced concrete apron that withstand maximum calculated velocities for all return period flood events. The riprap protection will include a key at the perimeter of the protection.

A line of sheet piles will be installed along the replacement Spillway crest, extending from the face of the lock wall south to the south end of the Spillway. Those sheets will terminate at another row of sheet piles aligned orthogonally to the Spillway crest and that extend from the upstream edge of the upper apron to the downstream edge of the lower apron. The primary function of the sheet piles will be to provide a second line of defense against undermining of the Spillway and aprons, rather than to form a cutoff against water seepage. The sheet pile walls will be designed to sustain differential earth loading that could result from the unlikely erosion of the south Spillway abutment.

The replacement Spillway lower concrete apron forms the primary protection against undermining of the Spillway by turbulent high-velocity flows. As described Section 3C of this report, the apron length is established based on open-channel hydraulics. The downstream edge of the Spillway apron will extend below grade at least to the depth of the stone filling described above.

Medium or heavy stone filling will be designed for these regions of turbulent flow adjacent to the replacement spillway and on all surfaces that are steeper than 10% grade. The riprap protection will include a key at the perimeter of the protection.

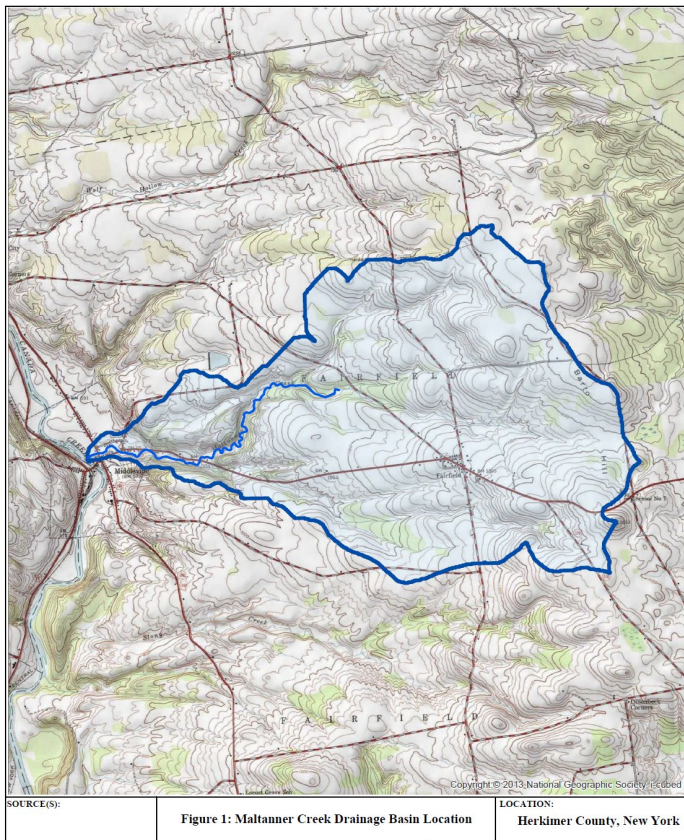
Maltanner Creek is located in the town of Fairfield and the village of Middleville, in Herkimer County. The creek is 4.1 miles long with a contributing watershed of 6.6 square miles.. The basin is 36 percent forested, with a mix of rural residential and agriculture uses throughout. Residential and commercial land uses are concentrated in the lower part of the basin in the village of Middleville, where Maltanner Creek flows into West Canada Creek. The watercourse has an average slope of 4.0 percent. Figure 1 depicts the drainage basin.

Maltanner Creek is a steep watercourse that generates a substantial amount of stream power during high flows. The bridges that span the creek are undersized, which restricts flows and causes flooding in the village of Middleville. The Maltanner Creek channel is lined by steep hillslopes that are eroding and contributing a coarse-grained sediment load to the creek, further restricting the channel and bridge capacity.

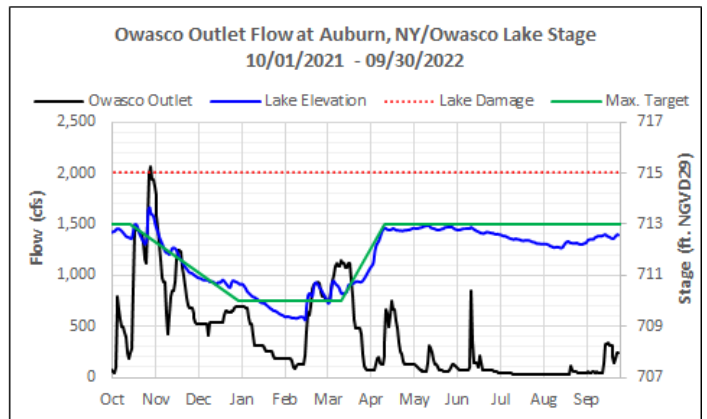
### Hydrographs for Oswego River Basin

1. Vertical datum is National Geodetic Vertical Datum of 1929 (NGVD29).
2. "Lake Damage" is the Owasco Lake stage (El. 715 ft. NGVD29) where damage to existing structures along the lake's shoreline is initiated.
3. "Owasco Outlet" is the flow (cfs) exiting Owasco Lake as measured at USGS Gage No. 04235440 Owasco Outlet at Genesee Street, Auburn, NY.
4. "Max. Target" is the rule curve that the lake regulator, City of Auburn, follows to make adjustments to the control structure at the lake's outlet.

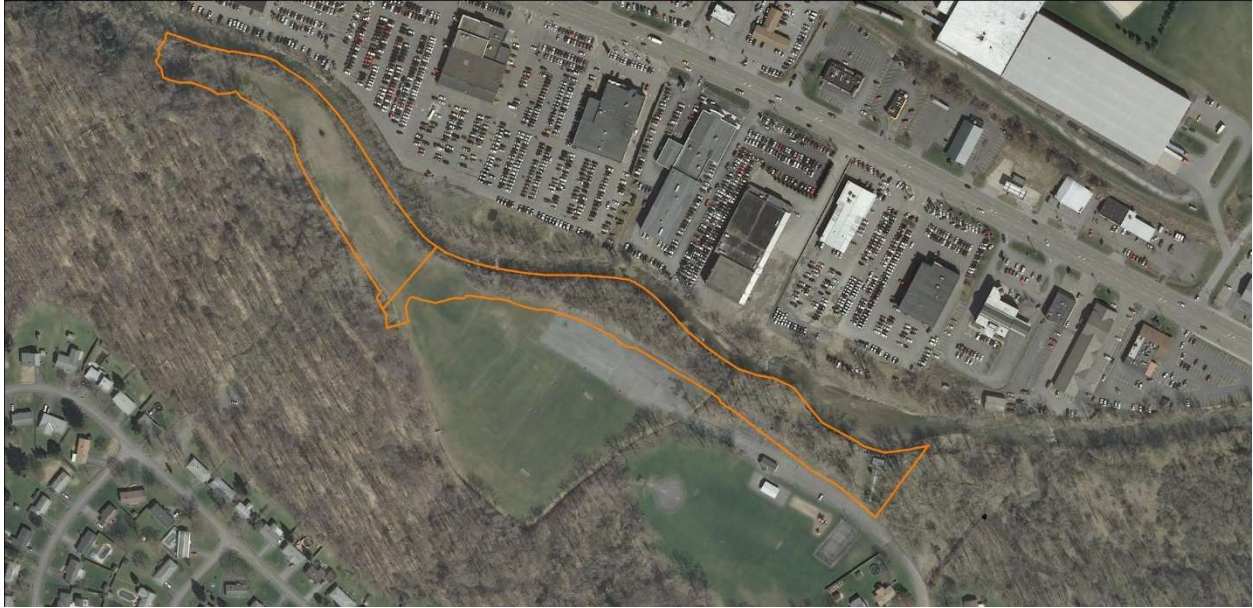
The purpose of this multi-phase floodplain restoration project is to create additional flood storage during high flow events on Sauquoit Creek, resulting in significant reductions in peak flood flows and the resultant flood damages to residents and business along Sauquoit Creek. Prior to construction, the eastern portion of Sauquoit Creek would routinely flood Commercial Drive during high precipitation events, causing extensive damage to businesses along this stream corridor. Construction was completed in August 2022. Total cost to construct this project was \$3.6 million with funding provided by New York State Environmental Facility Corporation’s (EFC) Green Innovation Grant Program (GIGP).

Figure 1. Aerial view of approximate extent of Project 1 floodplain restoration within Dunham Manor Park, Town of Whitestown.

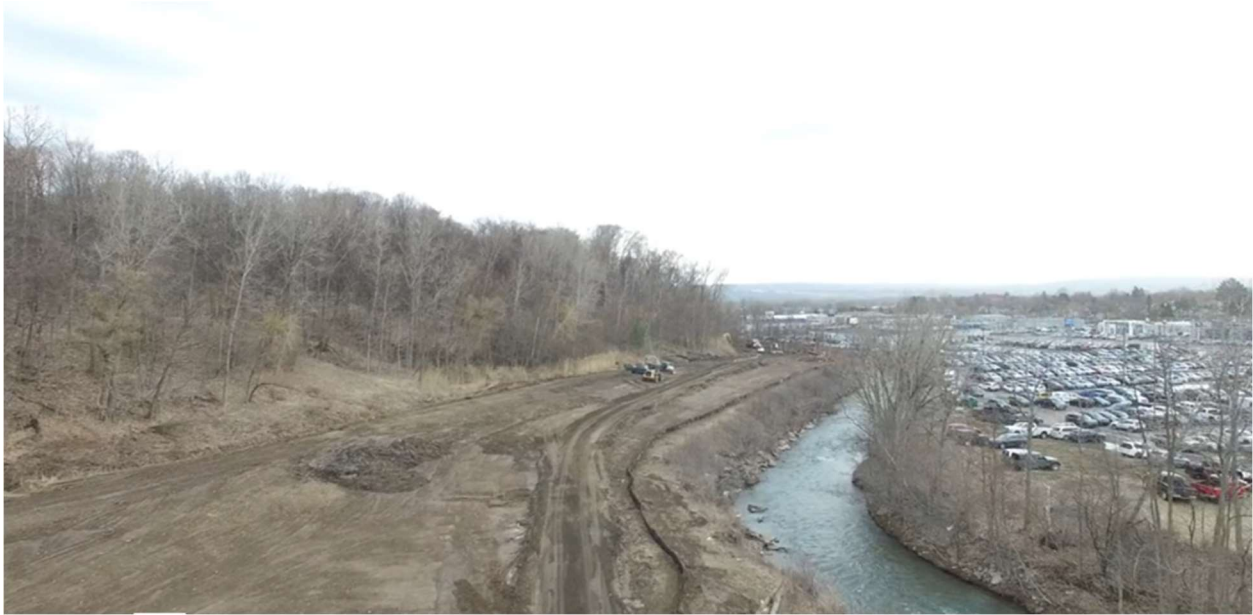
Figure 2. Aerial view of Project 1 underway in Dunham Manor Park, Town of Whitestown.

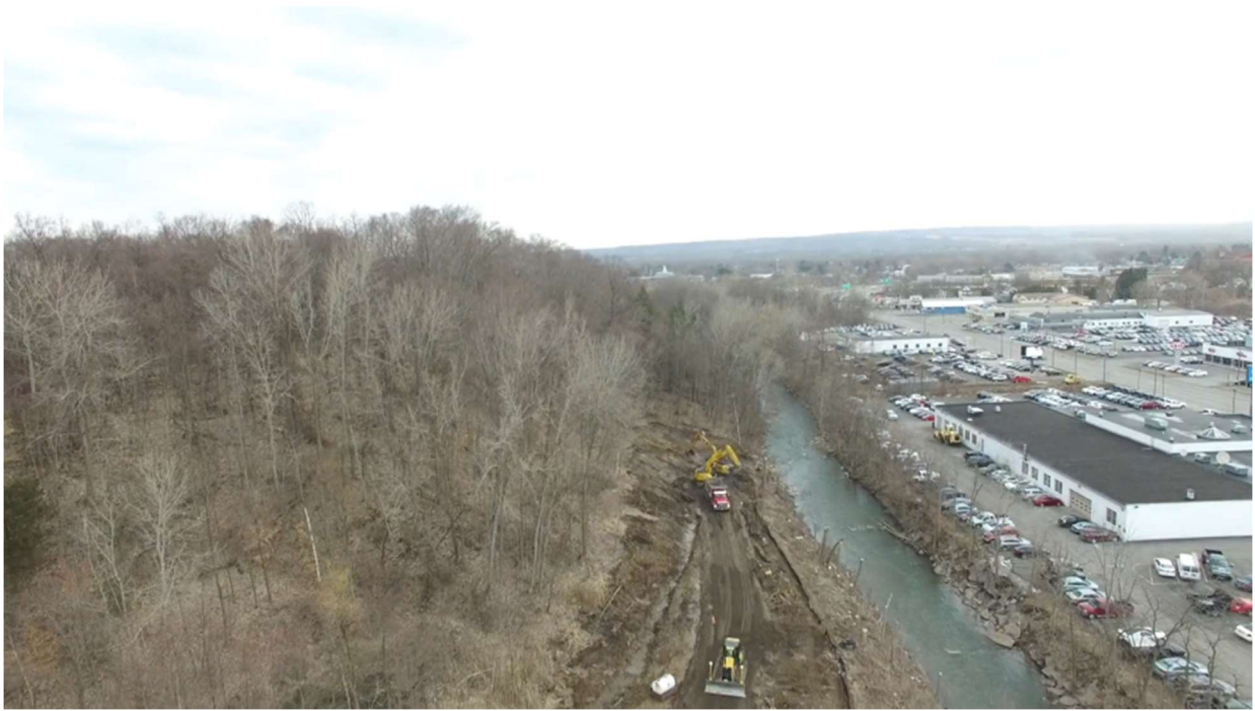
Figure 3. Aerial view of Project 1 underway in Dunham Manor Park, Town of Whitestown.

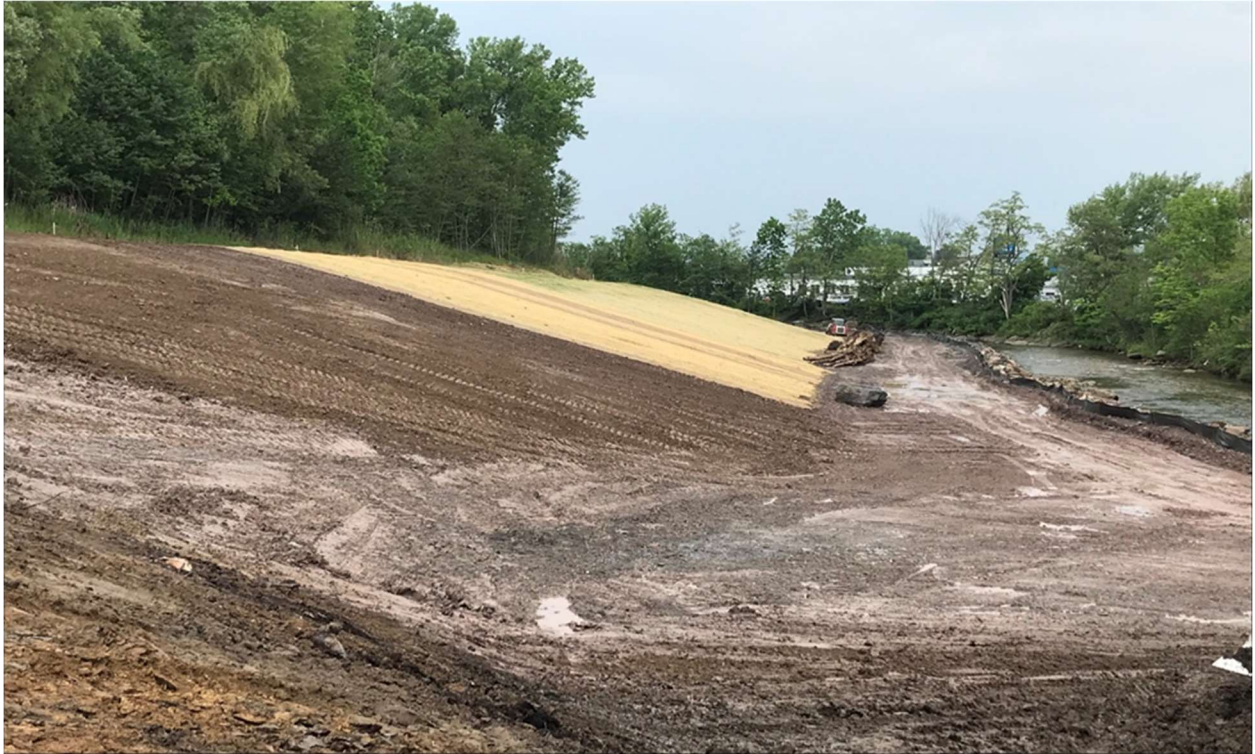
Figure 4. Ongoing construction of Project 1 underway in Dunham Manor Park, Town of Whitestown.

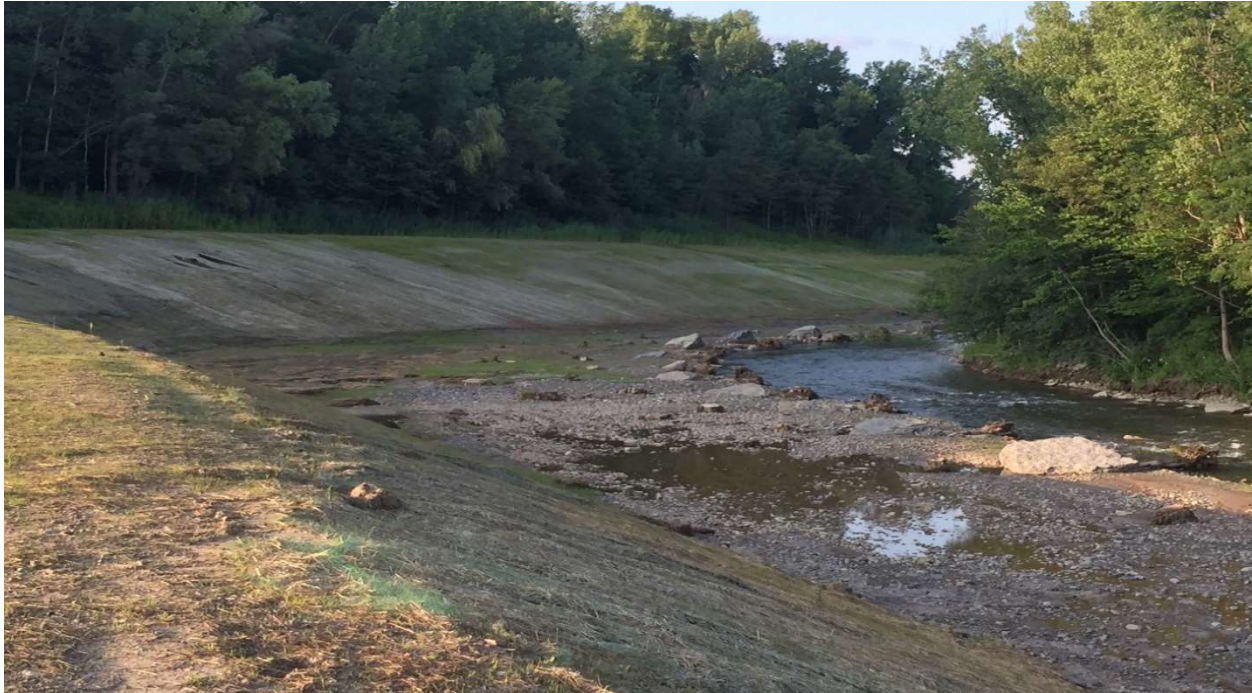
Figure 5. Completed construction of Project 1 within Dunham Manor Park, Town of Whitestown.

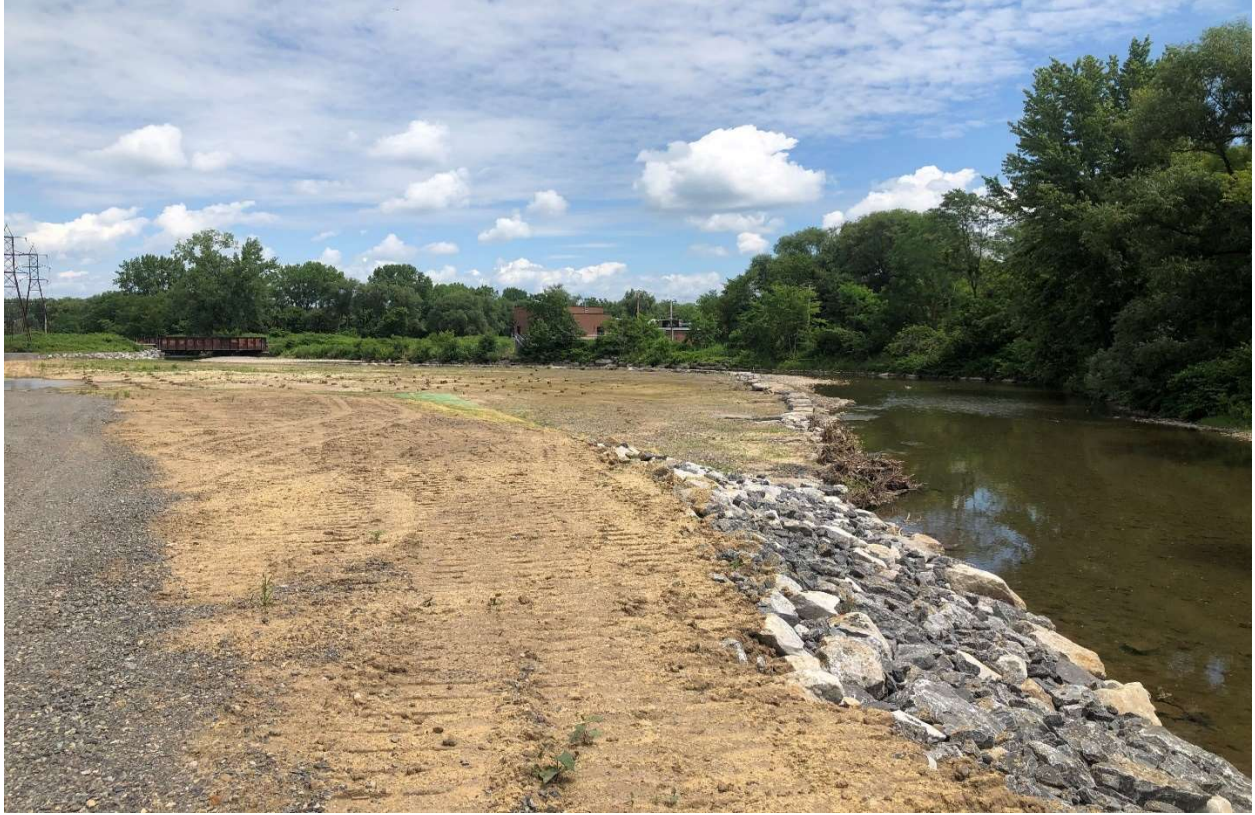
Figure 6. Ground level view of Project 2 floodplain restoration just south of CSX railroad. CSX bridge is in the background.

Further downstream on Sauquoit Creek within the Village of Whitesboro, a second flood mitigation project was undertaken by the Town of Whitestown. Known as Project 2 of the Sauquoit Creek Channel & Floodplain Restoration Program, this project included the restoration of an additional 12 acres of floodplain (Figure 6), along with the installation of five 48-inch culverts underneath the CSX Rail Line (Figure 7). These two flood mitigation projects have been hydraulically modeled and will significantly reduce flood flow elevations within this portion of Sauquoit Creek, which experiences chronic and severe flooding to homes and businesses within the Village of Whitesboro. Total cost to construct this project was \$3.7 million with funding provided by EFC’s GIGP and \$1.0 million was provided by NYDOT to design and install the five culverts in the CSX railroad bed.

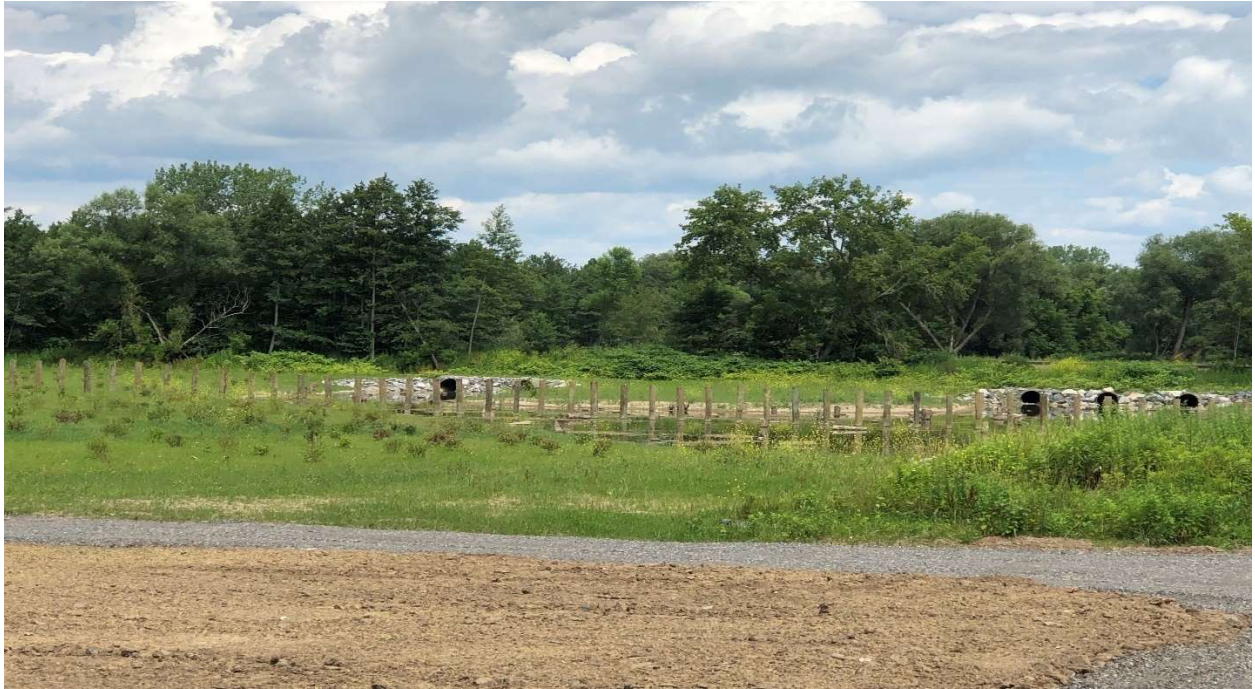
Figure 7. Ground level view of Project 2 floodplain restoration and the installation of five 48-inch culverts in CSX railroad bed.

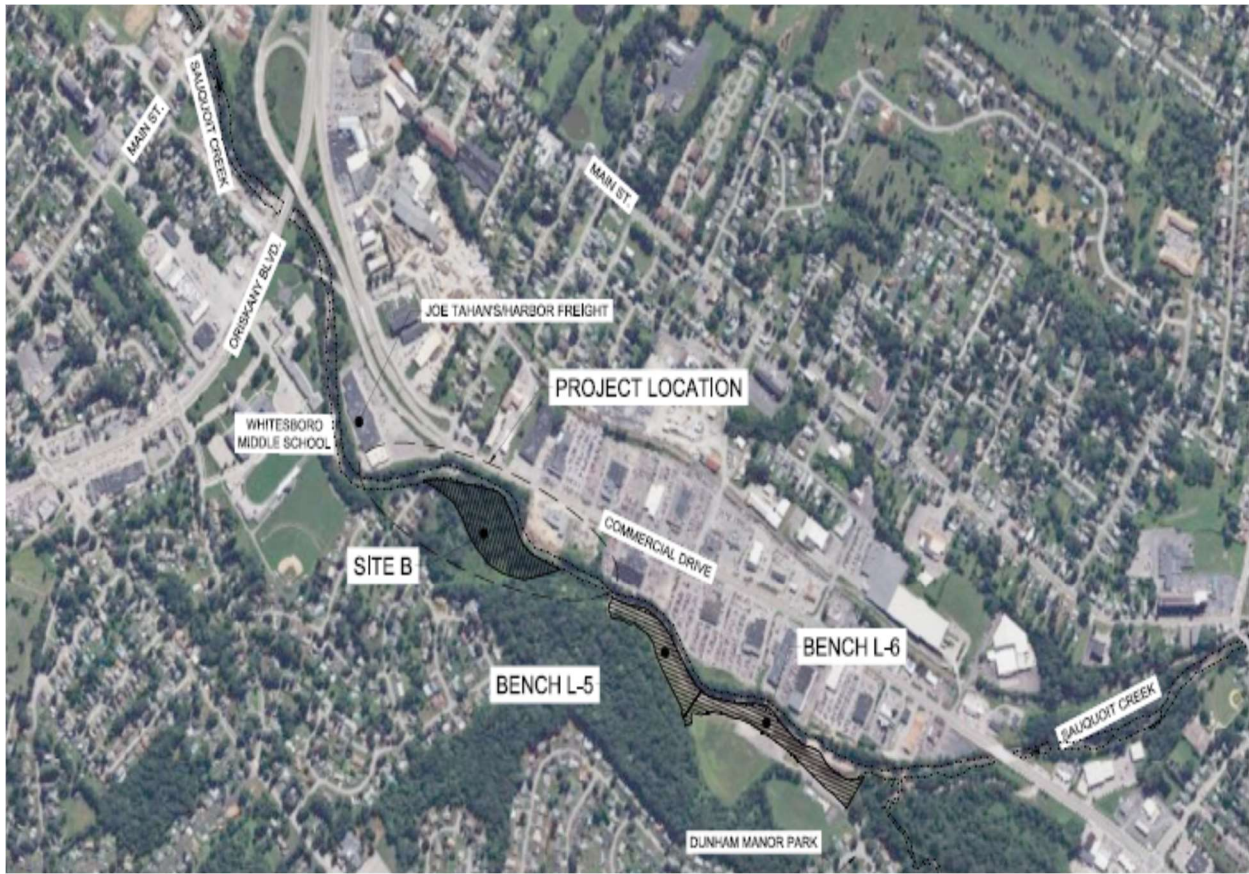
Further upstream on Sauquoit Creek within the Town of Whitestown, Project 3 – Site B consists of an additional 5 acres of restored floodplains (Figure 9). This project is located directly downstream from Dunham Manor Park, extending the two floodplains that were previously restored in this area. Construction of this floodplain restoration project is anticipated in 2024.

Figure 9. Aerial view of Project 3-Site B along Sauquoit Creek within town of Whitesboro. This project is located just downstream from the floodplains that were restored in Dunham Manor Park.

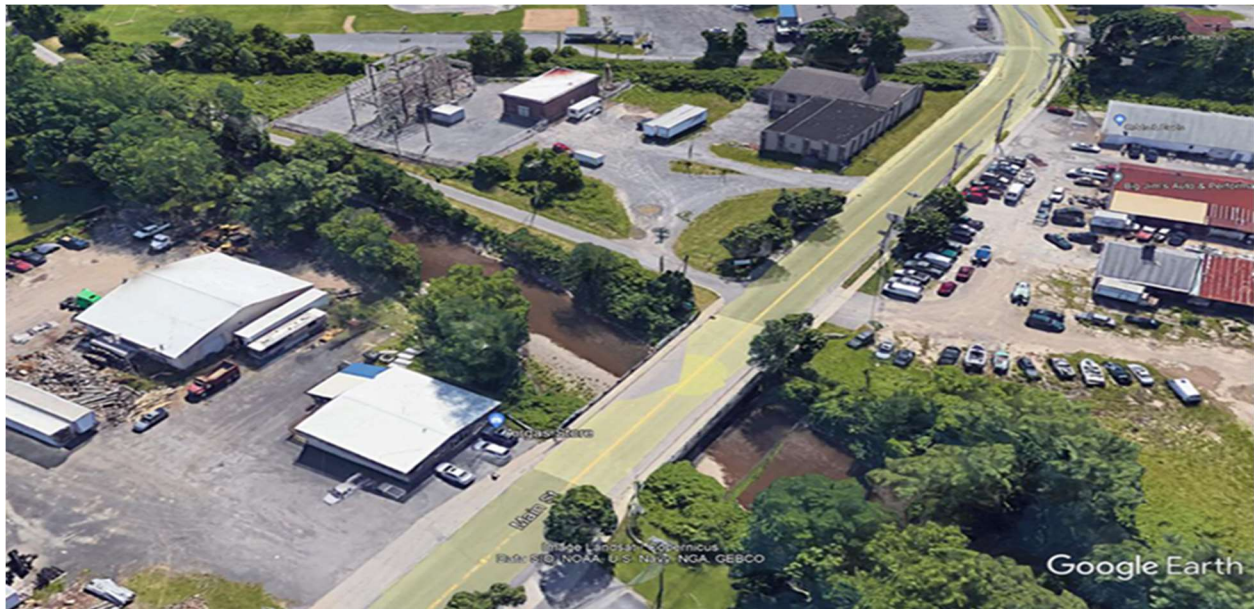
Just upstream from the CSX floodplain restoration project, the New York State Department of Transportation (NYSDOT) will be replacing two significantly undersized bridges that cross the lower Sauquoit Creek within the Village of Whitesboro. Main Street bridge and State Route 69 or “Oriskany Boulevard” bridge (Figures 10 - 13) bridges will be replaced with significantly larger spanned structures, which will allow floodwaters to safely pass underneath the bottom (i.e., low chord) of the bridges. This will also reduce the potential for debris and ice jams that have historically occurred at these structures, further reducing the potential of flooding in this area. NYSDOT is also incorporating additional floodplain restoration measures between both bridge replacement projects to further enhance flood mitigation benefits within the Village. These two major capital replacement and restoration initiatives should be fully designed in 2024 with construction anticipated in 2025/2026 timeframe.

Figure 10. Aerial view of Main Street bridge that will be replaced and upsized by NYSDOT. Please note areas just upstream of this bridge will also be restored to natural floodplains all the way up to State Route 69 bridge.

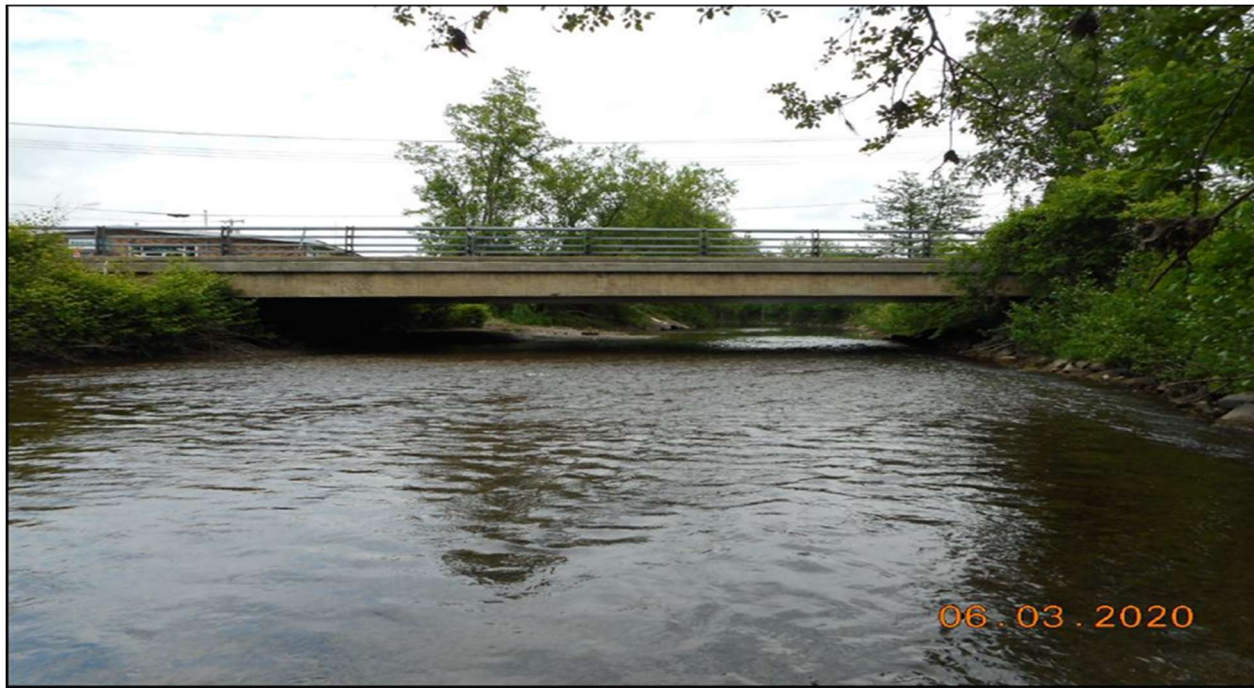
Figure 11. Ground level view of Main Street bridge that will be replaced and upsized by NYSDOT.

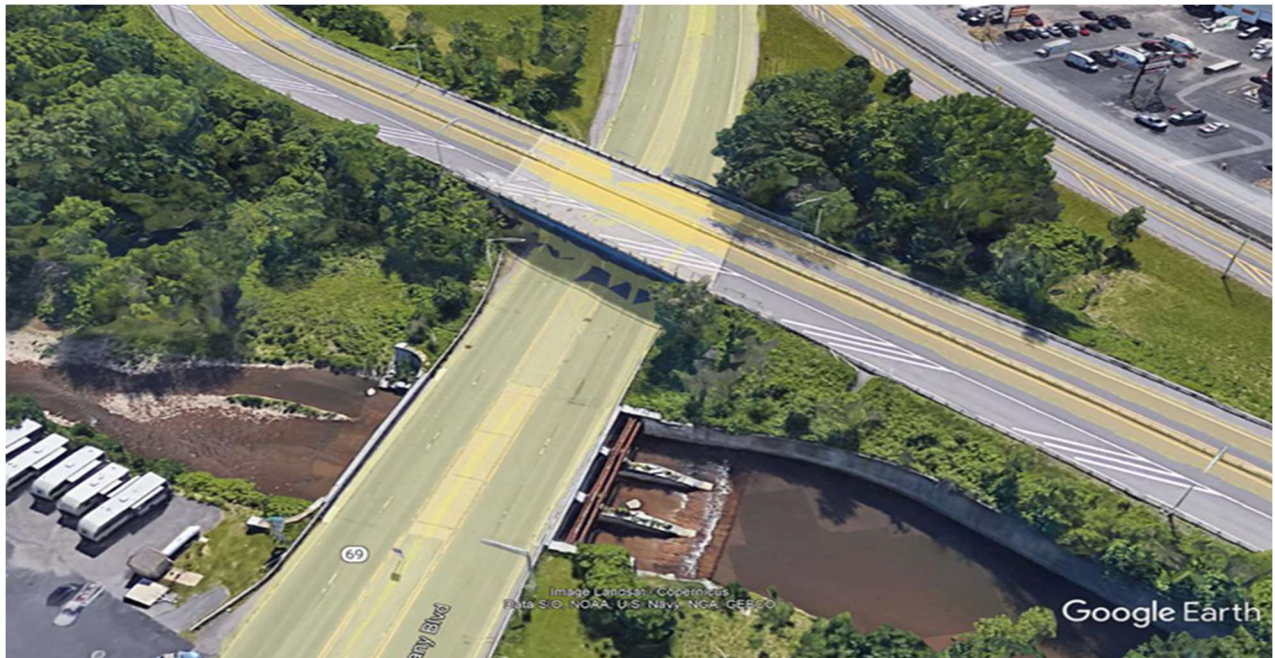
Figure 12. Aerial view of State Route 69 or Oriskany Boulevard Bridge that will be replaced and upsized by NYSDOT.

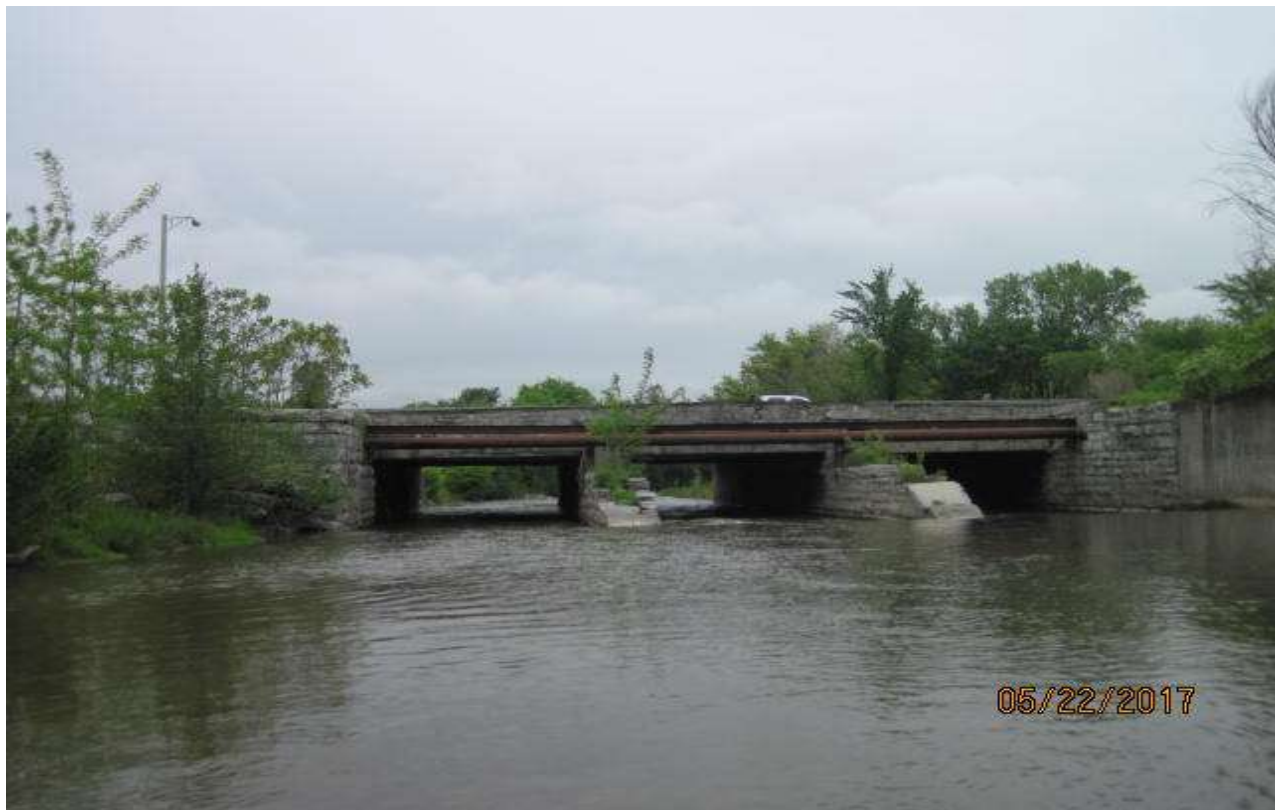
Figure 13. Ground-level view of State Route 69 or Oriskany Boulevard bridge the will be replaced by NYSDOT. This bridge is a chronic source of debris/ice jams due to the remnants of the old Erie Canal Aqueduct adjoining the bridge piers. The old Erie Canal Aqueduct structure will be removed as part of the new bridge replacement to alleviate future debris/ice jams.

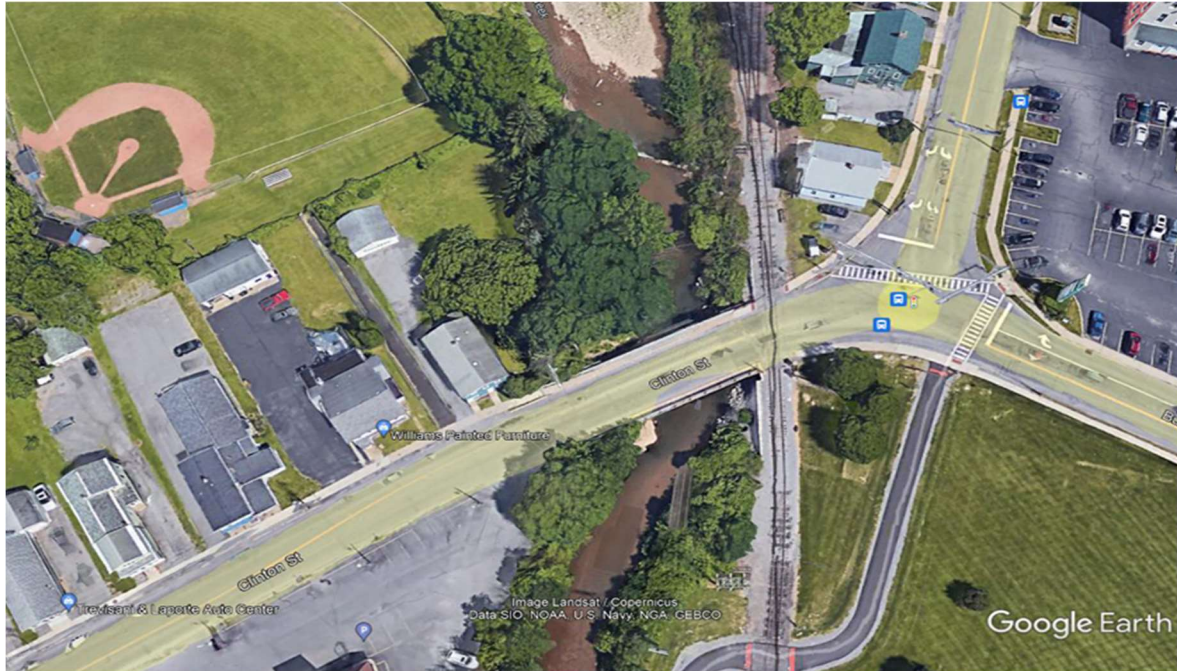
Given site constraints, the new bridge structure is expected to pass the current 100-year recurrence interval without causing backwater. The Town of New Hartford has secured \$1.6 million through NYSDOT's local federal-aid transportation program to support preliminary design of this project. The Town of New Hartford is also pursuing FEMA Hazard Mitigation Grant Program (HMGP) funding to cover additional costs incurred as a result of significantly upsizing this bridge structure.

Figure 15. Aerial view of Clinton Street bridge replacement on Sauquoit Creek by the Town of New Hartford.

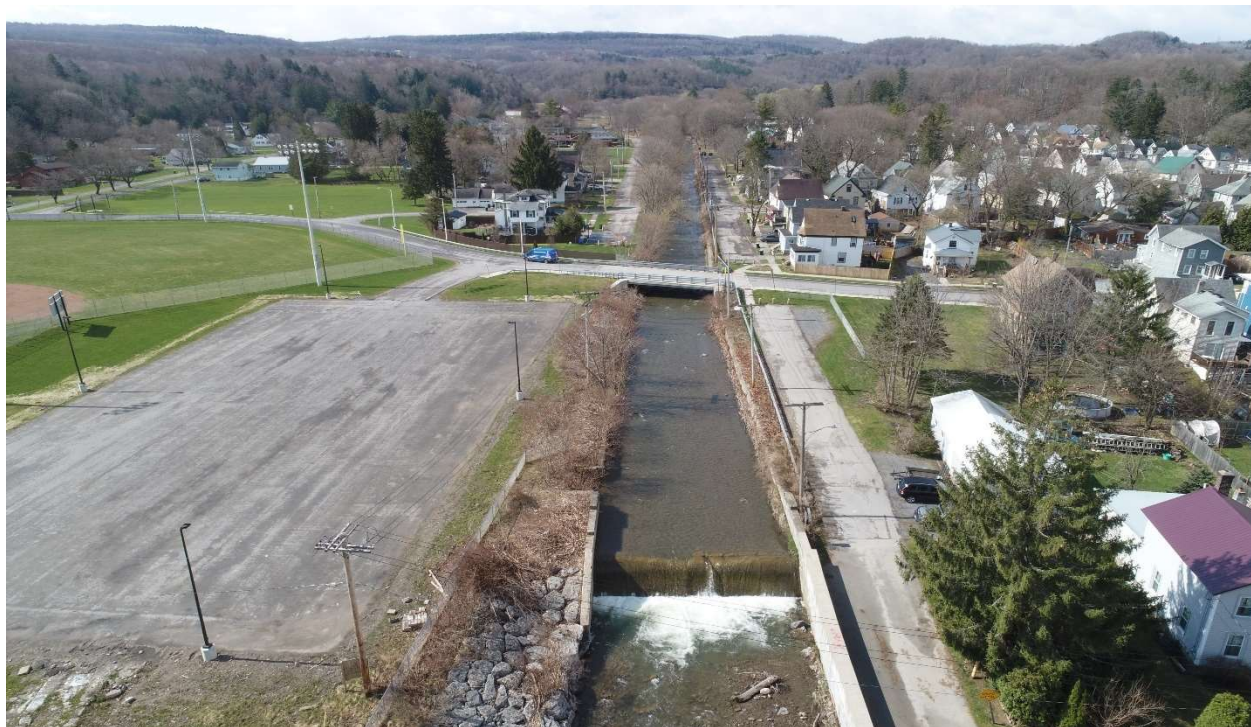
Figure 18 Preconstruction – Aerial view of Steele Creek looking upstream. Remington Arms Company Dam is in the foreground, which causes the channel bed to be raised by as much as 15 feet, contributing to frequent and damaging flooding within the community.

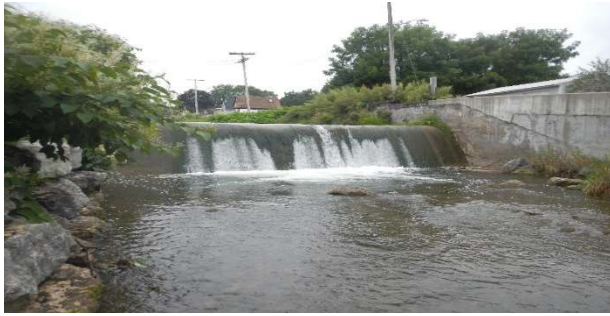
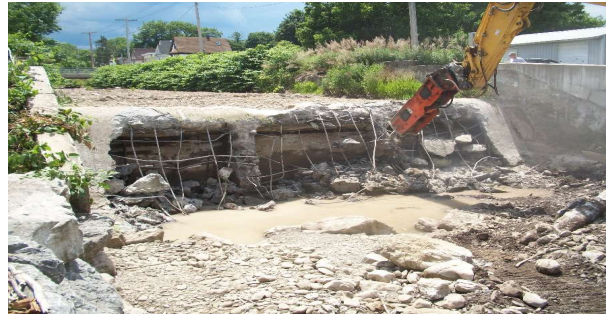
Figure 19 Remington Arms Company Dam before (left) and during (right) project construction, Steele Creek, Village of Ilion.

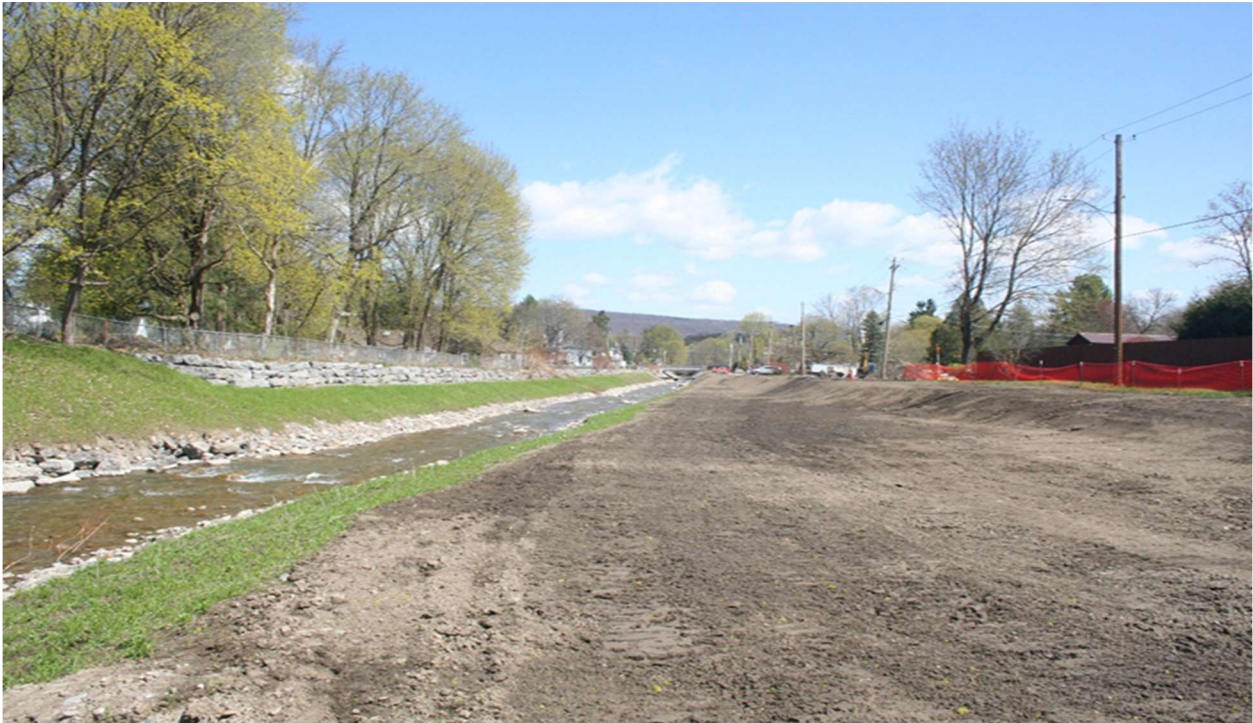
Figure 21. During construction – view looking downstream showing stream channel and floodplain restoration on Steele Creek, Village of Iliion.

A second stream and floodplain restoration project was also completed in the upper portion of Steele Creek within the Village of Ilion (figure 17 and 18). This project covered Steele Creek beginning at the Clapsaddle Farm Road bridge, extending north to just beyond English Street and Central Valley Academy. This project included properly sizing a new stream channel, stream bank stabilization, removal of the Remington Arms Company Dam, and partial removal of East River Drive to facilitate additional floodplain restoration (Figures 19 -24). This comprehensive, multifaceted flood mitigation project will provide additional flow capacity through this stream reach, greatly reducing potential of future flooding to residents in area.

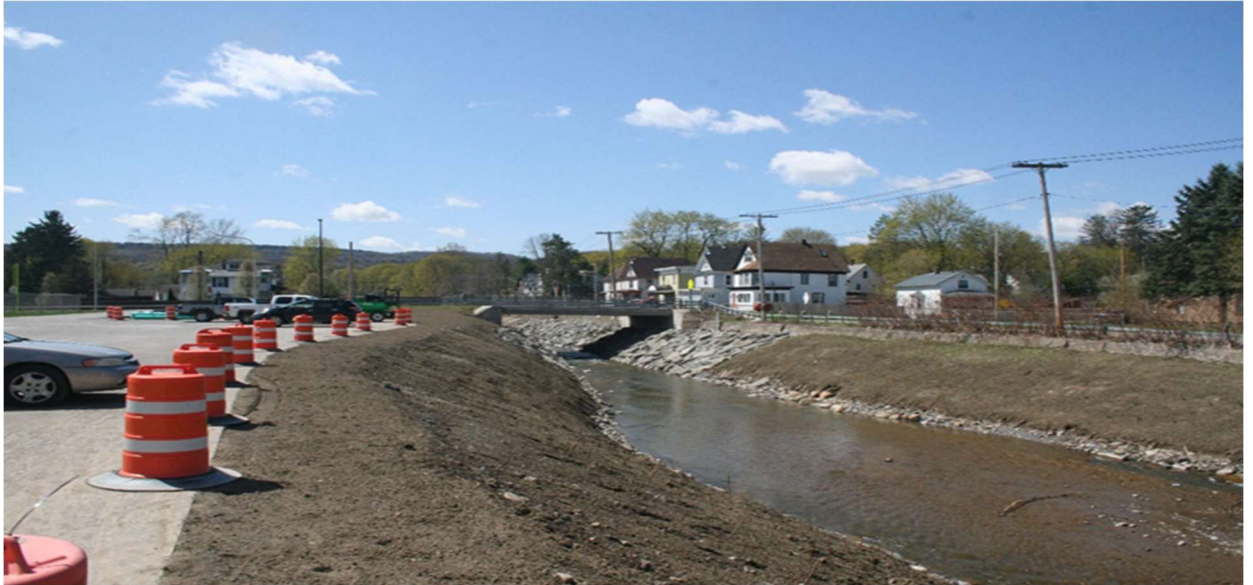
Figure 22. During construction – view looking upstream towards Fredrick’s Street bridge on Steele Creek within the Village of Iliion..

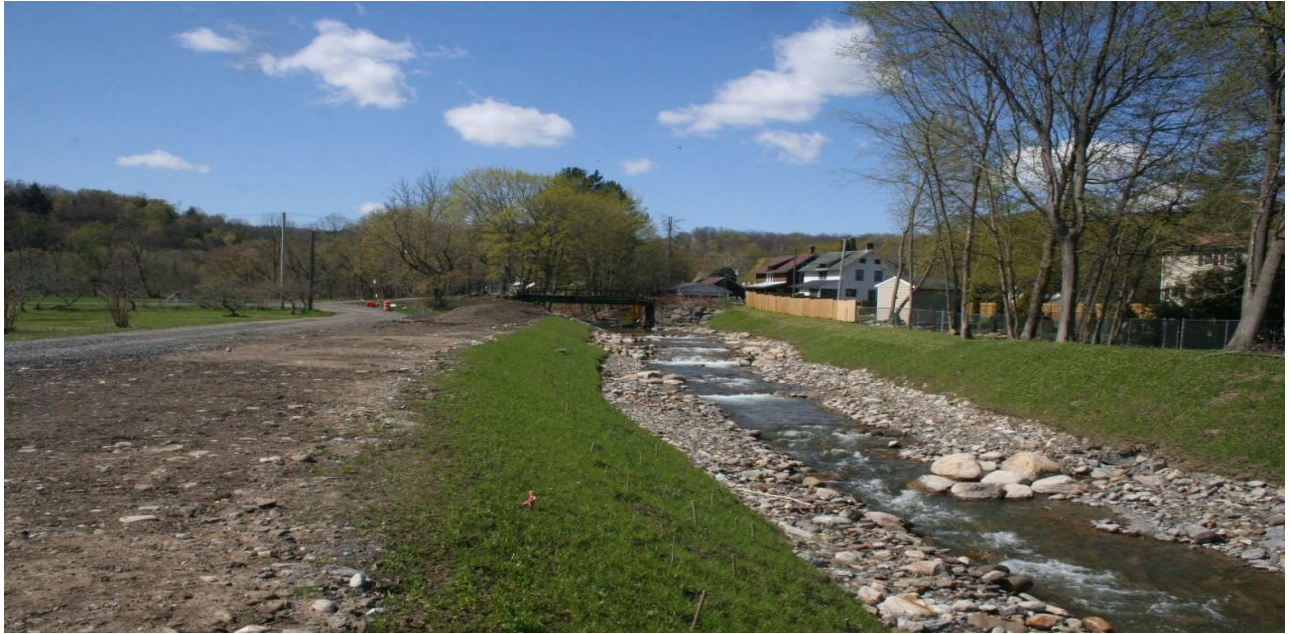
Figure 23. Post construction – View of upstream portion of Steele Creek restoration showing stream channel with in-stream features, floodplain restoration and partial removal of East River Drive. Flood buyouts also occurred to the left, just outside the picture.

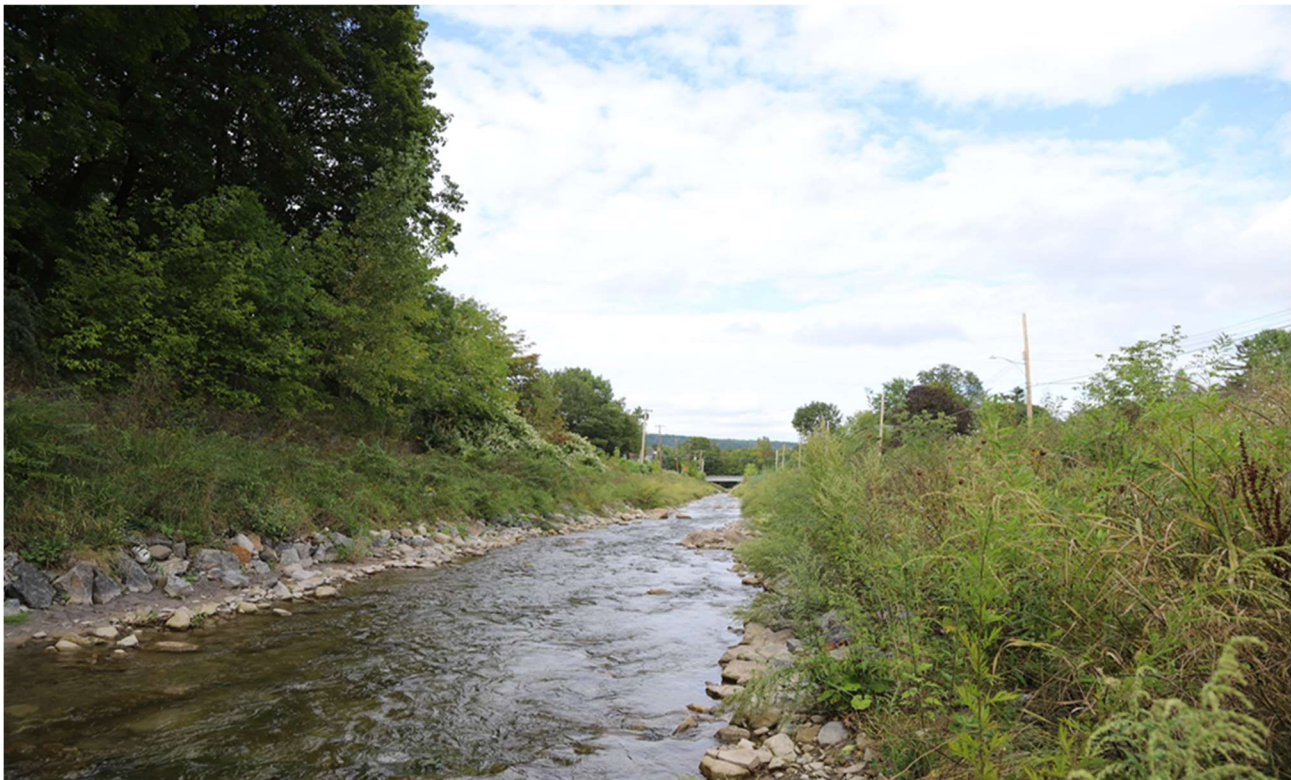
Figure 24. Post construction - View looking downstream on Steele Creek two years after the project was constructed. In-stream features are visible in the channel. The constructed floodplain conveys flood flows during major storm events.

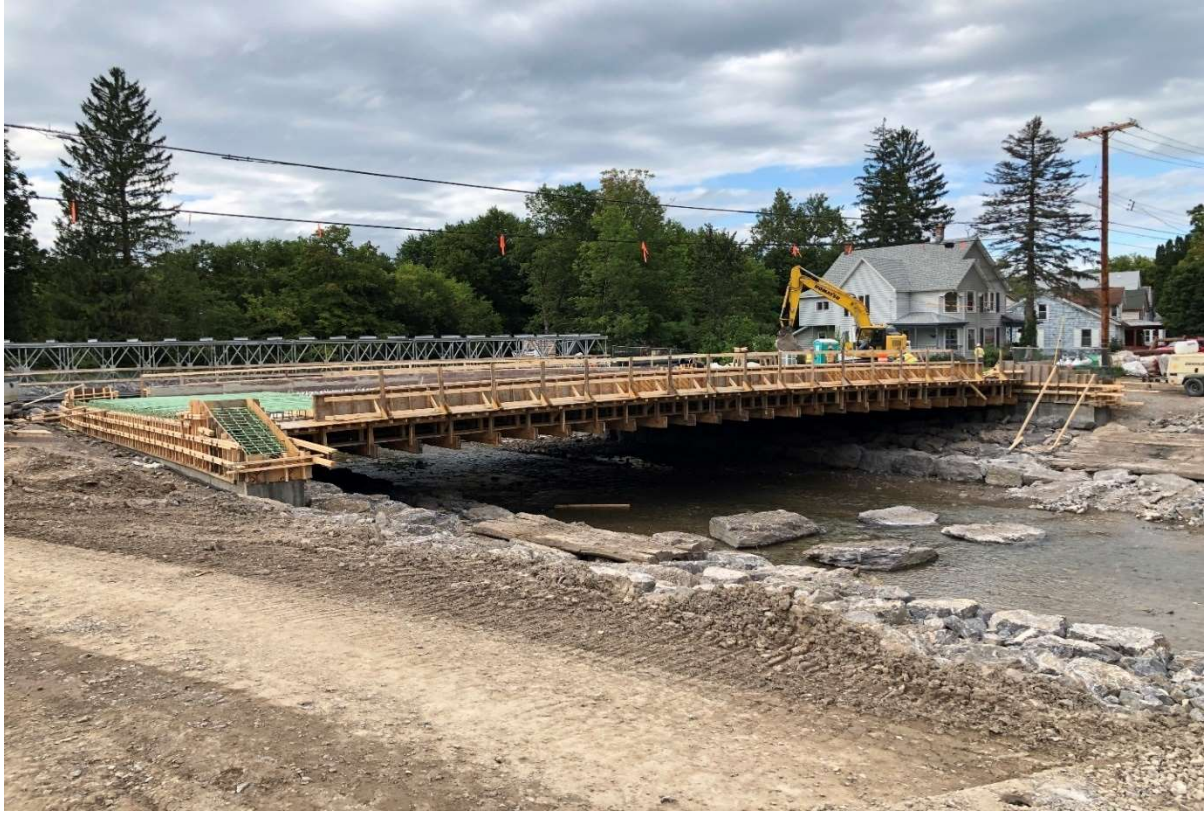
Figure 26 – Photo of new State Route 51 (Otsego Street) bridge being replaced by NYSDOT. Several homes surrounding the bridge were acquired by the Village giving NYSDOT sufficient area to install a significantly larger structure.
