## APPENDIX A

UPSTATE FLOOD MITIGATION TASK FORCE

# **Mohawk River Basin Report Abstracts & Summaries**

FEBRUARY 2023

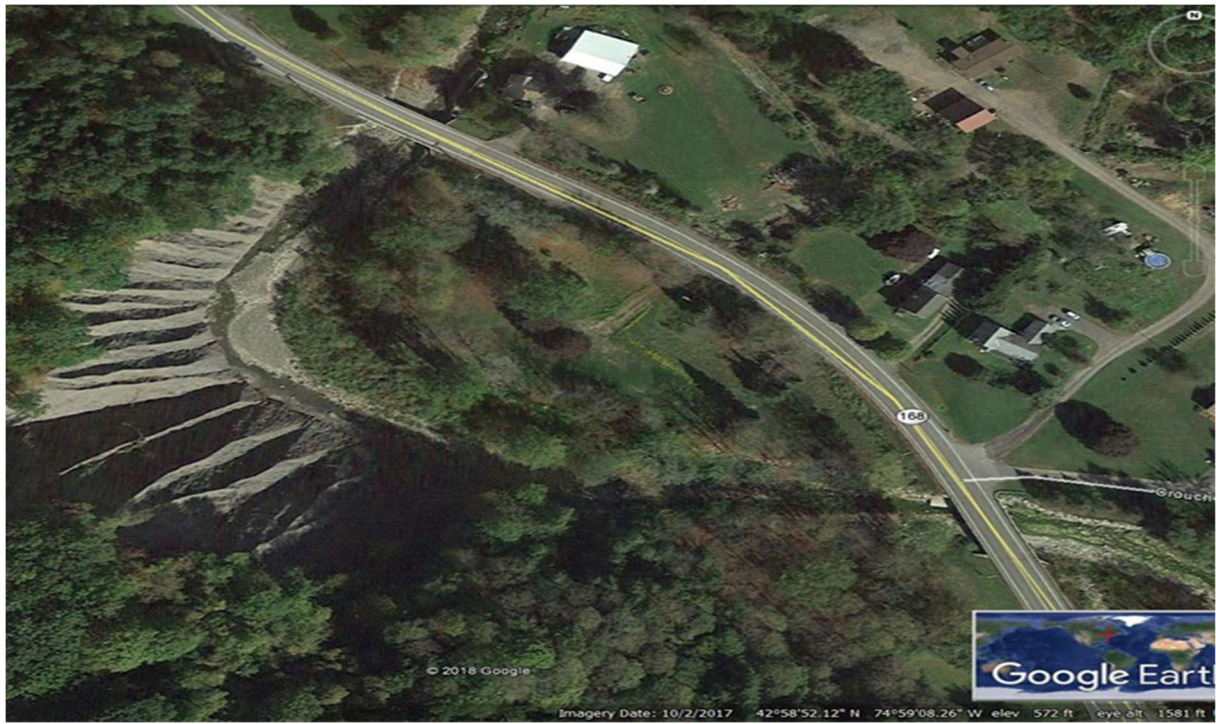
Figure 29. Aerial view of massive slope failure on Fulmer Creek.

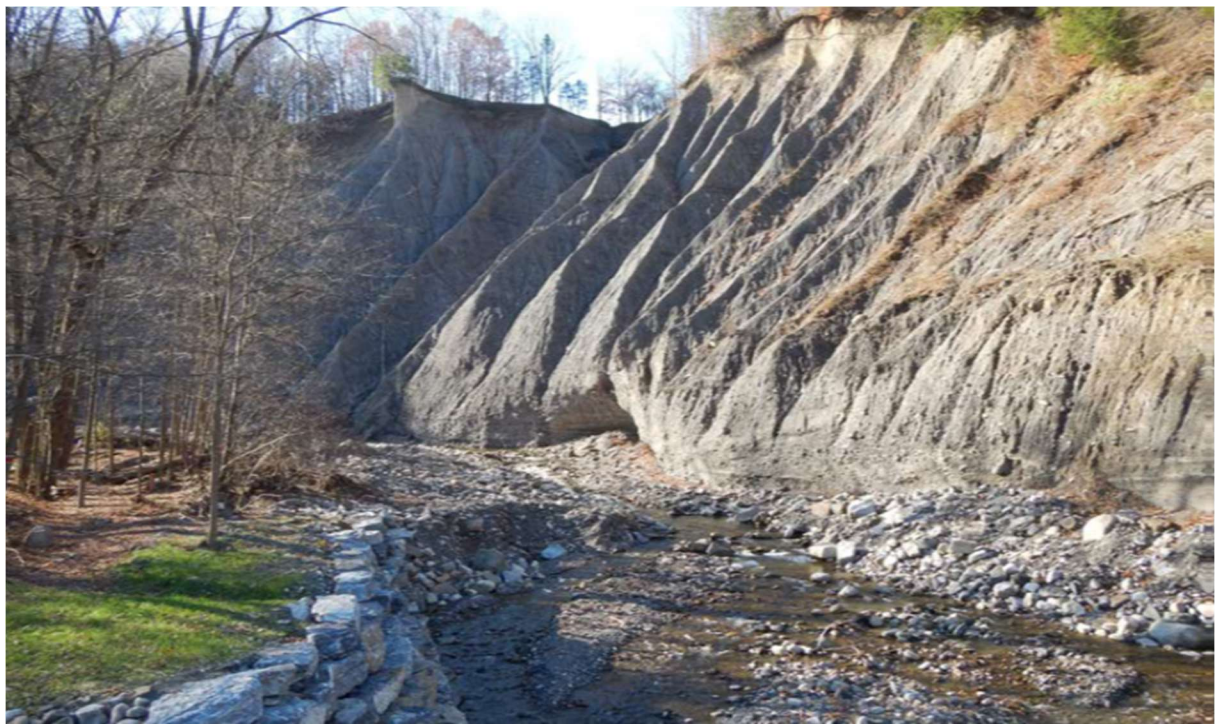
Figure 30. Looking upstream at massive slope failure on Fulmer Creek.

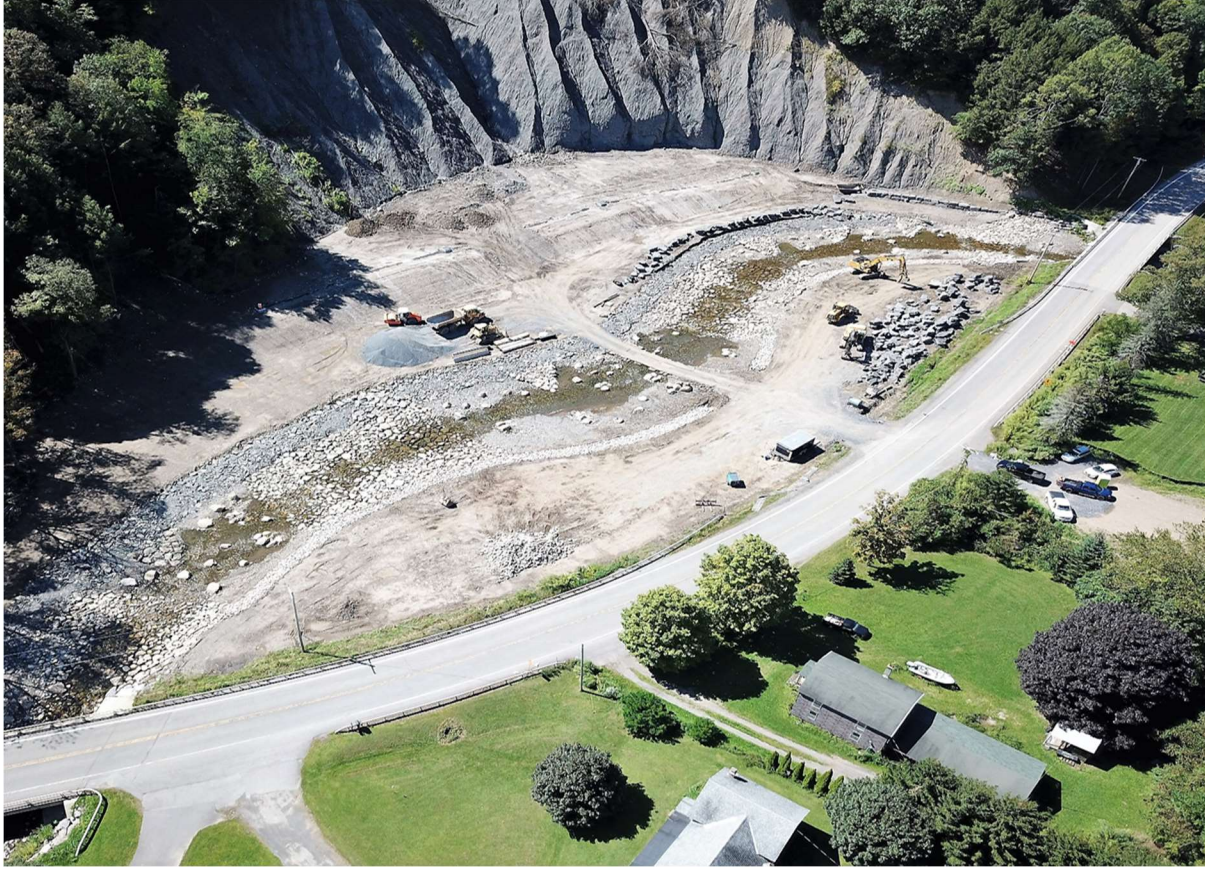
Figure 31. Aerial view of ongoing slope stabilization and floodplain restoration project on Fulmer Creek.

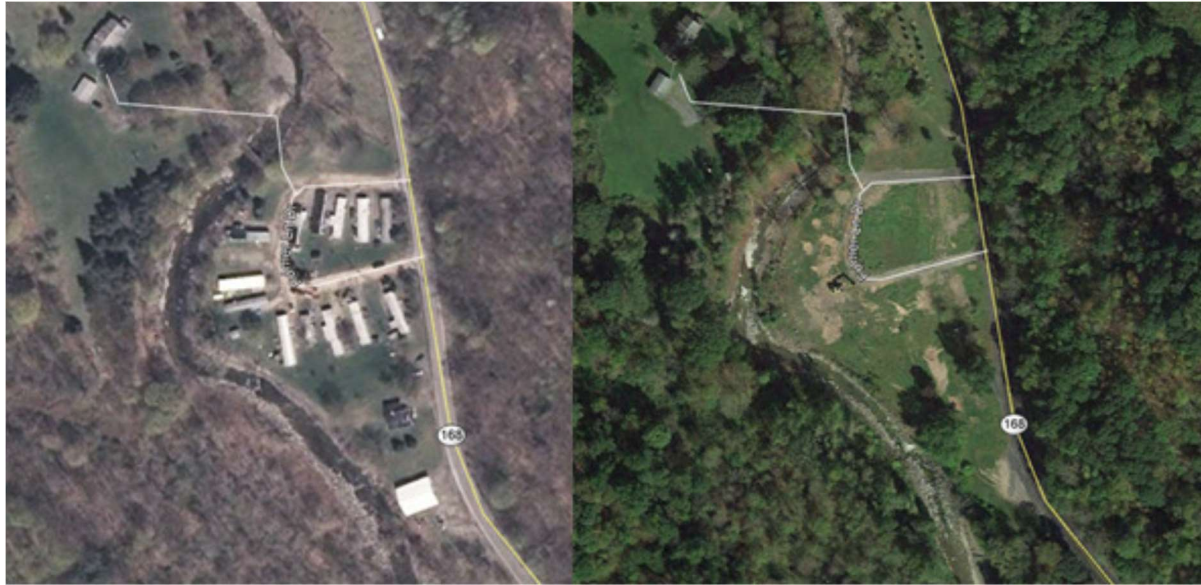
BEFORE ACQUISITION & DEMOLITION

AFTER ACQUISITION & DEMOLITION

Further downstream from the streambank stabilization project, this project involved acquisition of the former Leatherstocking Trailer Park property in the Town of German Flatts, the removal of flood damaged structures and infrastructure, the restoration of the floodplain, stream channel improvements, and the development of a recreational facility (Figure 32). This project not only removed residents from harm’s way, it also provided flood mitigation benefits to residents further downstream within the Village of Mohawk.

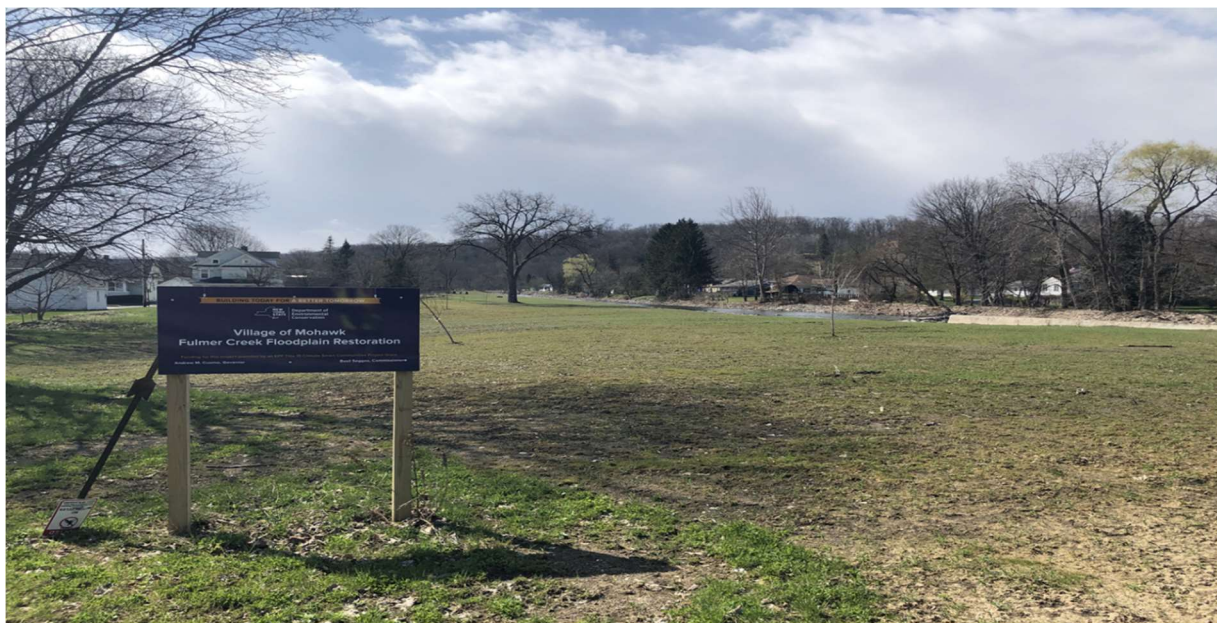
Figure 33. Photo of completed Fulmer Creek floodplain restoration project within Village of Mohawk.

Through the 2017 GIGP, EFC awarded the Village of Mohawk \$2 million to complete stream channel and floodplain restoration along approximately 2,900 feet of Fulmer Creek. This project included full channel improvements and floodplain restoration beginning several hundred feet below West Main Street bridge and extending up to the State Route 28 bridge (Figures 33 and 34). Total project cost (including local match) was \$2.2 million.

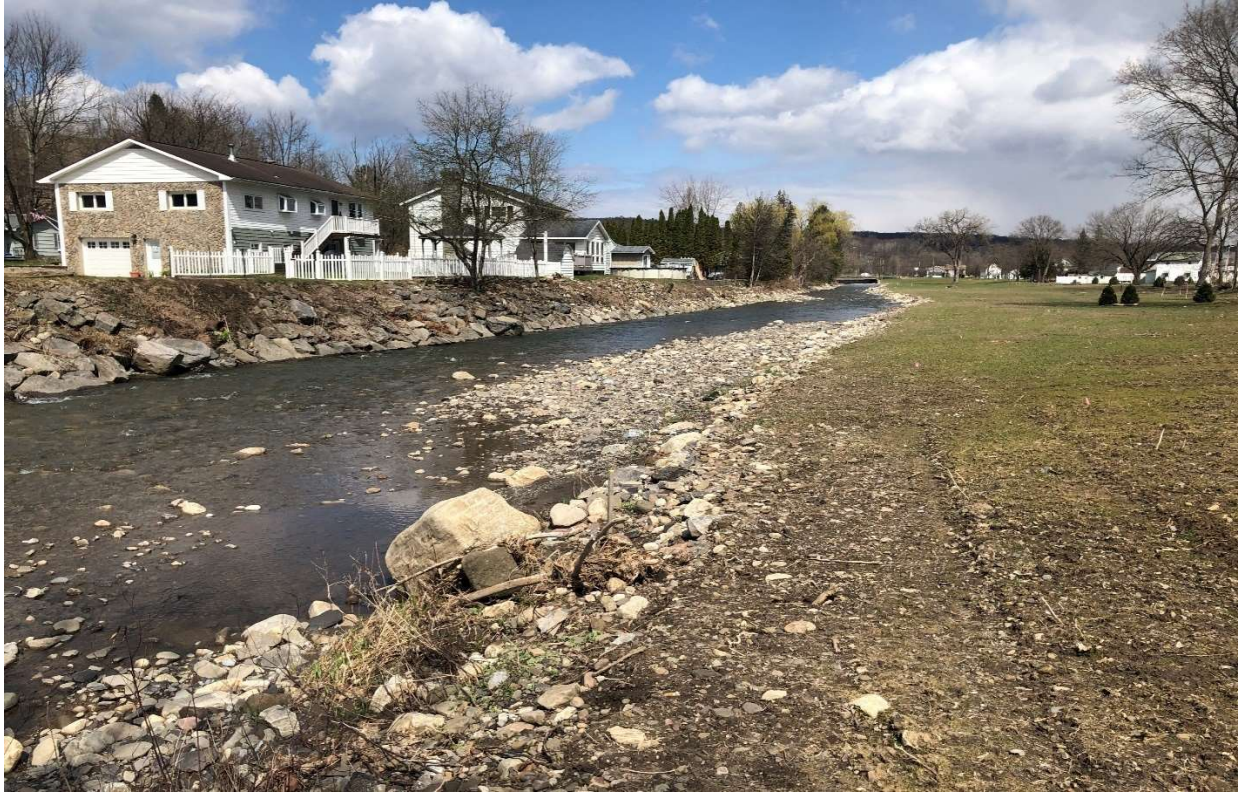
Figure 34. Photo of completed Fulmer Creek floodplain restoration project within Village of Mohawk.

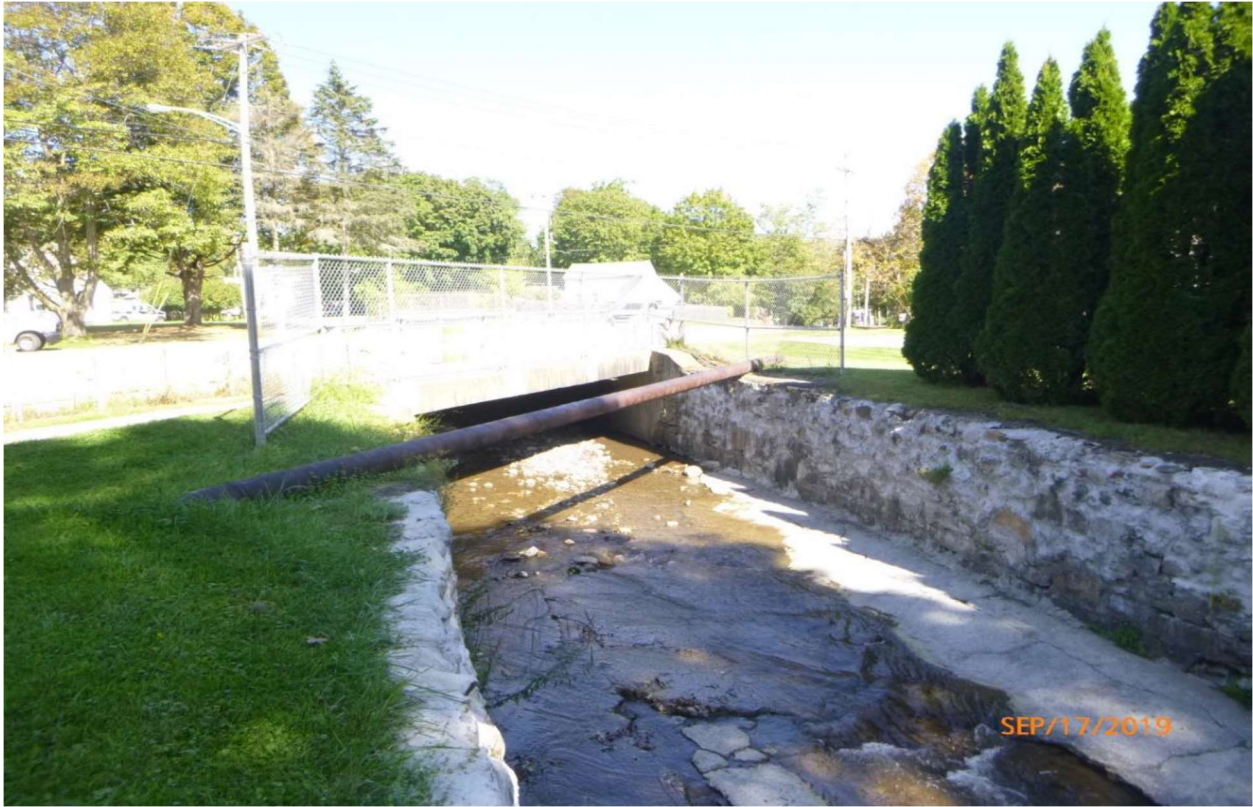
Figure 35. Photo of West German Street on Bellinger Brook within the Village of Herkimer.

The Village of Herkimer is currently in the process of replacing the West German Street bridge (Figures 35 and 36). The West German Street bridge is an old structure that is structurally deficient and was identified in the 2014 Bellinger Brook flood assessment/study as being significantly undersized from a hydraulics perspective. During flood events, this undersized structure causes water to back up and spill over the stream channel into the Village causing significant flooding and damage to residences and businesses. The new bridge span has been significantly increased and will be able to pass current and future flood flows anticipated from climate change. The enlarged bridge will also allow future stream channel and floodplain restoration work to be completed along Bellinger Brook.

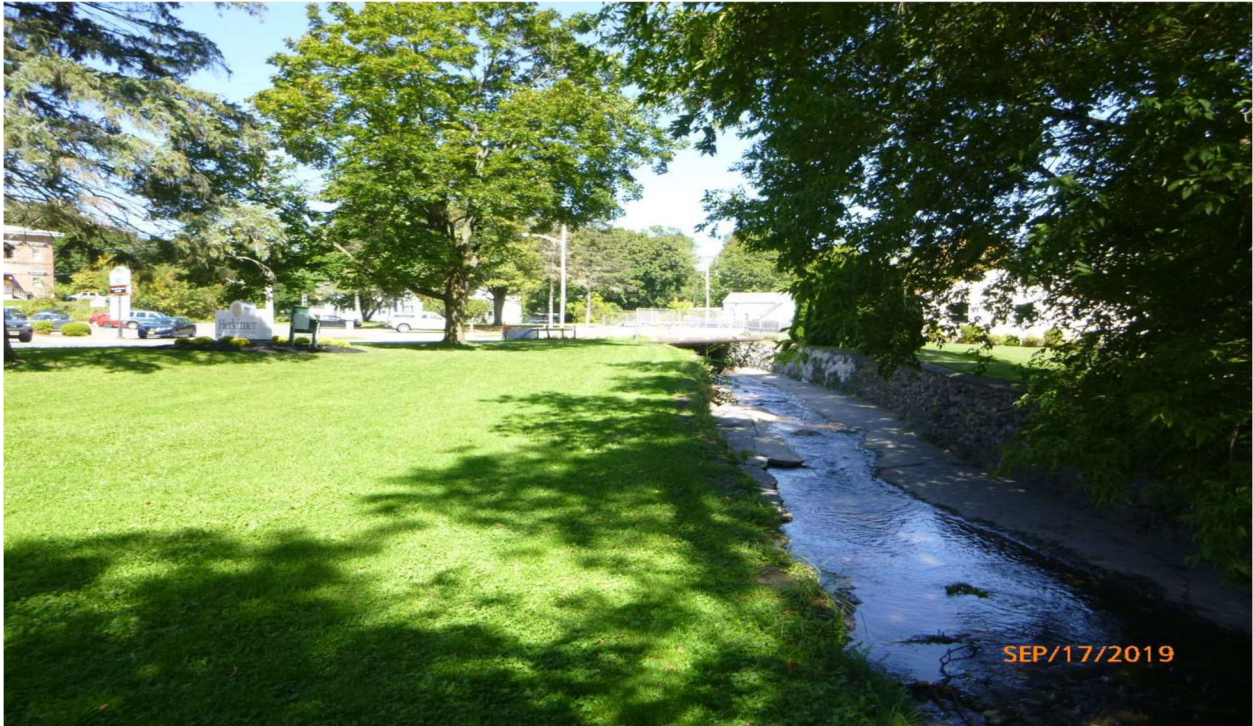
Figure 36. Bellinger Brook, looking north towards West German Street bridge crossing.

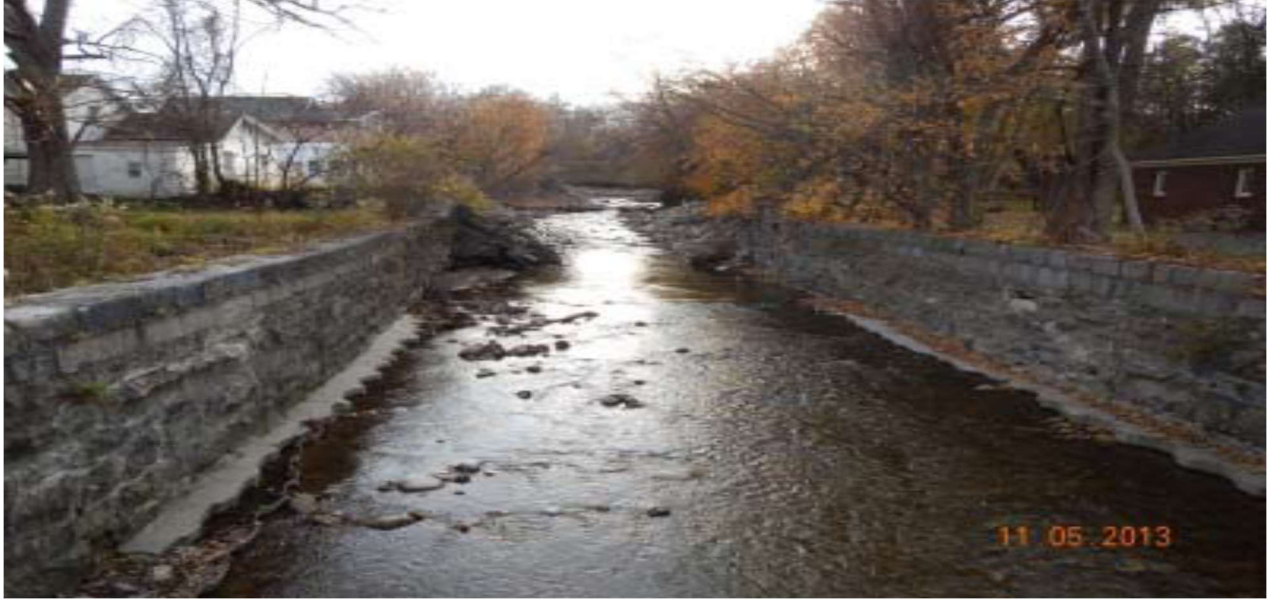
Figure 38. Looking upstream from the Main Street bridge, Moyer Creek is confined by the stone-lined channels before and after crossing Main Street.

The 2014 Moyer Creek flood assessment/study identified the Main Street bridge within the Village of Frankfort as a significant contributor to flooding (Figure 37 and 38). A timber crib dam is located 250 feet downstream of the Main Street bridge. This dam influences water surface elevations up to the Main Street bridge (Figure 39). To mitigate this flooding issue, the Village of Frankfort received funding to replace the Main Street bridge with a significantly larger structure, to restore the stream channel directly above and below the Main Street bridge and to remove the timber crib dam. These projects are expected to significantly improve flooding within the Village of Frankfort. This project is anticipated to be completed in 2024/2025.
