APPENDICES

Proposed Redevelopment of the former St. John Villa Campus

57 Cleveland Place

Staten Island, New York

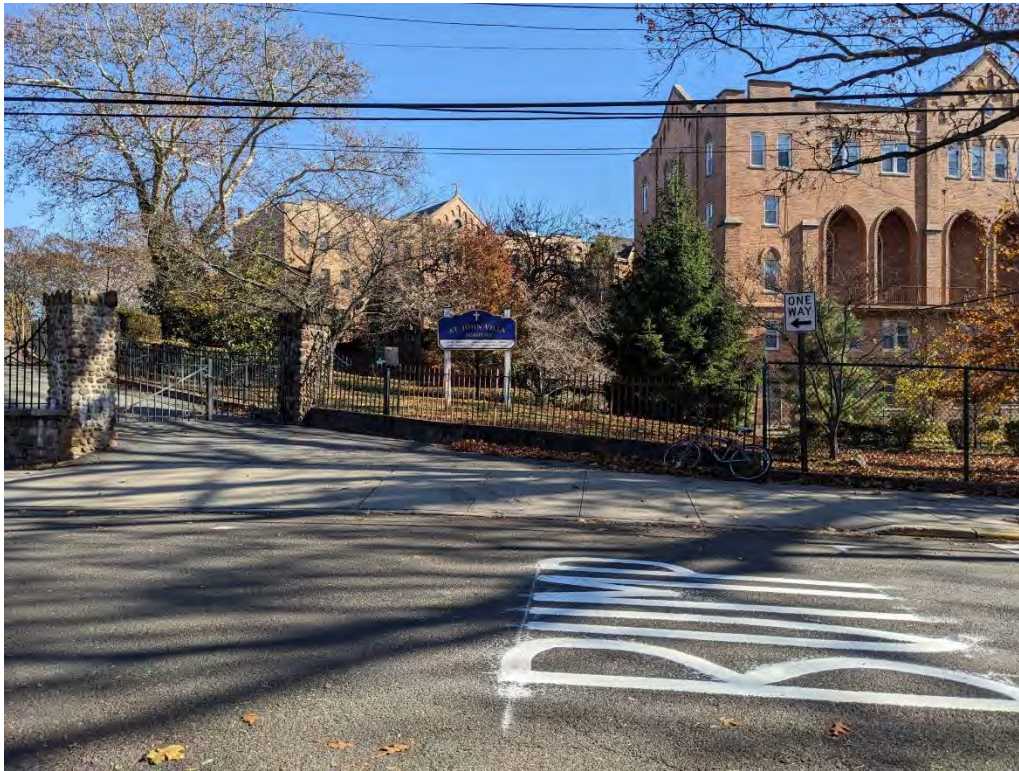
Photograph 1. The entrance to the St. John Villa campus from Cleveland Place. The former chapel building is on the right and the former elementary school building is in the far background. View looking east.

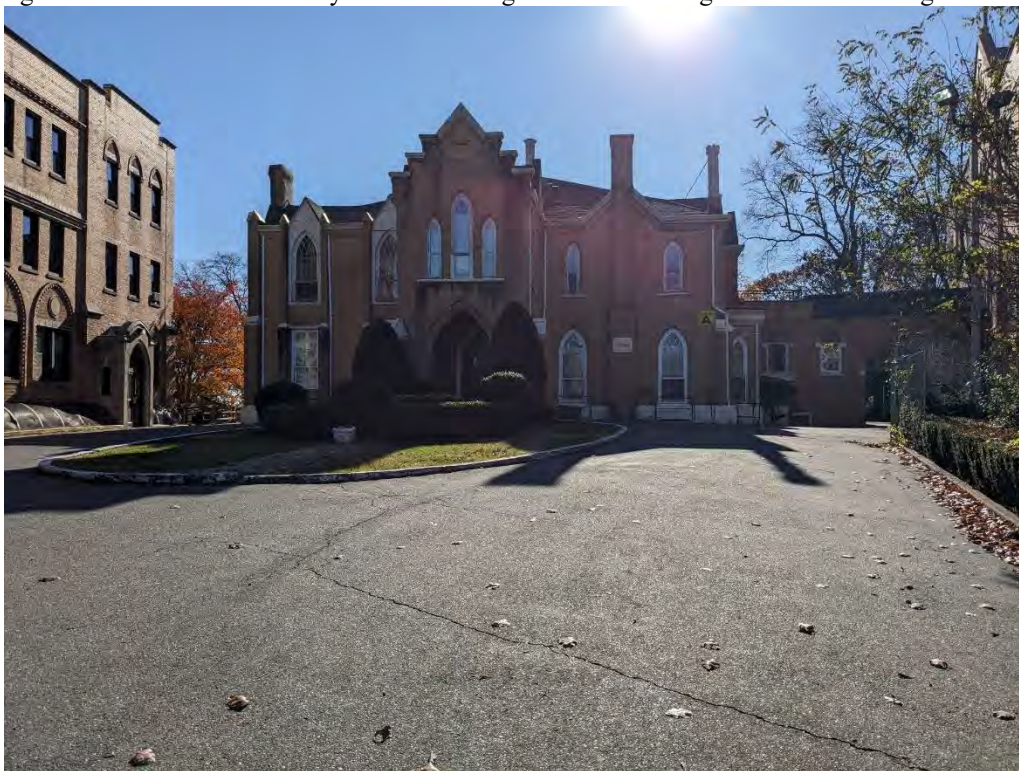
Photograph 2. The former Villa building, flanked by the former elementary school on the left and the former chapel on the right. View looking southeast.

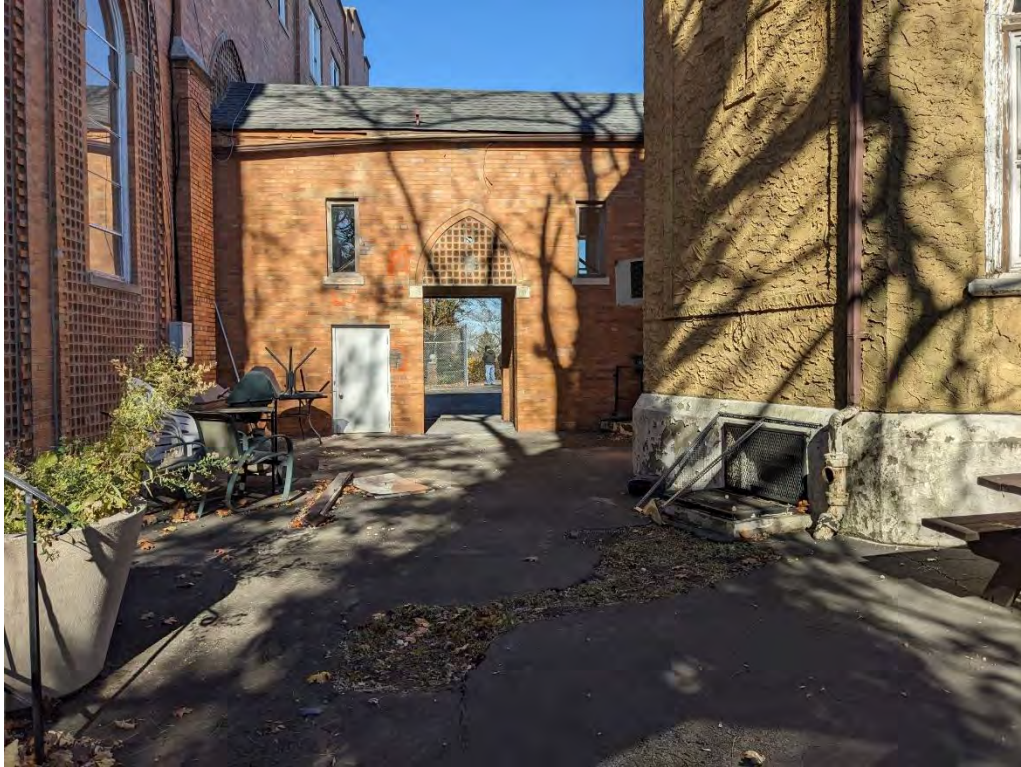
Photograph 3. The west side of the former Villa on the right, showing the connection to the former chapel on the left. Note the window well for the Villa's basement on the right. View looking northwest.

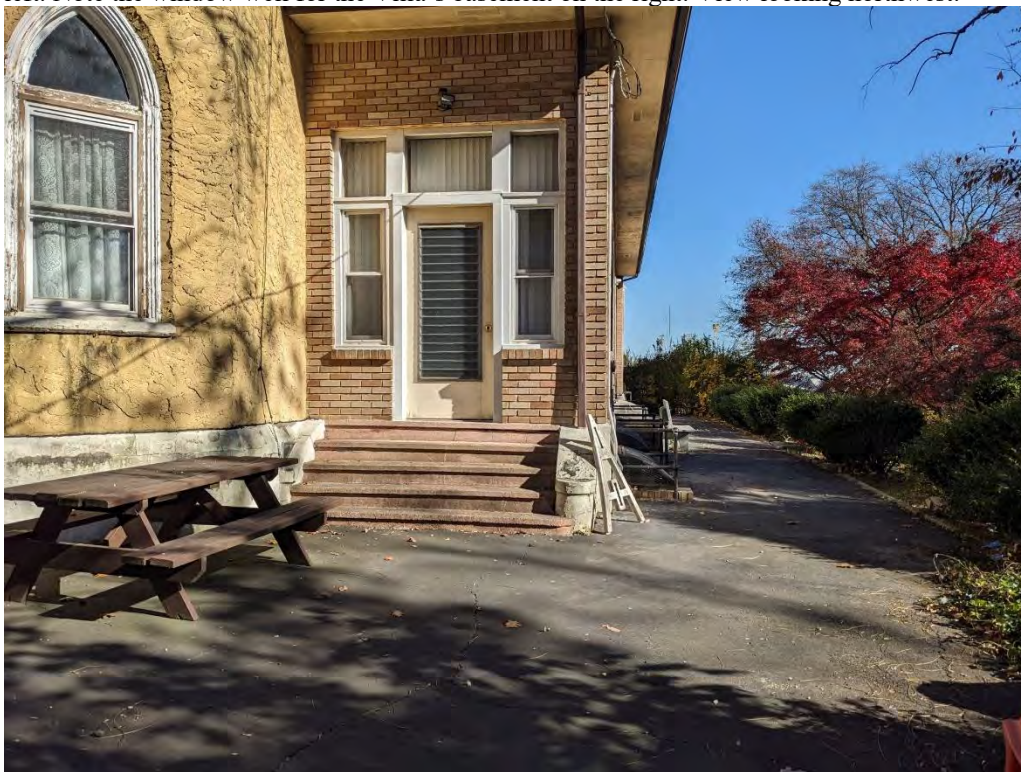
Photograph 4. The rear of the former Villa, showing the former location of the wraparound porch that has been enclosed as an addition with a full basement. Window wells to the basement are located along the edges. View looking northeast.

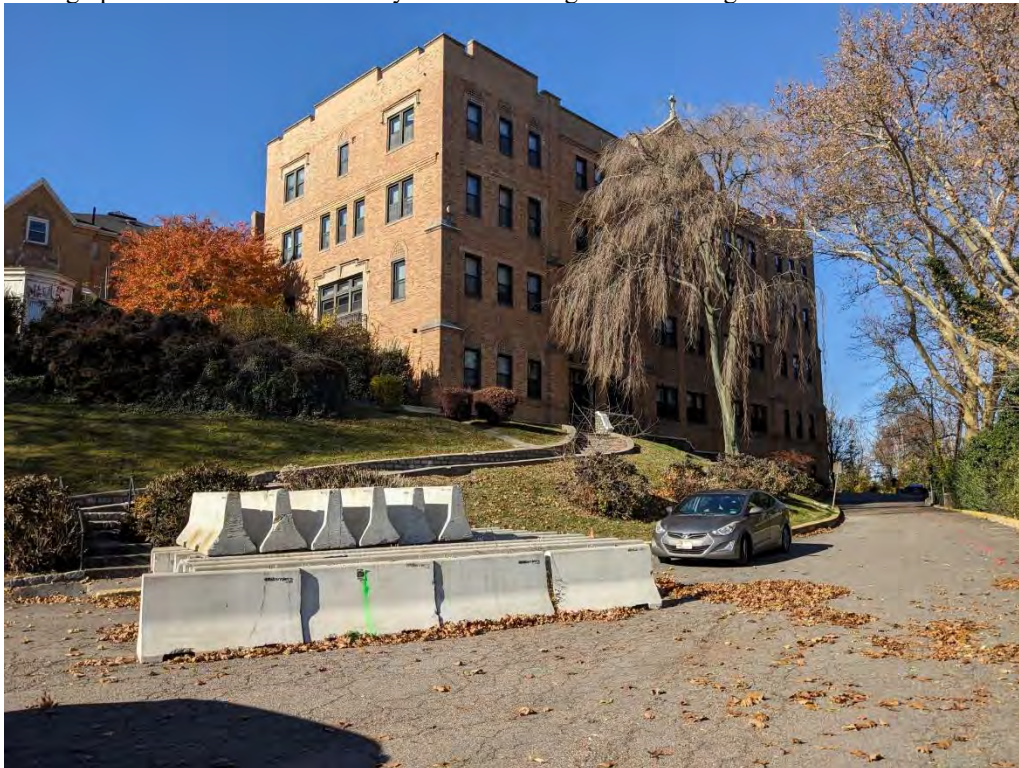
Photograph 6. The former elementary school building, showing its construction into the side of the hill. View looking northwest.

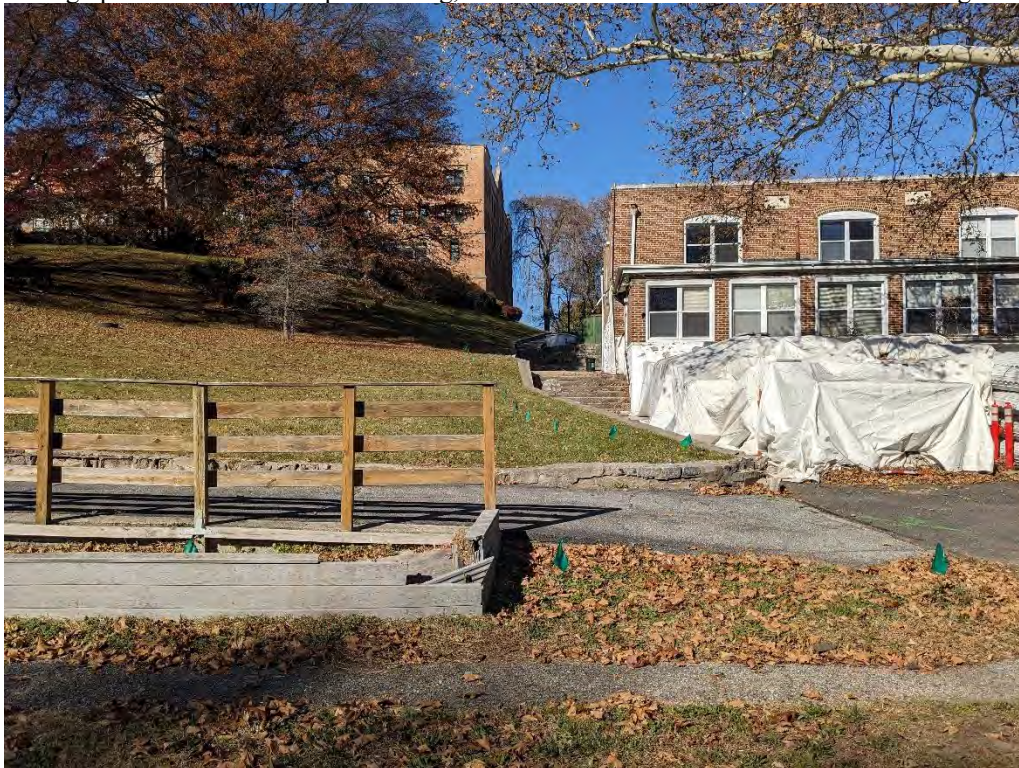
Photograph 8. The former annex building on the right, with the former Villa and the former elementary school in the left background.

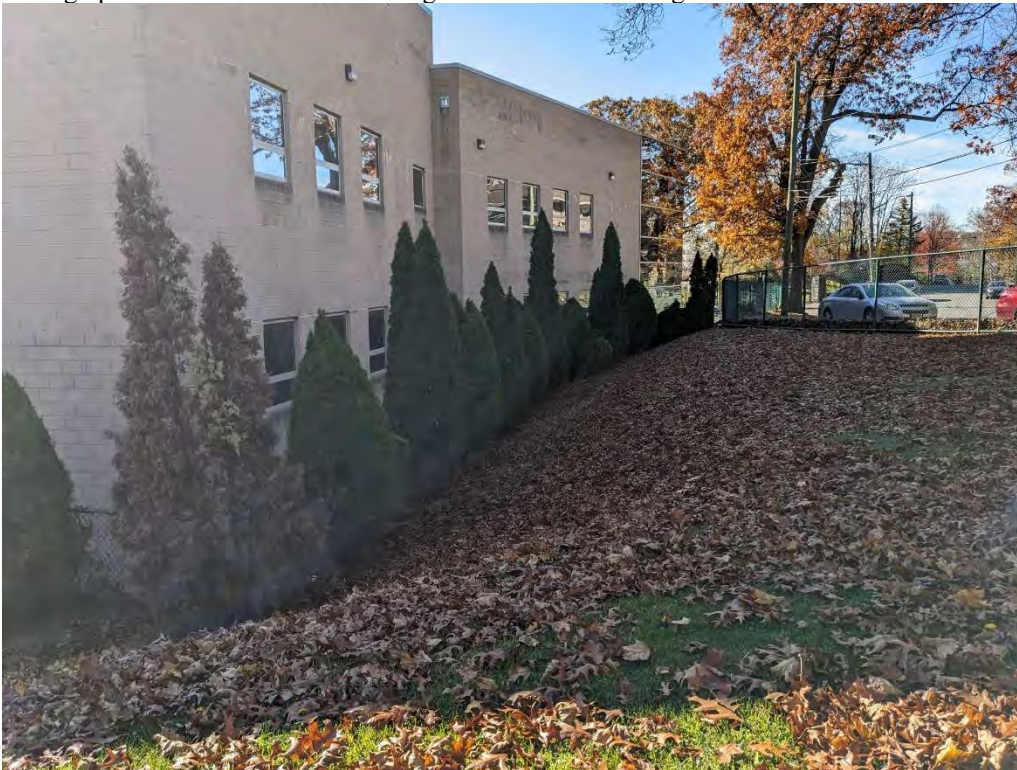
Photograph 10. The side of the former high school. View looking southwest.

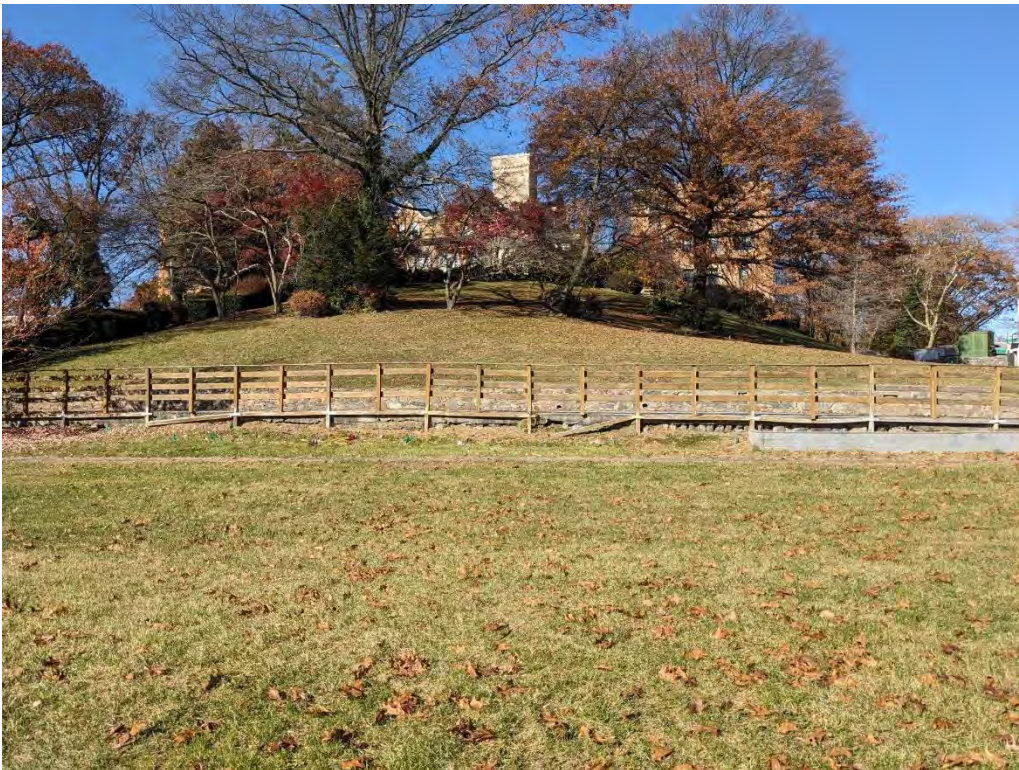
Photograph 14. The steep slope rising up to the former Villa, former chapel and former elementary school in the background.

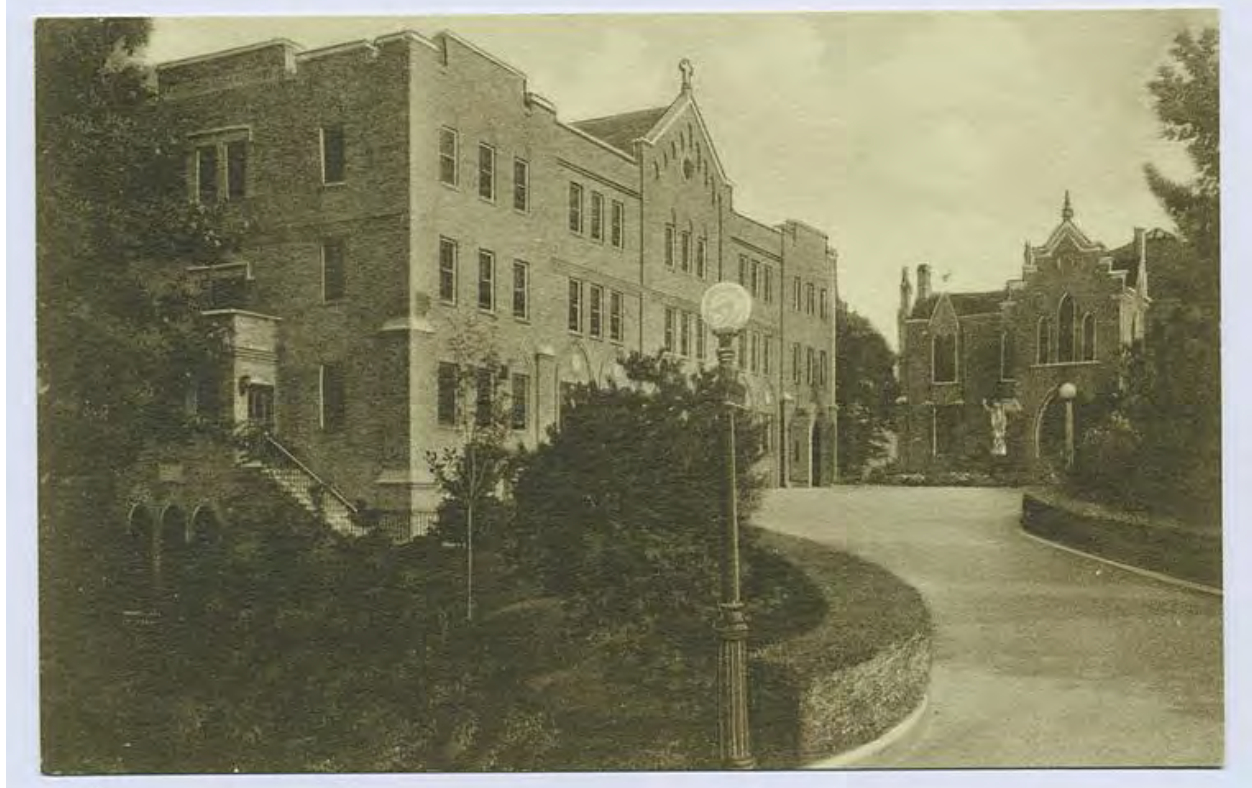
A similar undated view after the third story had been added to the elementary school in 1935, looking southeast.

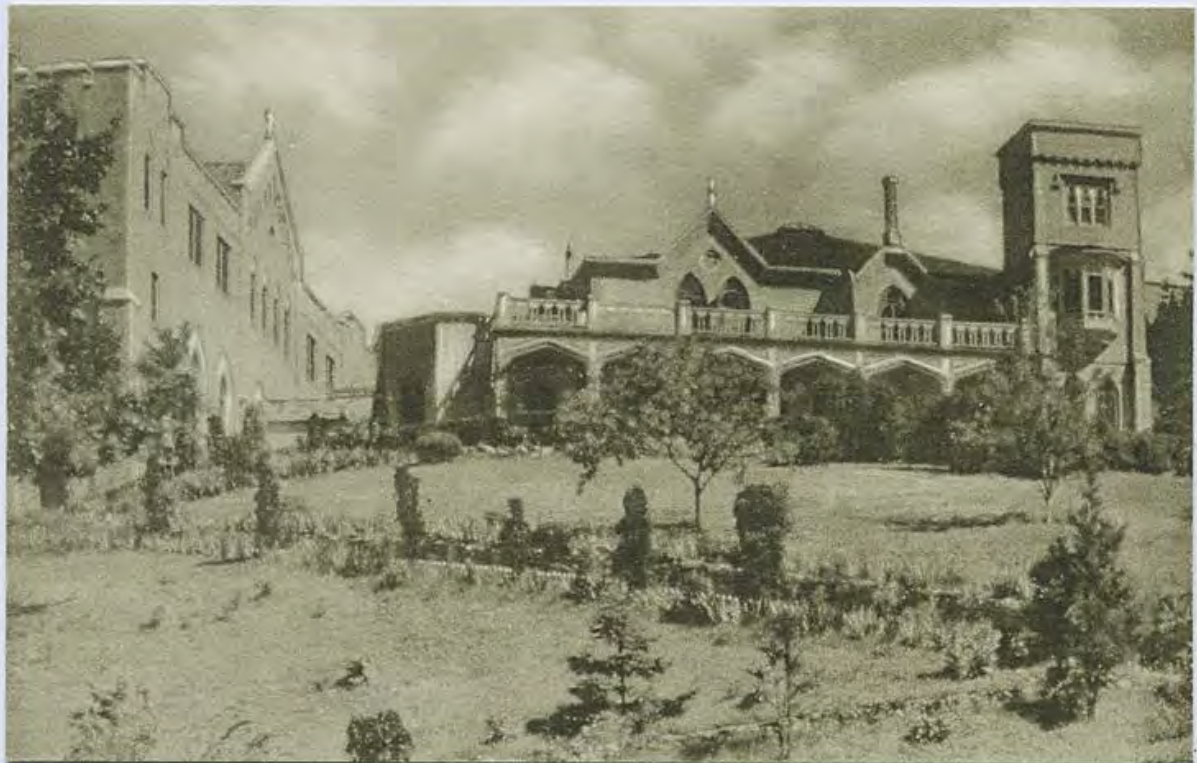
An undated view of the rear of the Villa, showing the wraparound porch that later was rebuilt and enclosed as an extension with a full basement. View looking northwest.

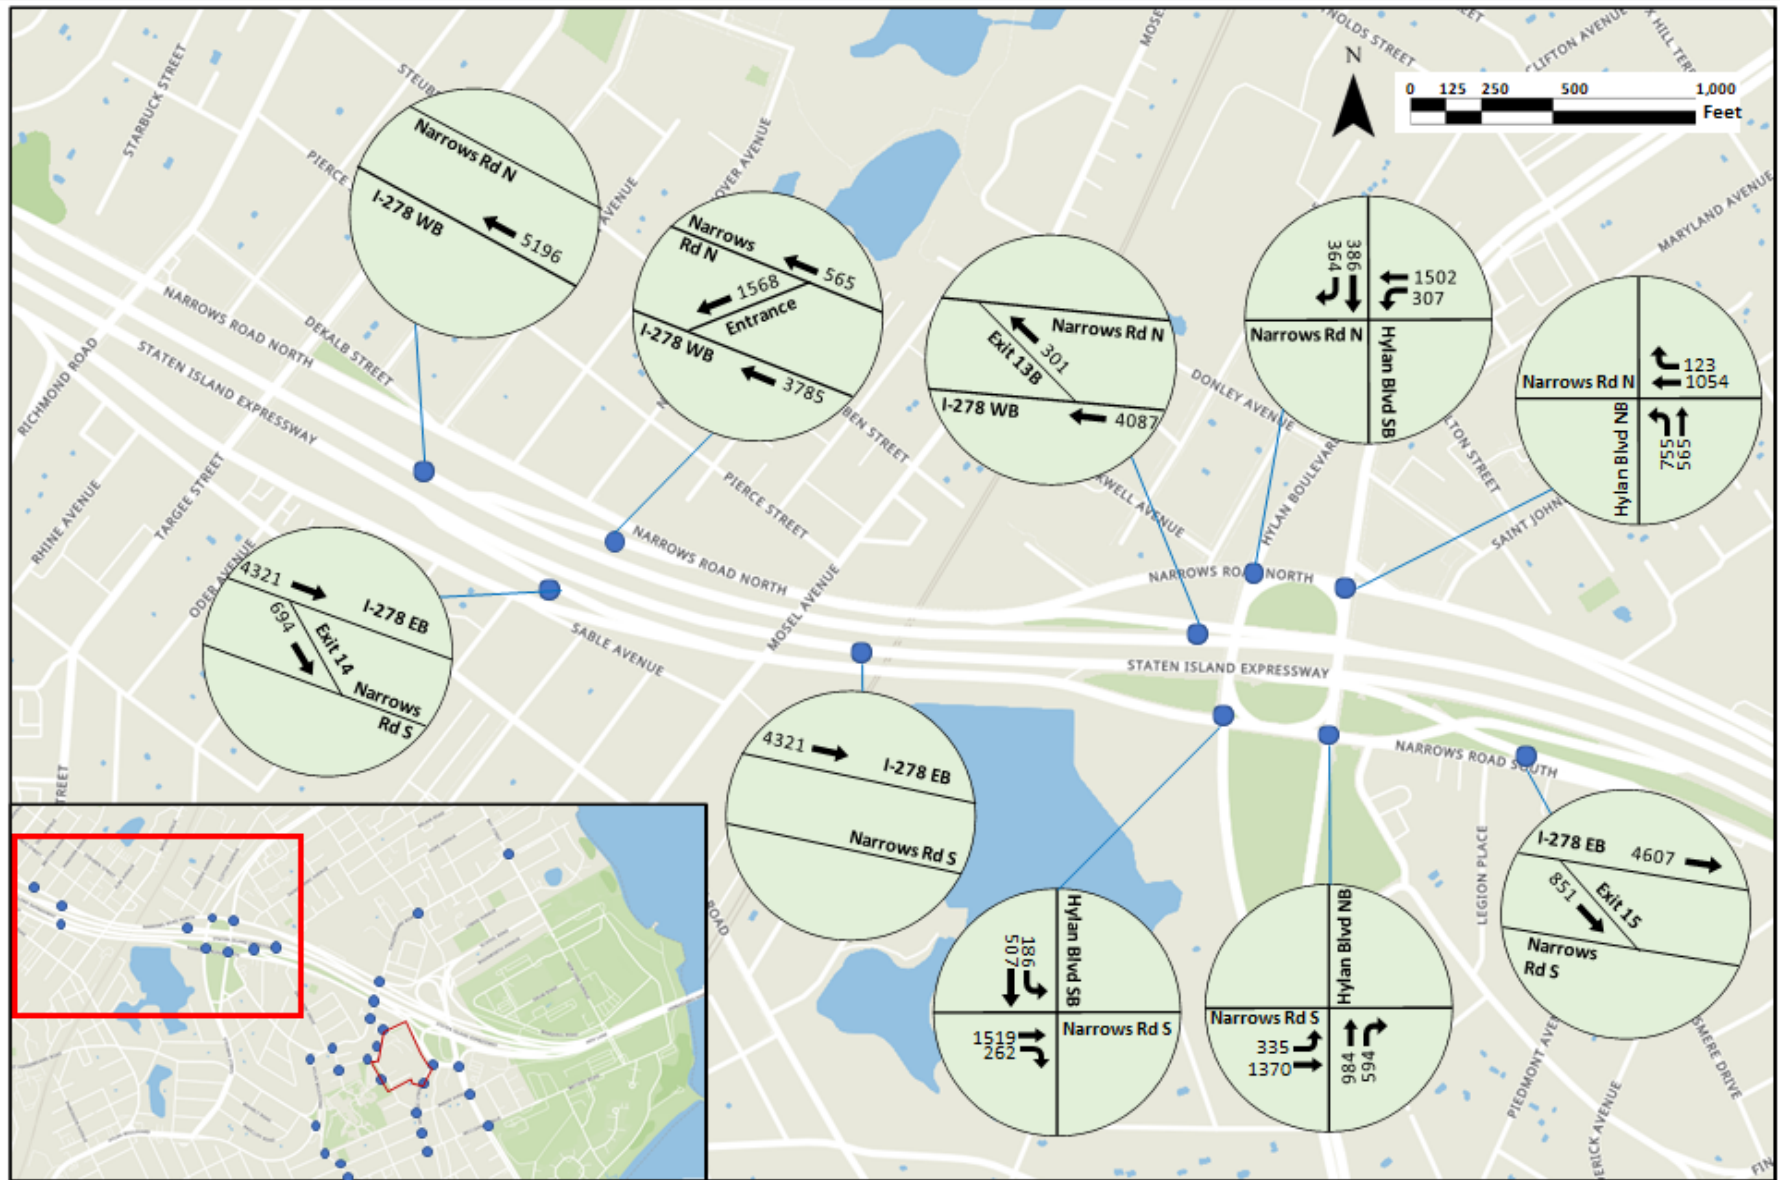
Figure 3C

**2030 (Q1) TRAFFIC VOLUMES
CONSTRUCTION OPERATIONAL SCENARIO
AM PEAK HOUR**

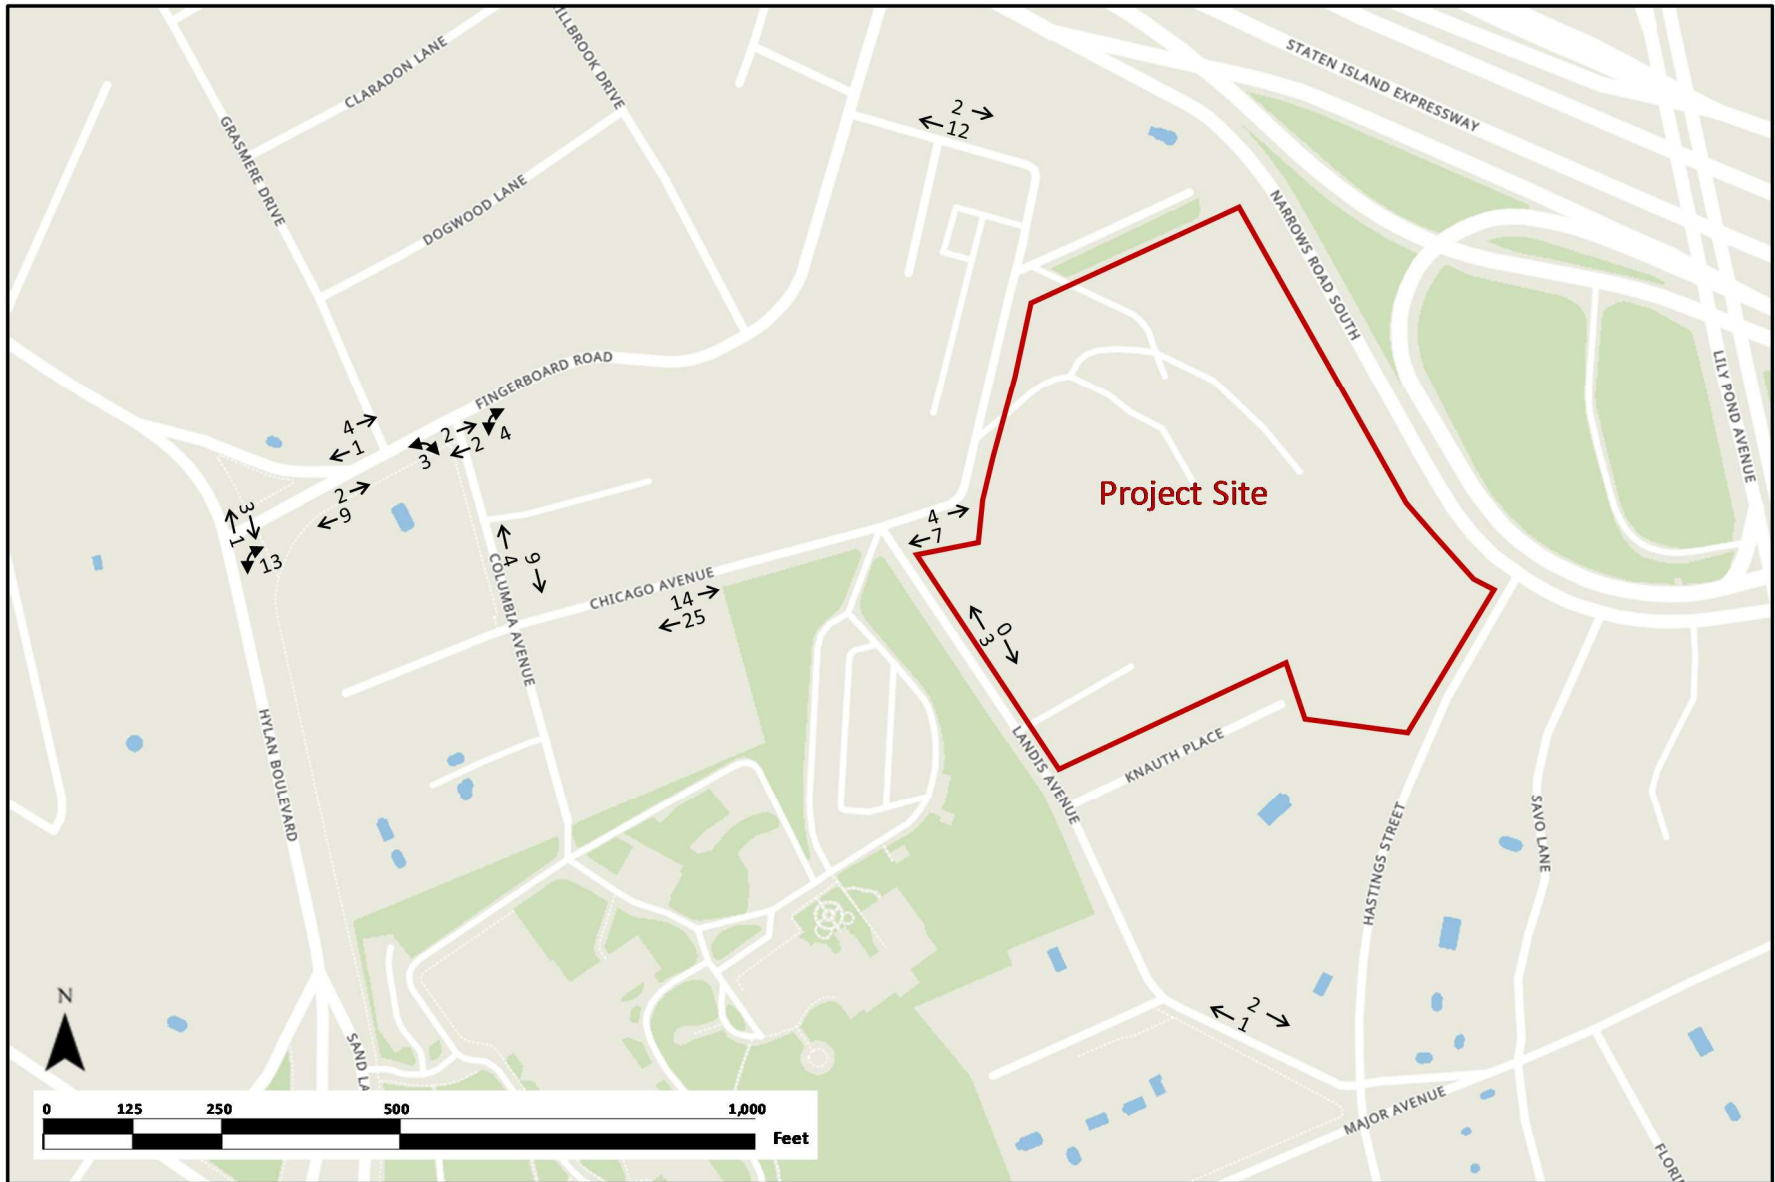
Figure 1

**EXISTING PEDESTRIAN VOLUMES
AM PEAK HOUR**

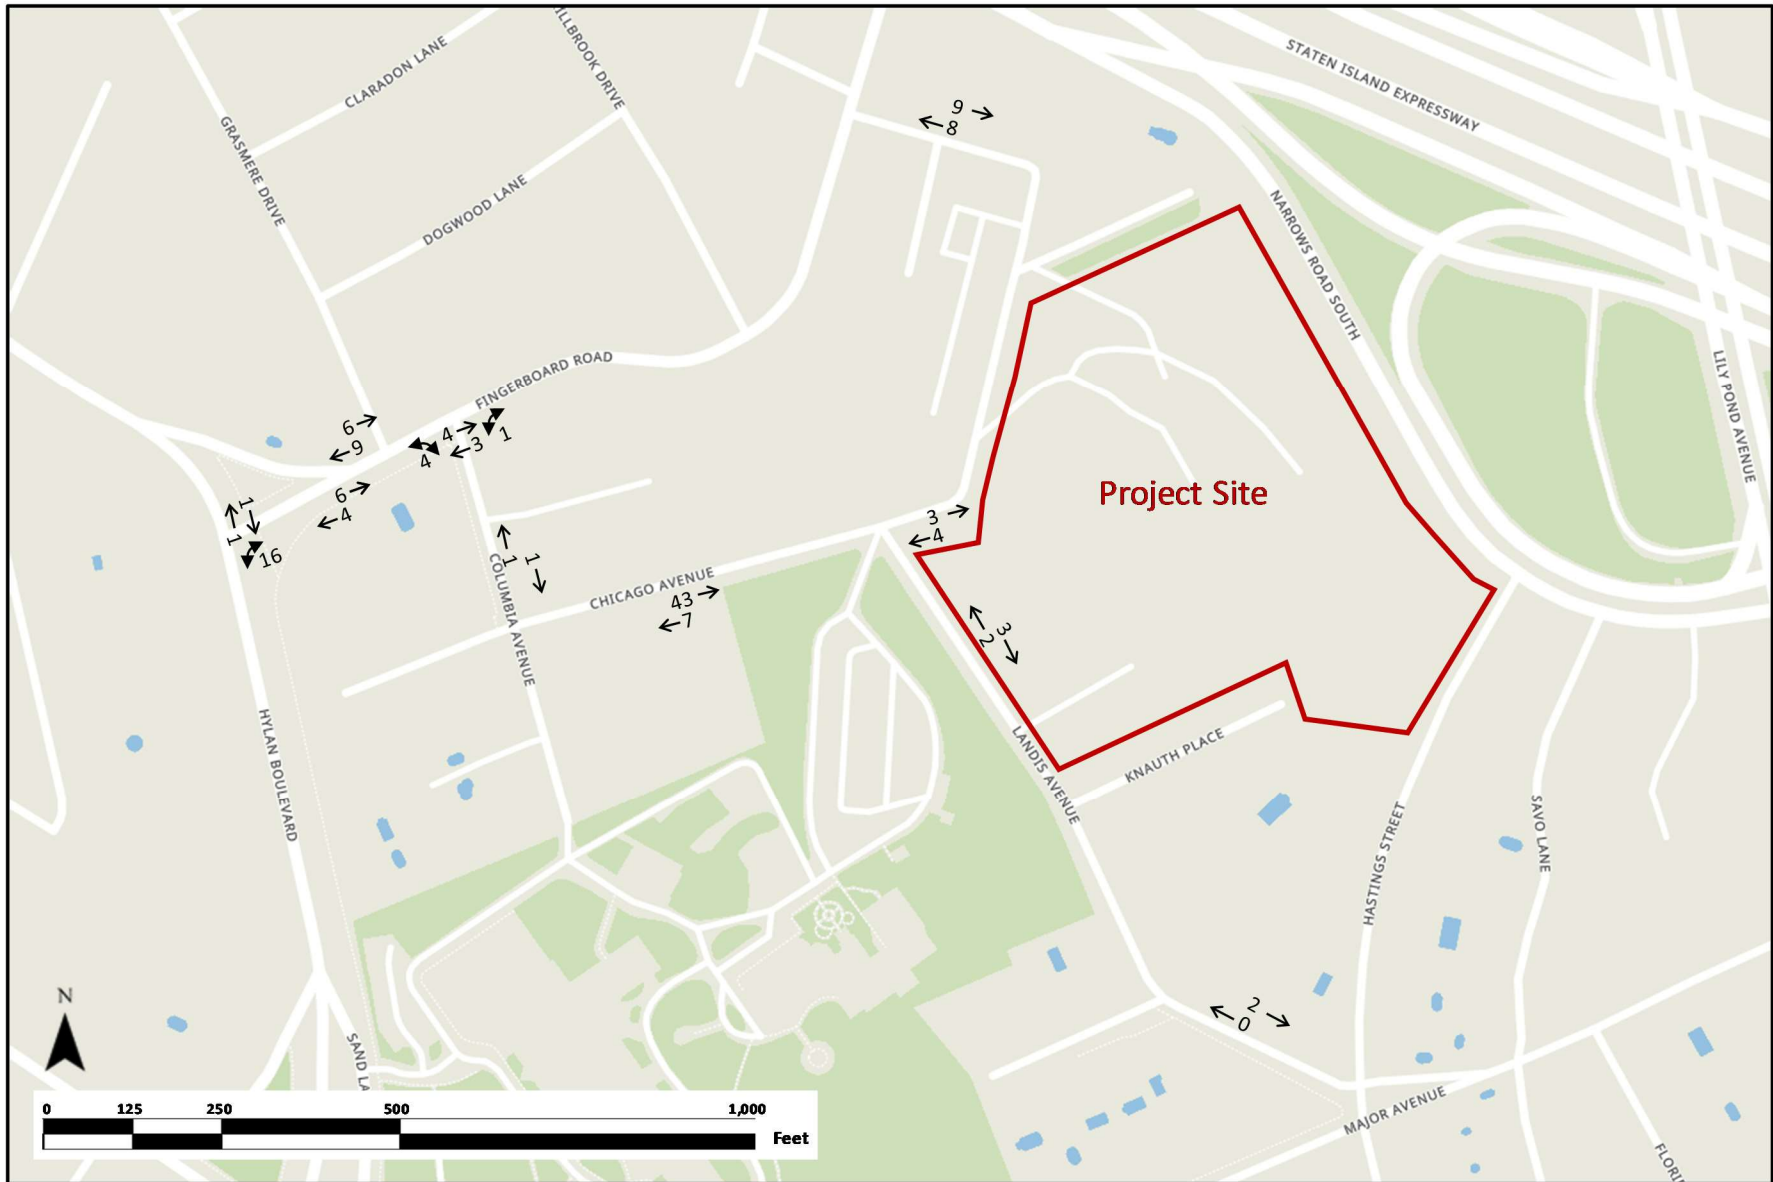
Figure 2

**EXISTING PEDESTRIAN VOLUMES
PM PEAK HOUR**

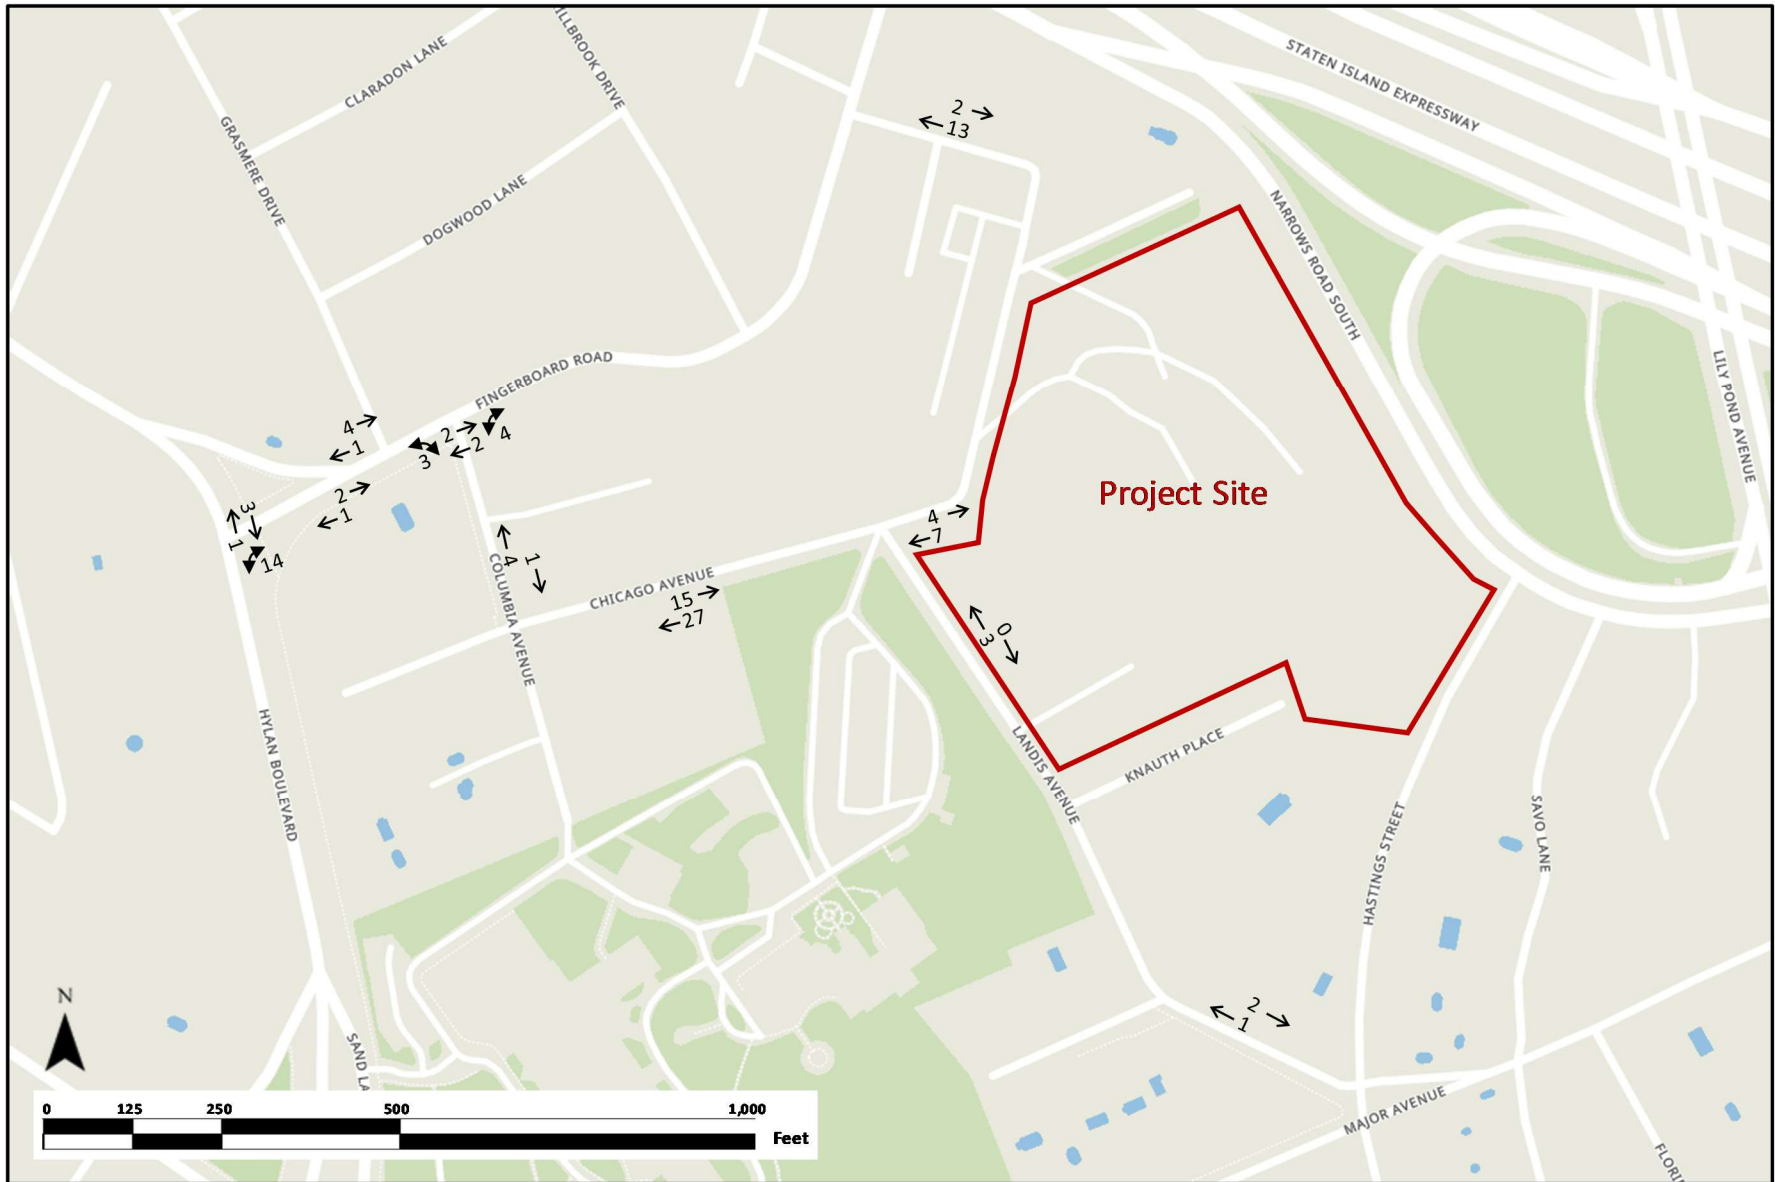
Figure 3

**2030 NO ACTION PEDESTRIAN VOLUMES
AM PEAK HOUR**

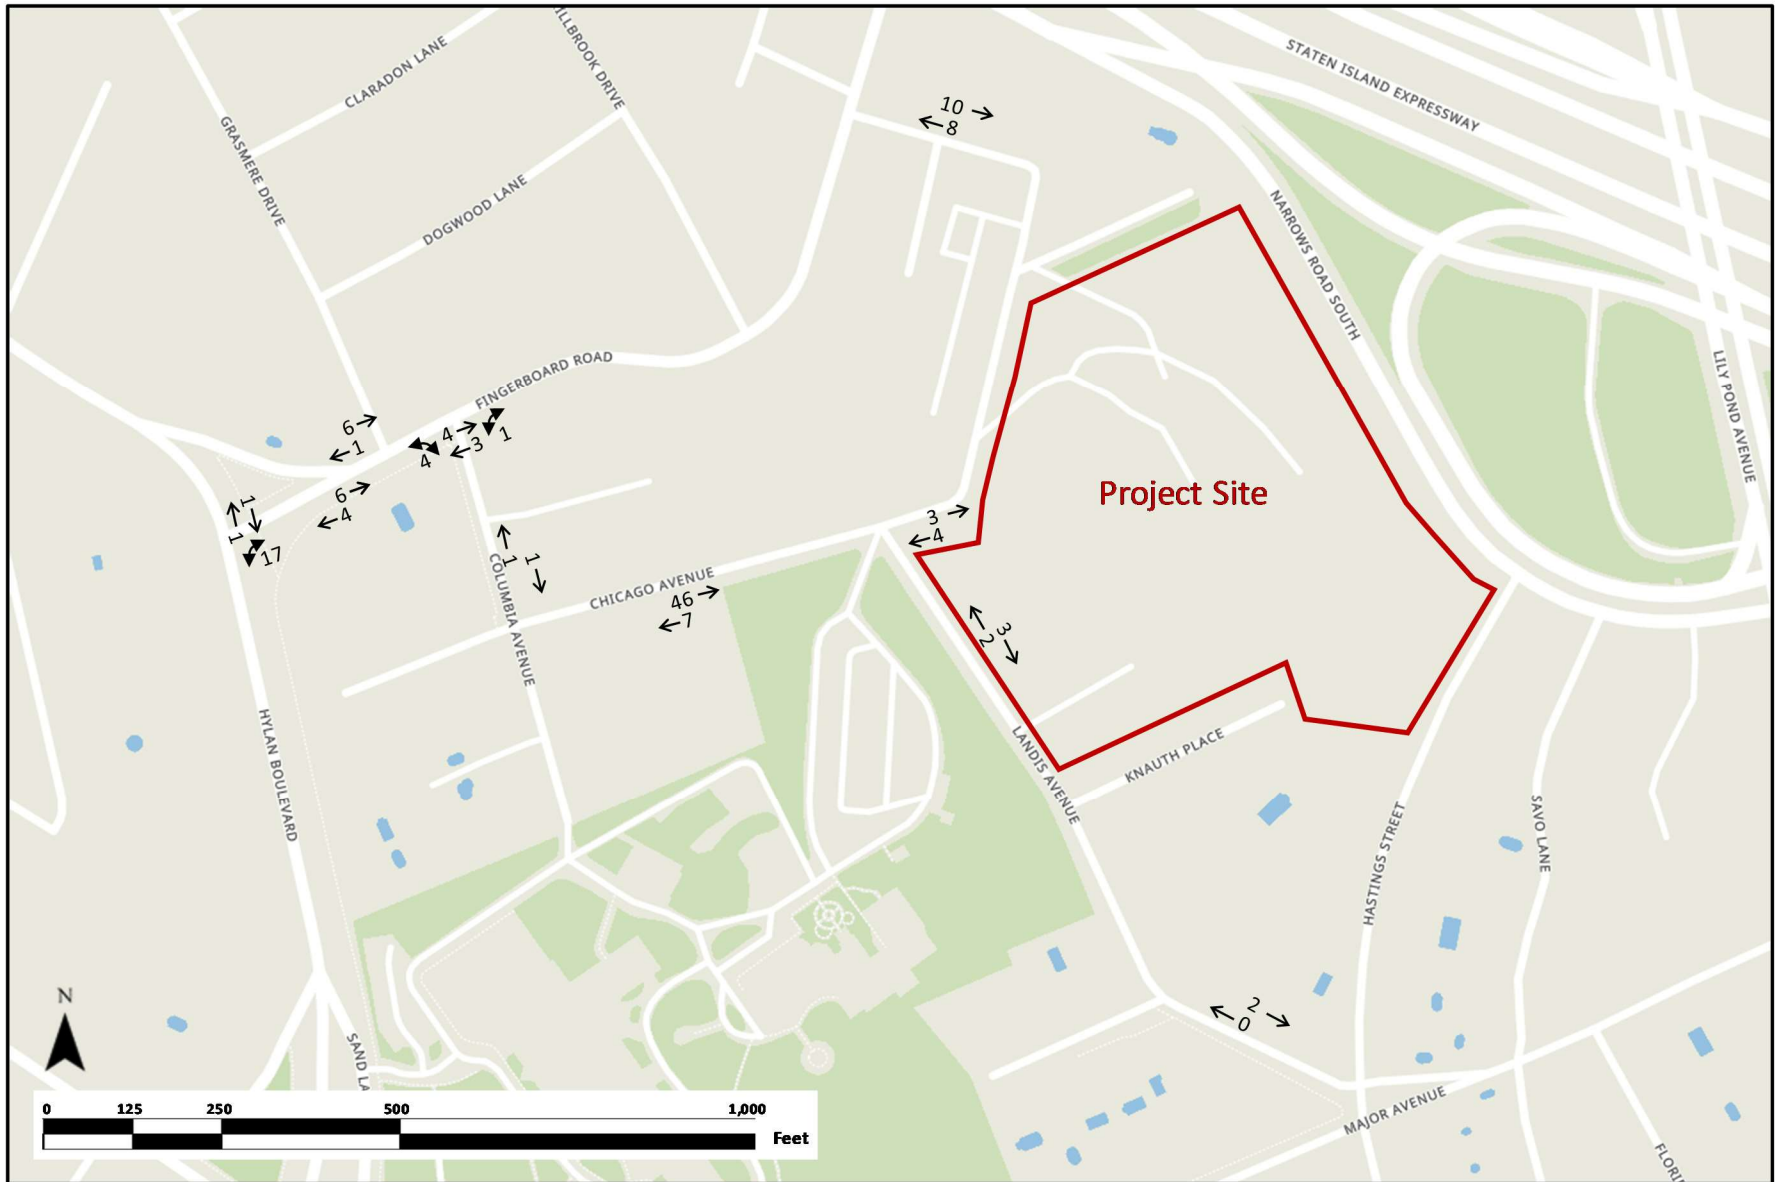
Figure 4

**2030 NO ACTION PEDESTRIAN VOLUMES
PM PEAK HOUR**

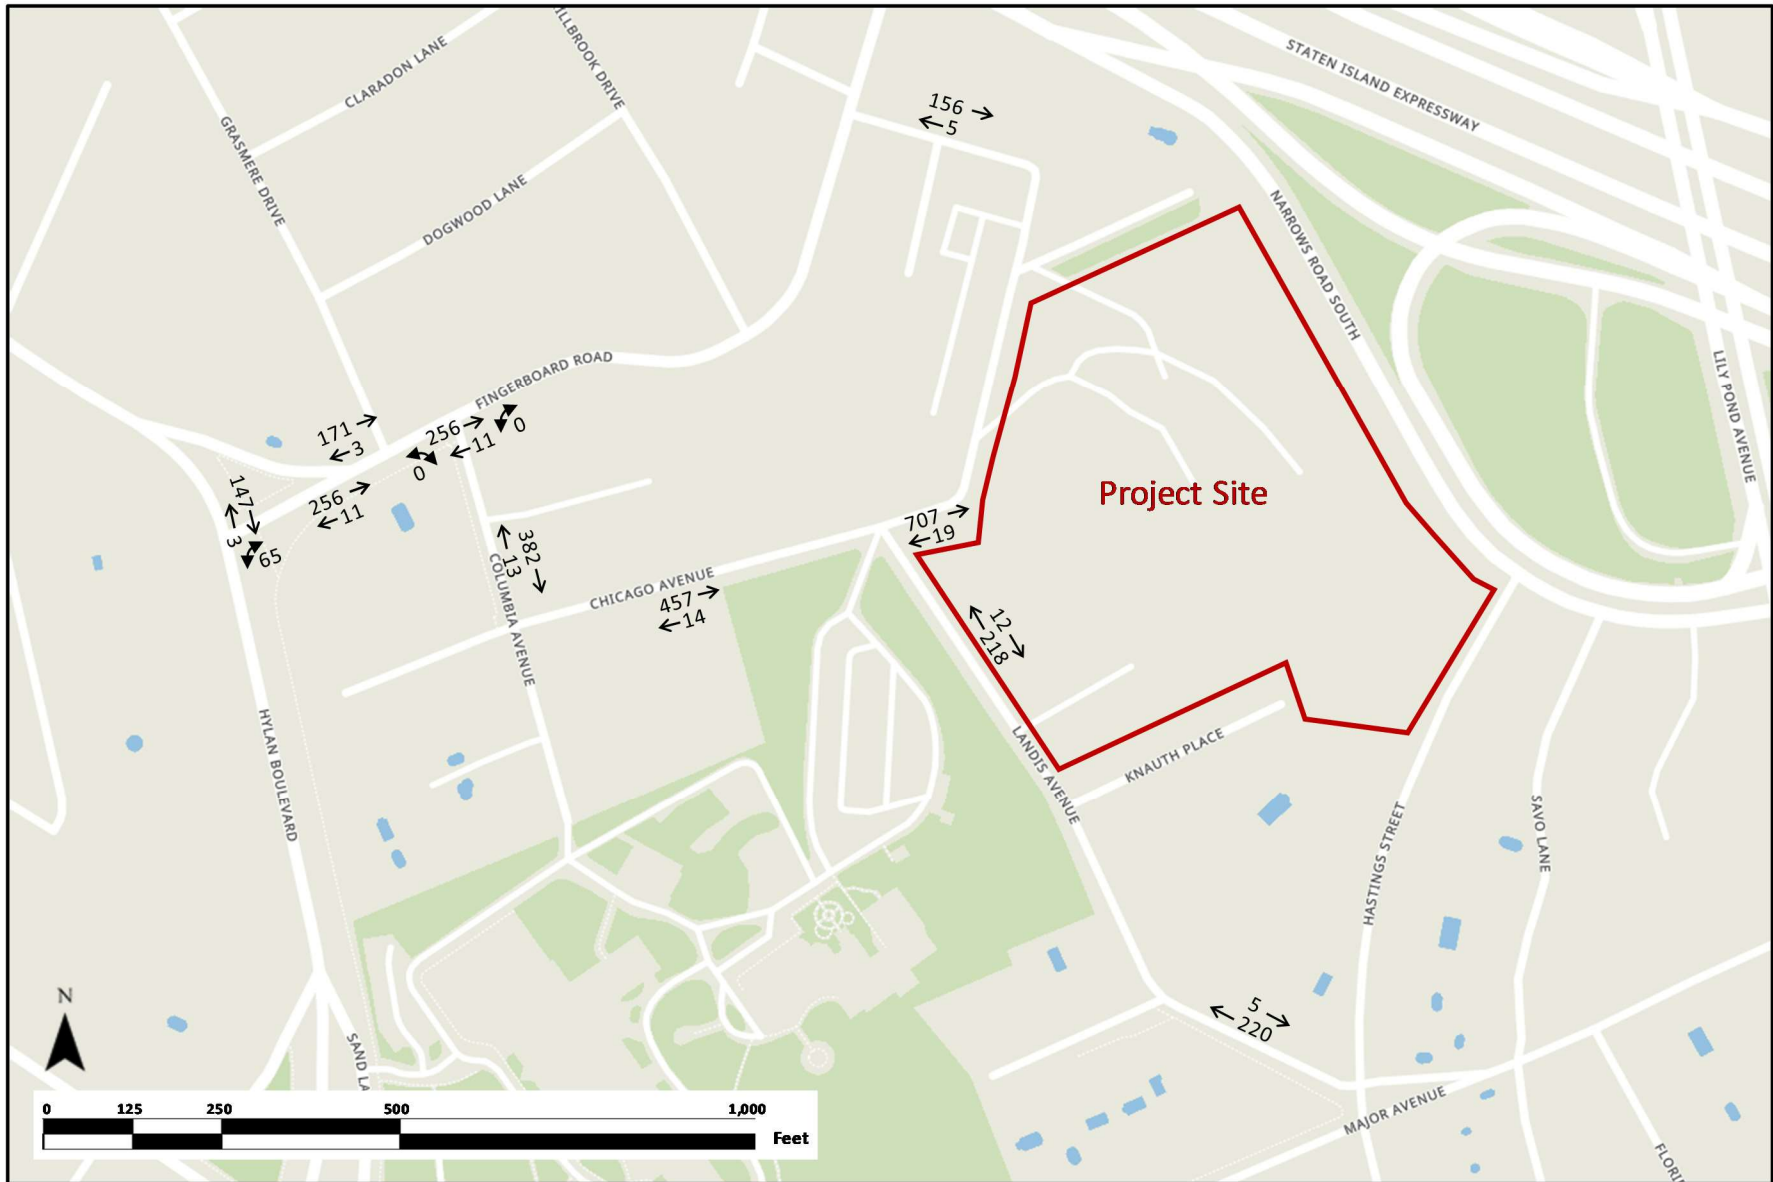
Figure 5

**2030 WITH ACTION PEDESTRIAN VOLUME INCREMENTS
AM PEAK HOUR**
