APPENDICES

Proposed Redevelopment of the former St. John Villa Campus

57 Cleveland Place

Staten Island, New York

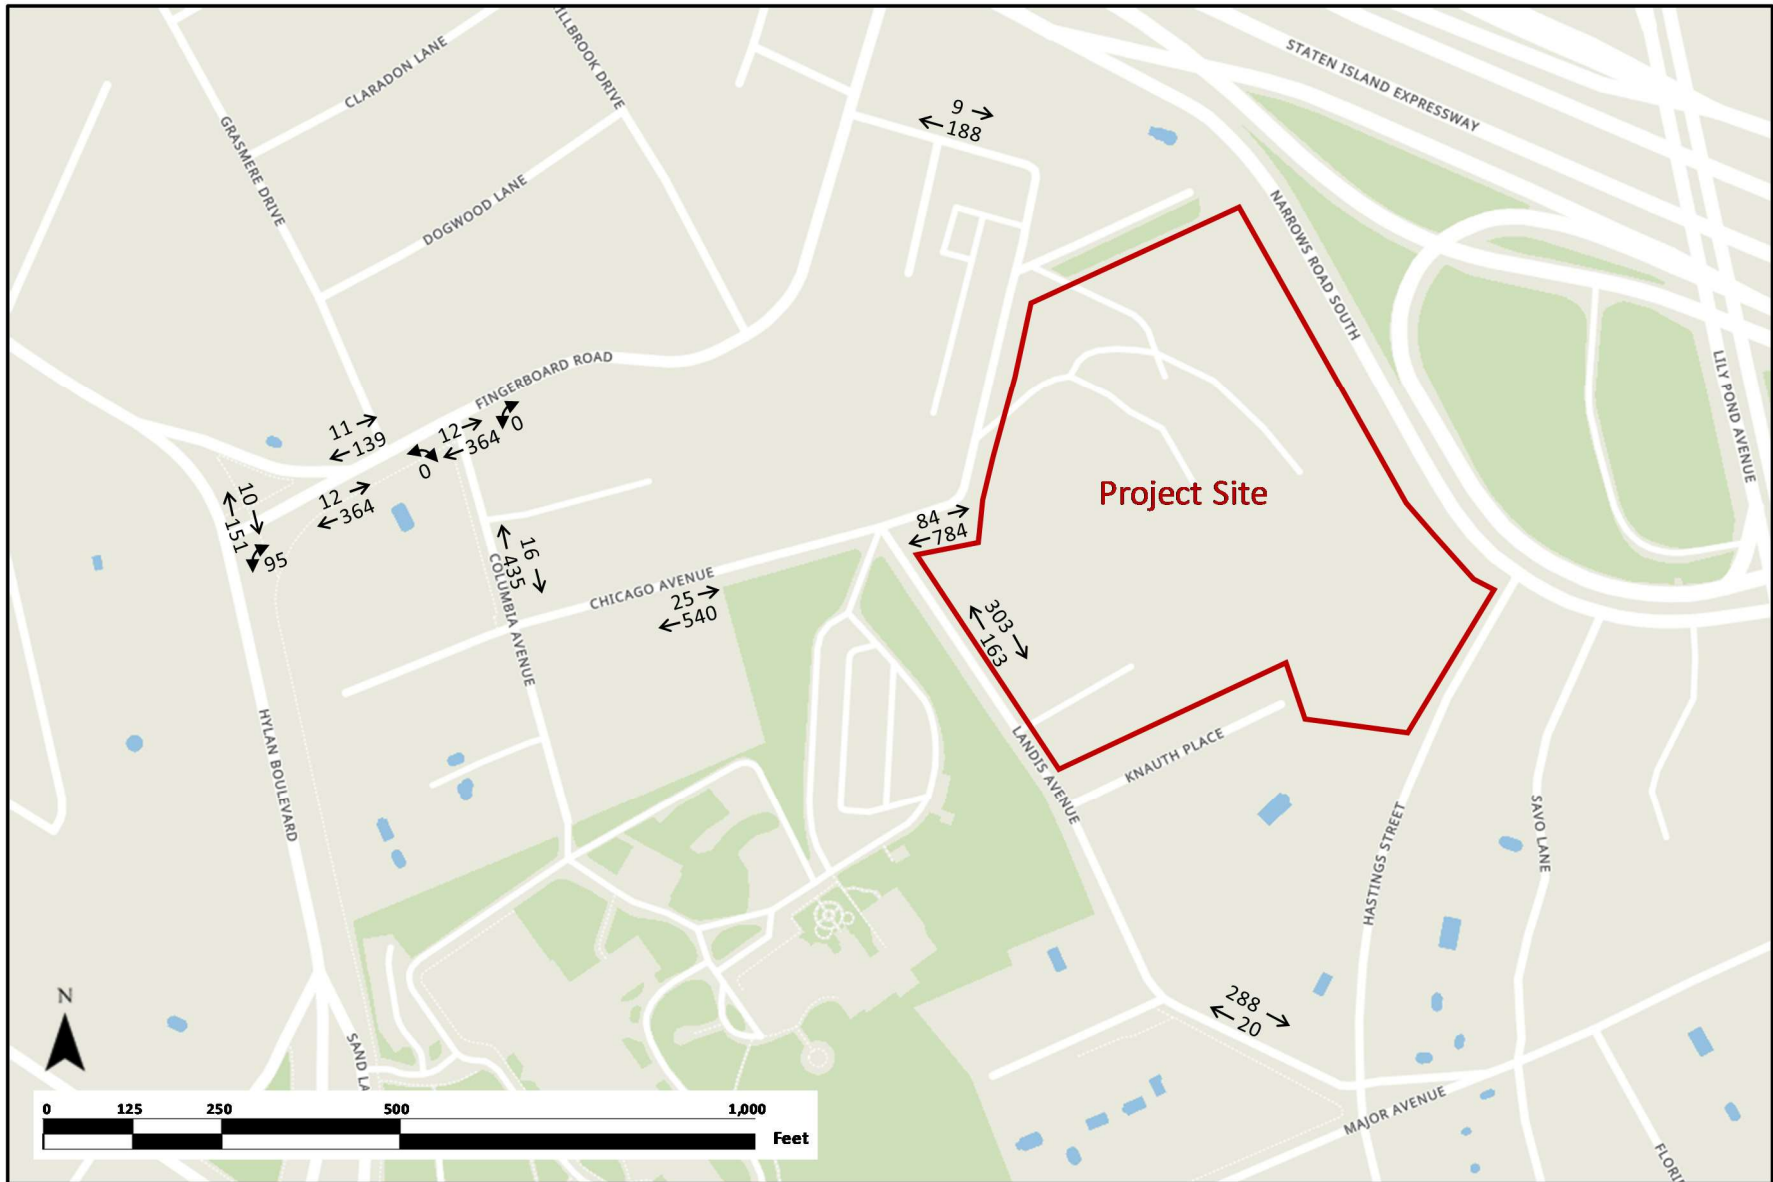
Figure 6

**2030 WITH ACTION PEDESTRIAN VOLUME INCREMENTS
PM PEAK HOUR**

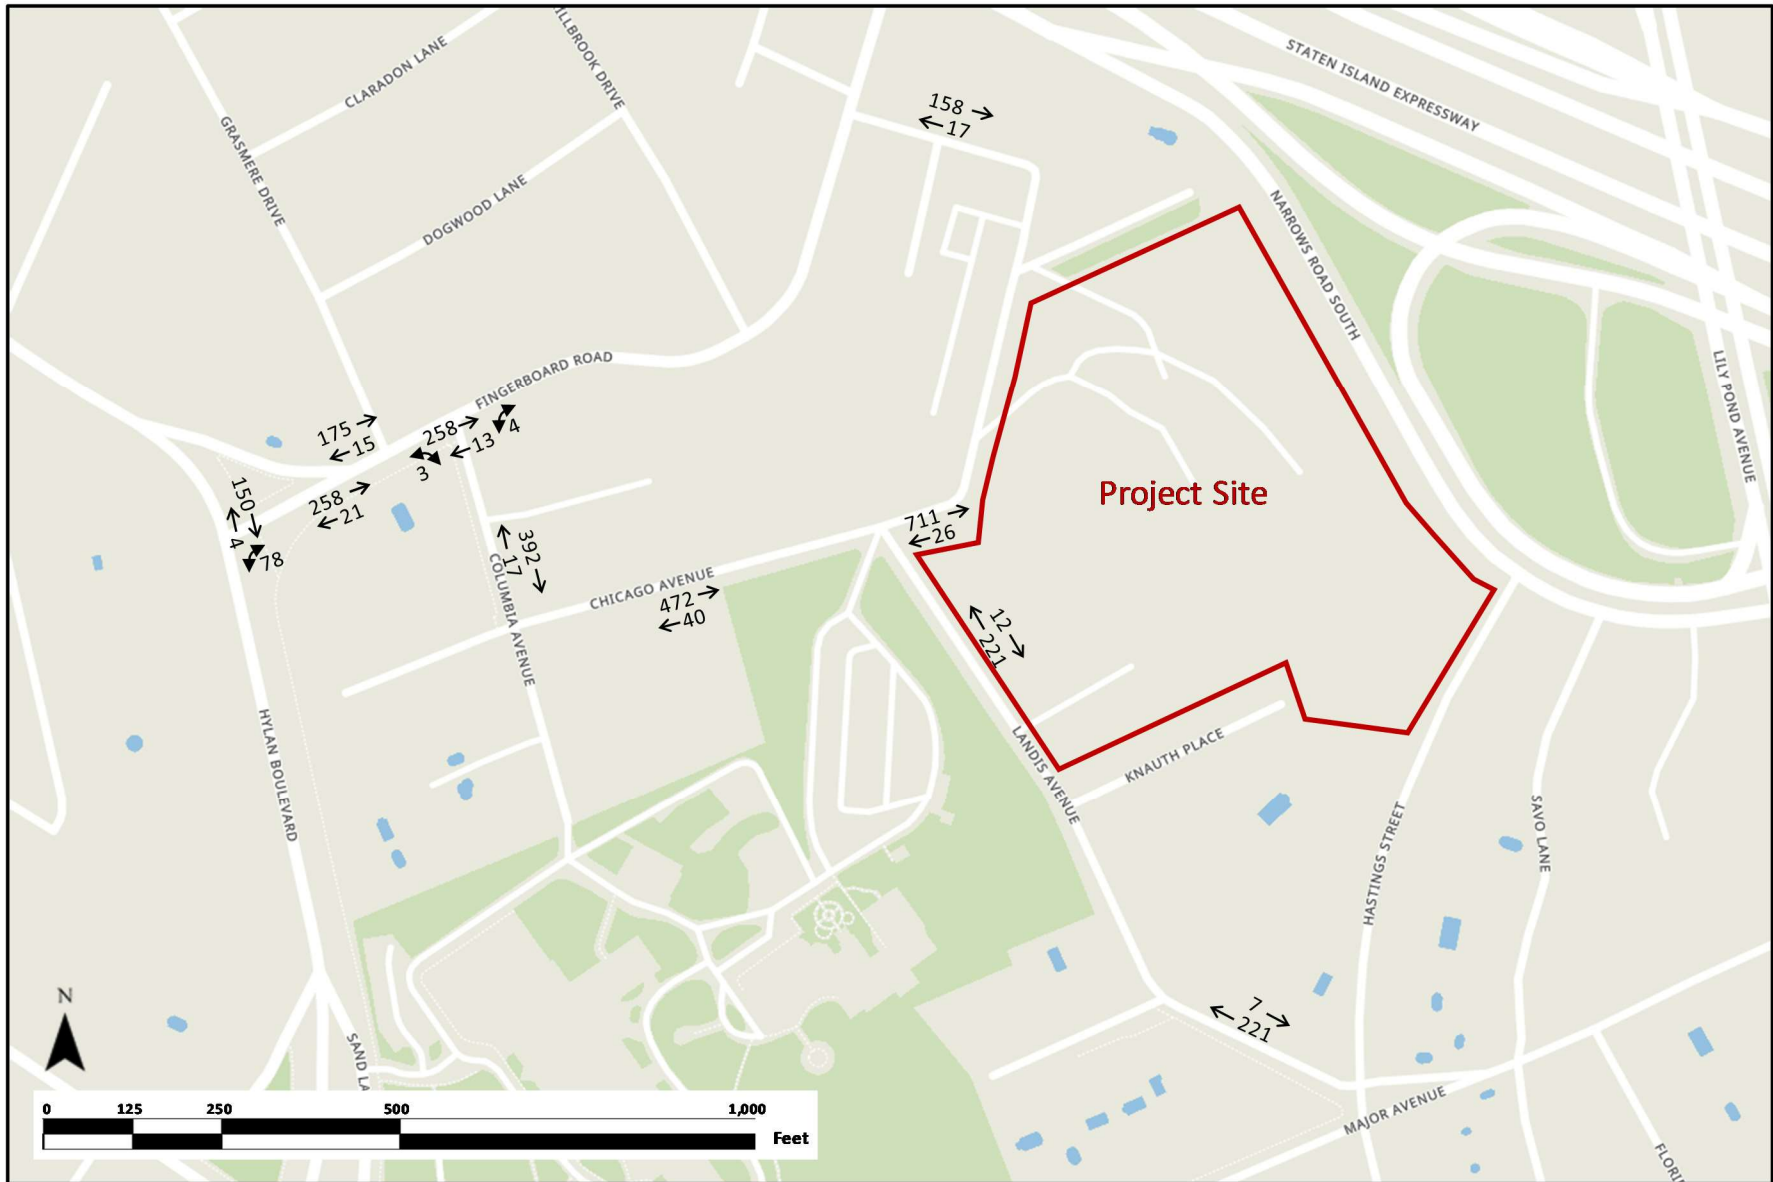
Figure 7

**2030 WITH ACTION PEDESTRIAN VOLUMES
AM PEAK HOUR**

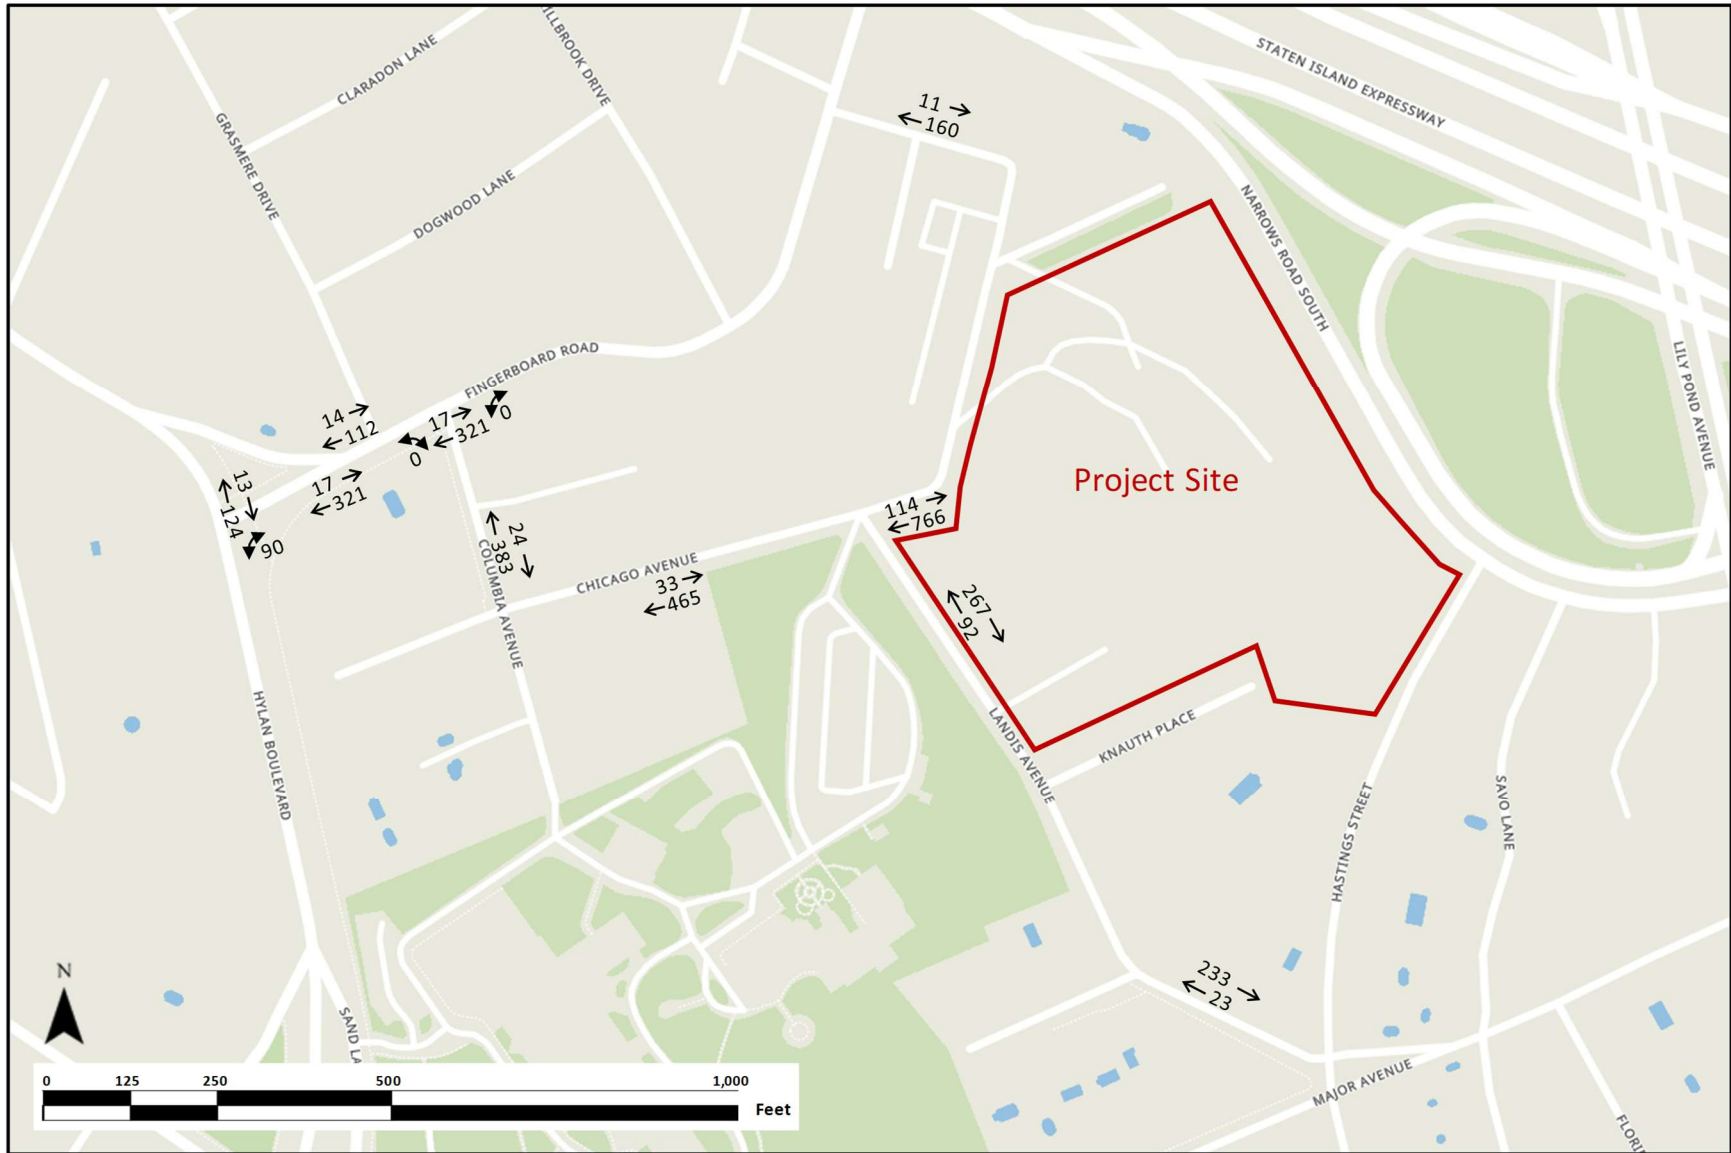
Figure 2

**2030 (Q1) PEDESTRIAN VOLUME INCREMENTS
CONSTRUCTION OPERATIONAL SCENARIO
PM PEAK HOUR**

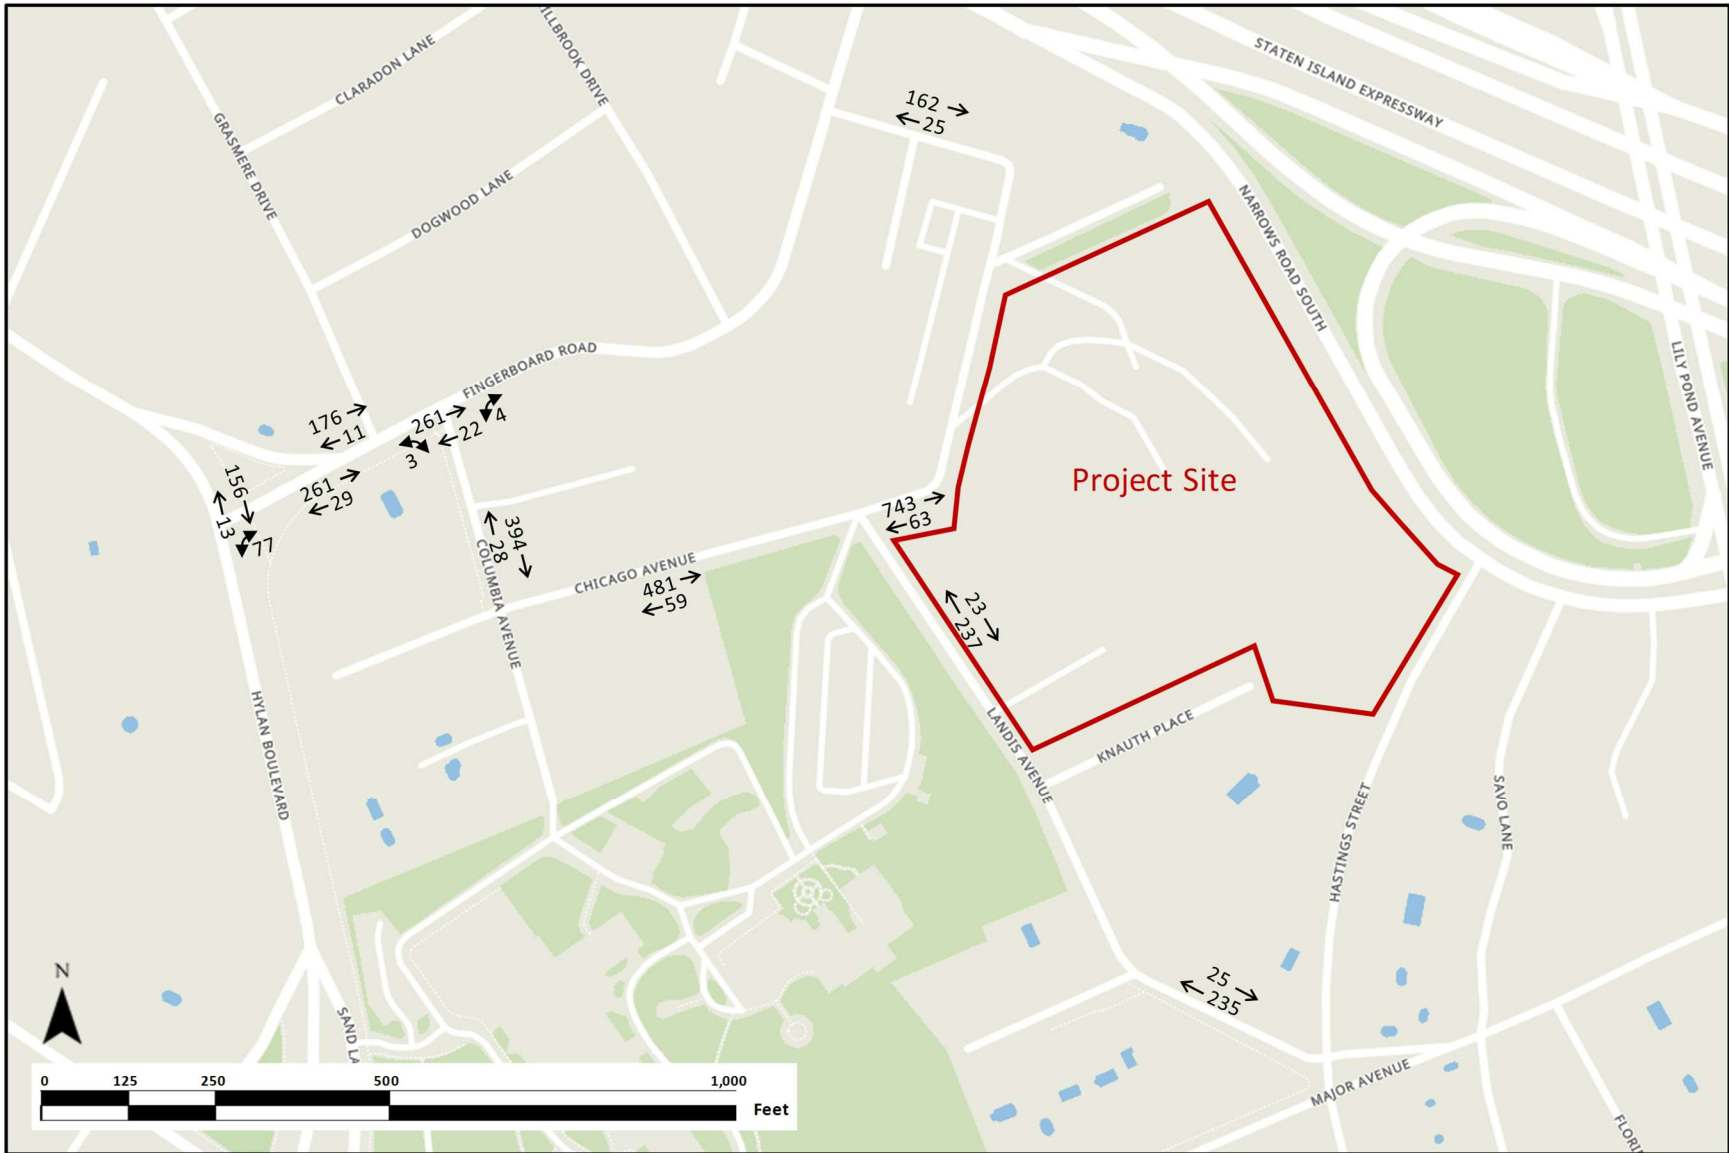
Figure 3

**2030 (Q1) WITH ACTION PEDESTRIAN VOLUMES
CONSTRUCTION OPERATIONAL SCENARIO
AM PEAK HOUR**
