# Development Tree Management Report

## Department of Transport

Management of trees at La Trobe Golf Club, Alphington

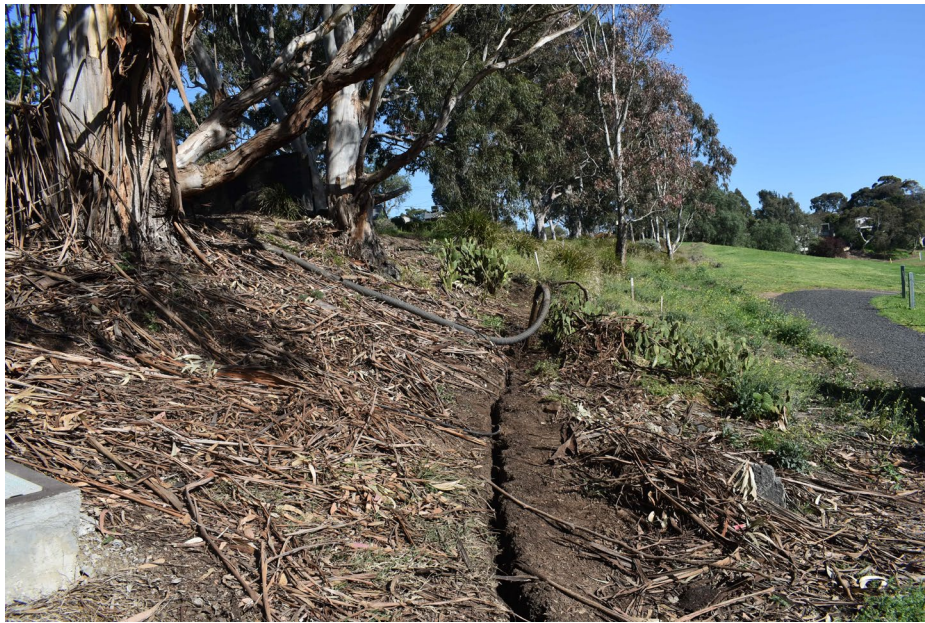
Figure 3: Trench adjacent Trees 6 and 7

Hydro excavation was carried out along the footprint of the path which was 3m from the trunk of Tree 6 and 3.5m from the trunk of Tree 7; excavation extended 3m either side of the trunks. The trench depth went to 600mm.

Fourteen roots in total greater than 20mm were seen in the trench, left intact and recorded. Five of these measured 20mm in diameter, six measured 30mm in diameter, one measured 40mm in diameter, another measured 50mm in diameter and the largest measured 60mm in diameter. Roots over 40mm in size can be classed as structural roots, however, the ones found are small structural roots for the size of the trees and it is likely that the roots supporting these trees are further down the soil profile or on other sides of the tree. Providing excavation does not exceed 600mm in depth and follows the NDD excavation line (no closer to the trees), then the trees are expected to remain viable with the construction of the path.

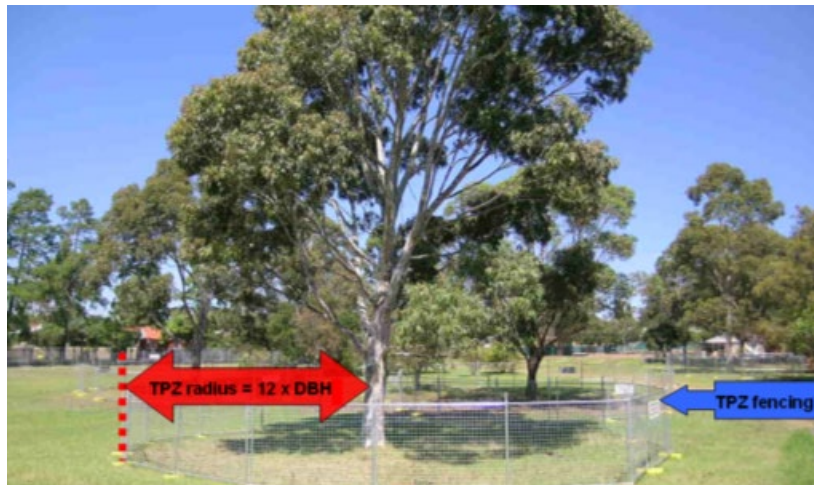
Figure 11: TPZ fencing is erected around retained trees prior to site works.

The Tree Protection Zone is delineated on site by a physical barrier of protective fencing that is a minimum of 1.8m high. It is installed around retained trees prior to site establishment and retained intact until completion of the works (Figure 11). Once erected, protective fencing must not be removed or altered without approval by the Project Arborist. The TPZ fence should be secured to restrict access.

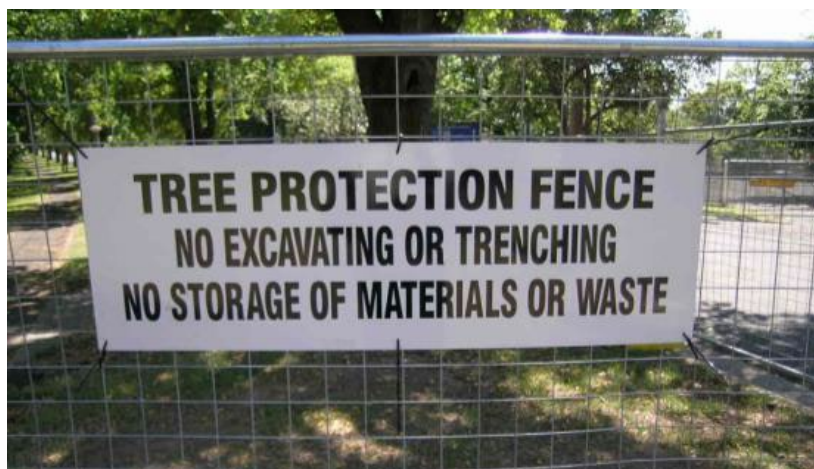
Figure 12: Example of a TPZ warning sign clearly displayed on TPZ fencing.

Signs identifying the TPZ should be placed around the edge of the TPZ and be clearly visible from within the development site (Figure 12).

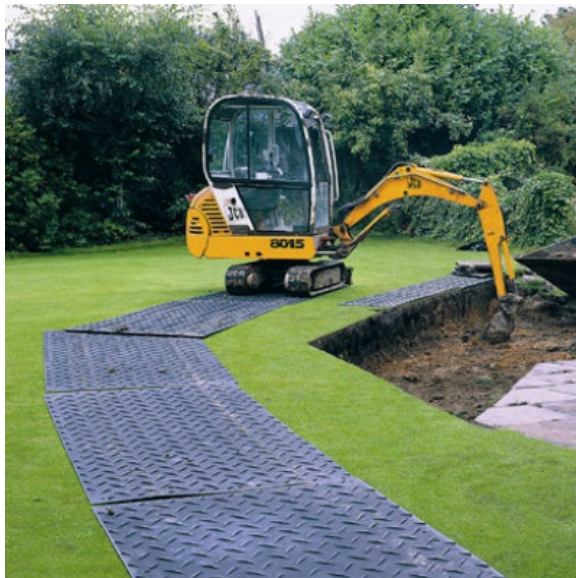
Figure 13: Track mats.

If temporary access for machinery is required within the TPZ, ground protection measures will be required. The purpose of ground protection is to prevent root damage and soil compaction within the TPZ. Examples of ground protection include track mats (Figure 13) and rumble boards strapped over mulch or crushed rock (Figure 14). Depending on weather conditions, geotextile fabric may be required to prevent mulch and crushed rock mixing into the site soils.
