REGIONAL ROADS VICTORIA

MAY 2021

BEAUFORT BYPASS ENVIRONMENT EFFECTS STATEMENT

SOILS AND GEOLOGY IMPACT ASSESSMENT

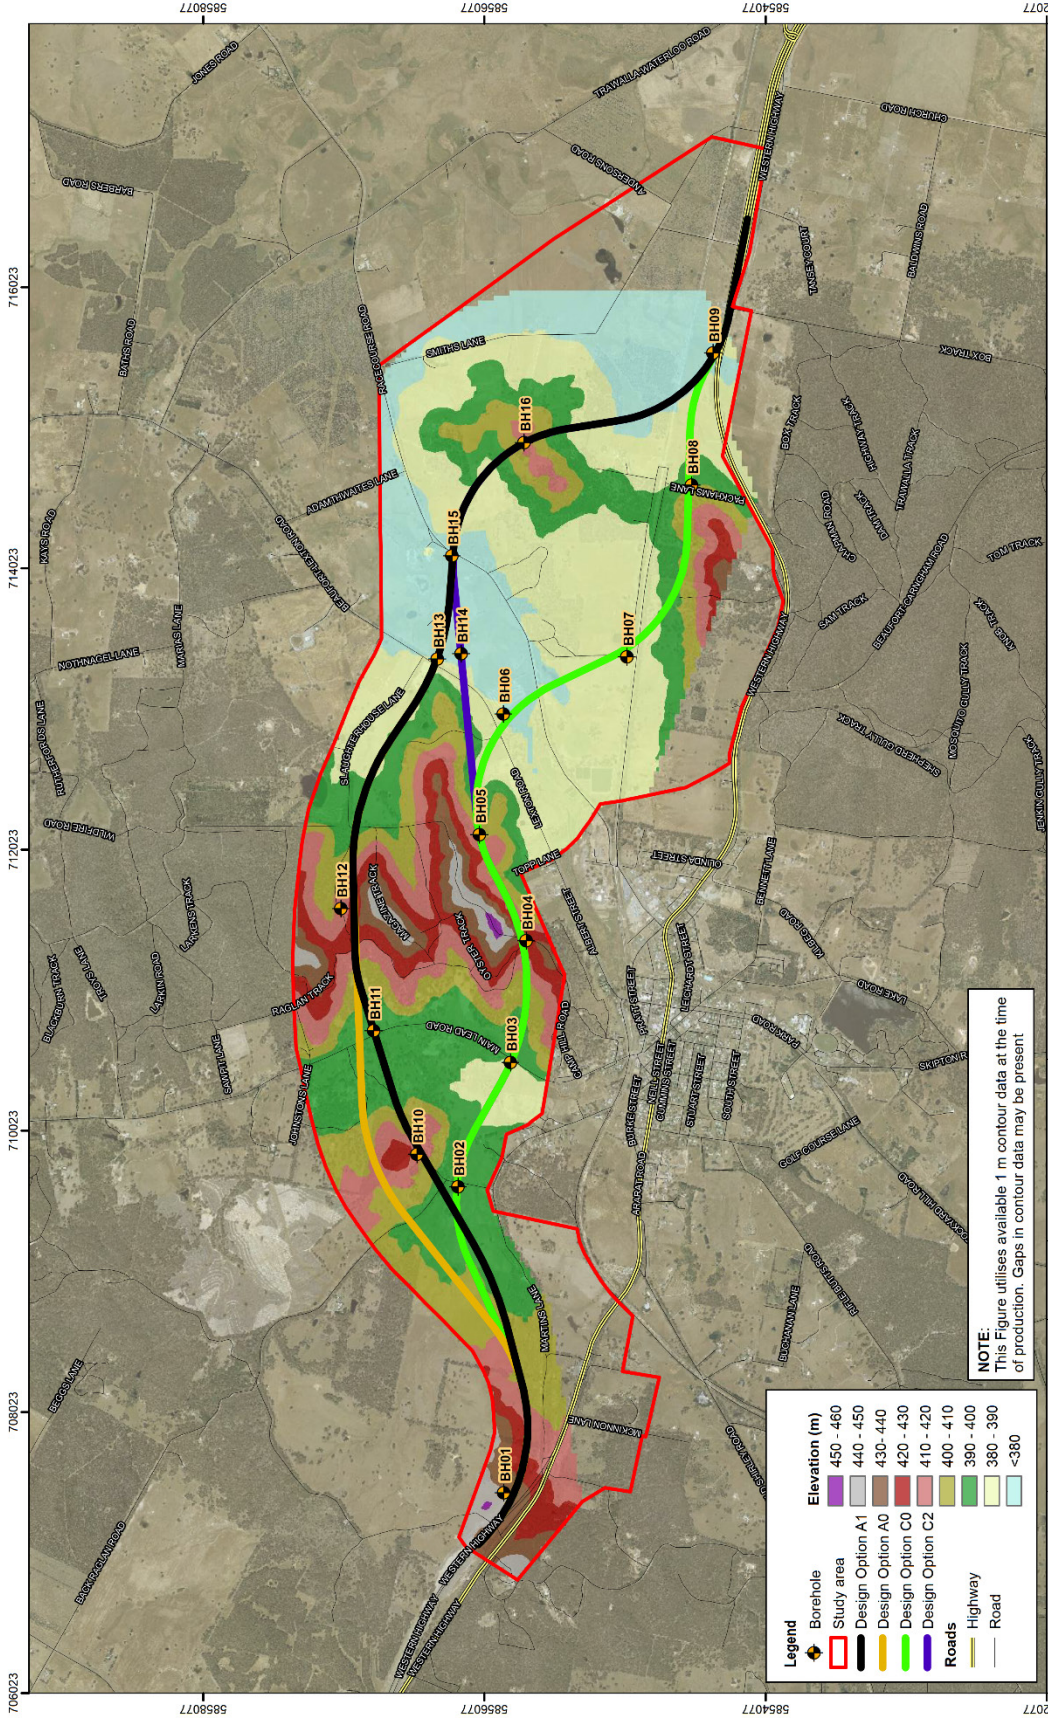
Figure 6.1 Topography

The general topography of all four bypass corridor options is undulating, with gently sloping hills to the east and west of Beaufort, and steeper sections through the Camp Hill area (Figure 6.1). The proposed construction approach to undulating environments will include cut through the steeper slopes to depths of about 15 m for all four options. These depths are based on a 1:2 cut batters, with benches every 5 m in height.

The fieldwork comprised the drilling of 16 boreholes at locations shown on Figure 6.1. The borehole locations were chosen based on the mapped geology and areas of greatest cut or fill. Three standpipe piezometers were installed in select borehole locations at the completion of drilling to allow for longer term groundwater monitoring.
