Contract Report

Compliance with traffic signals at
railway level crossings

for VicRoads

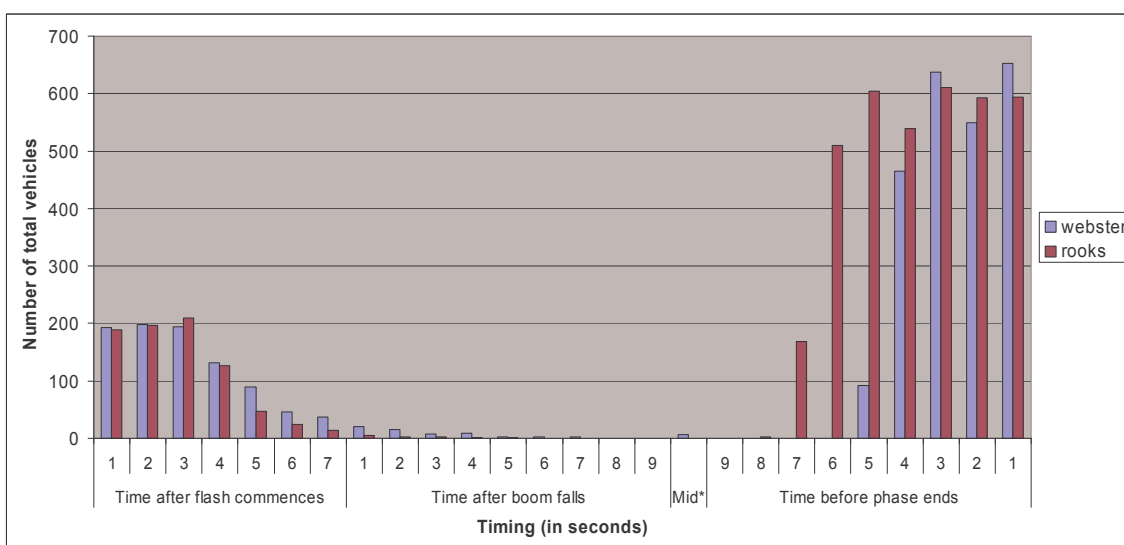
Vehicle violations at the Webster Street and Rooks Road rail level crossing, controlled by flashing lights and boom barriers, but no traffic lights, are shown in Figure 3.1.

Figure 3.1: Vehicles entering the Webster Street railway crossing after the onset of the flashing red signal

Figure 3.1 shows that the violations at the level crossing for the two sites are very similar to one another in that they predominantly occur either:

- within the first four seconds of the flashing lights becoming active
- after the train has passed and the boom barriers begin to rise, the majority of the violations occurring within the last four second of the level crossing operation.

Notes: *mid phase violations refer to logged vehicles detected at the logger installed at the stop line and not vehicles who have driven around the boom barrier. For further comment on vehicles that may have driven around the boom barrier refer below.

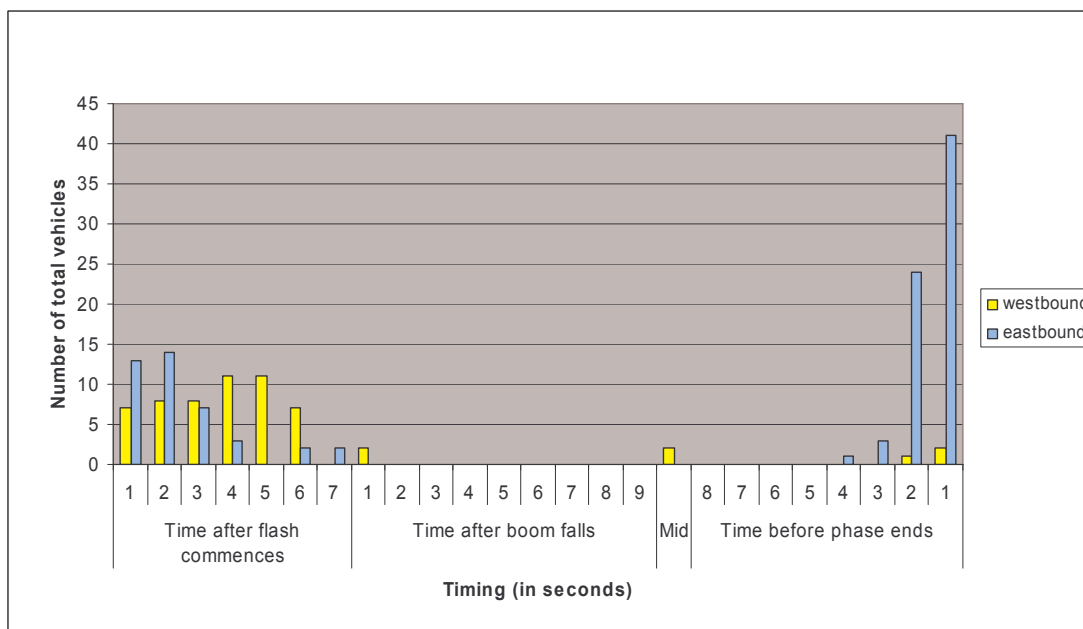
Figure 3.2: Vehicles entering the Tylden-Woodend Road rail crossing (both directions) after the onset of the flashing red lights

Figure 3.2 (Tylden-Woodend Road rail crossing) and Figure 3.3 (Kororoit Creek Road rail crossing) show driver violations at level crossing controlled by flashing lights and boom barriers

The pattern of driver violations at both sites is different for each direction. Tylden-Woodend Road eastbound and Kororoit Creek Road westbound have the majority of their violations occurring at the end of the phase. However, Kororoit Creek Road eastbound has the majority of violations occurring at the start of the phase, while at the Tylden-Woodend Road there are a substantial number of violations for traffic in both directions at the start of the signal operation. Due to the large number of violations at the end of the phase, the proportion of violations at the start of the phase is less for eastbound traffic. The implication is that the pattern of violations at level crossing sites are not uniform from crossing to crossing, or and from one approach to the opposite approach at the same crossing.

The fact that motorists are prepared to enter the crossing until the boom barrier begins to fall to fall or before its rise is complete suggests that motorists may be judging the need to stop by the position of the boom barrier .

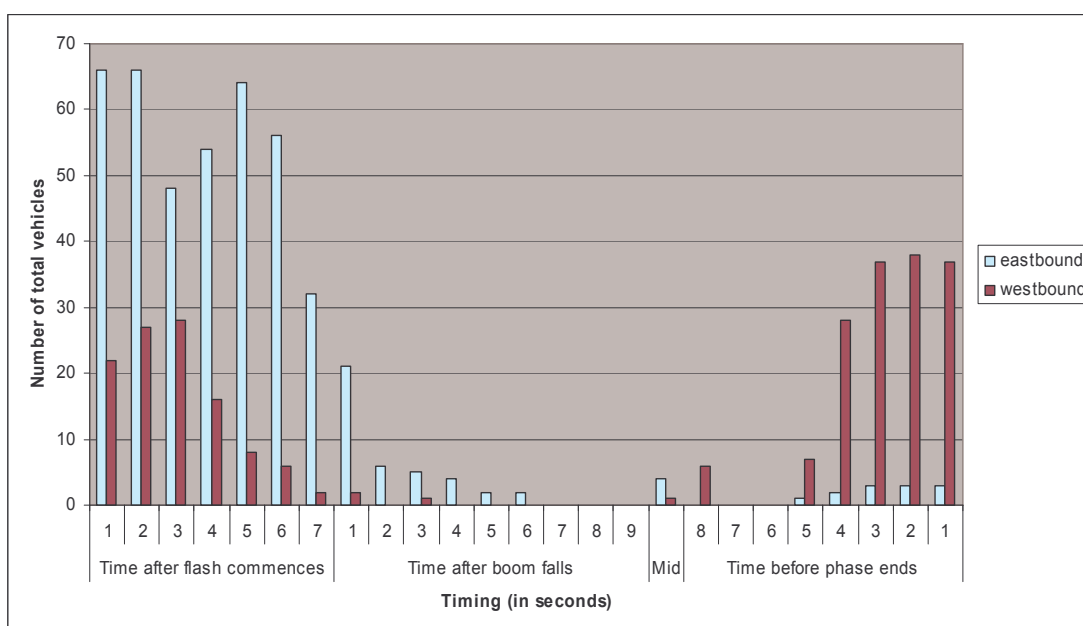
Figure 3.3: Vehicles entering the Kororoit Road rail crossing (both directions) after the onset of the flashing red lights

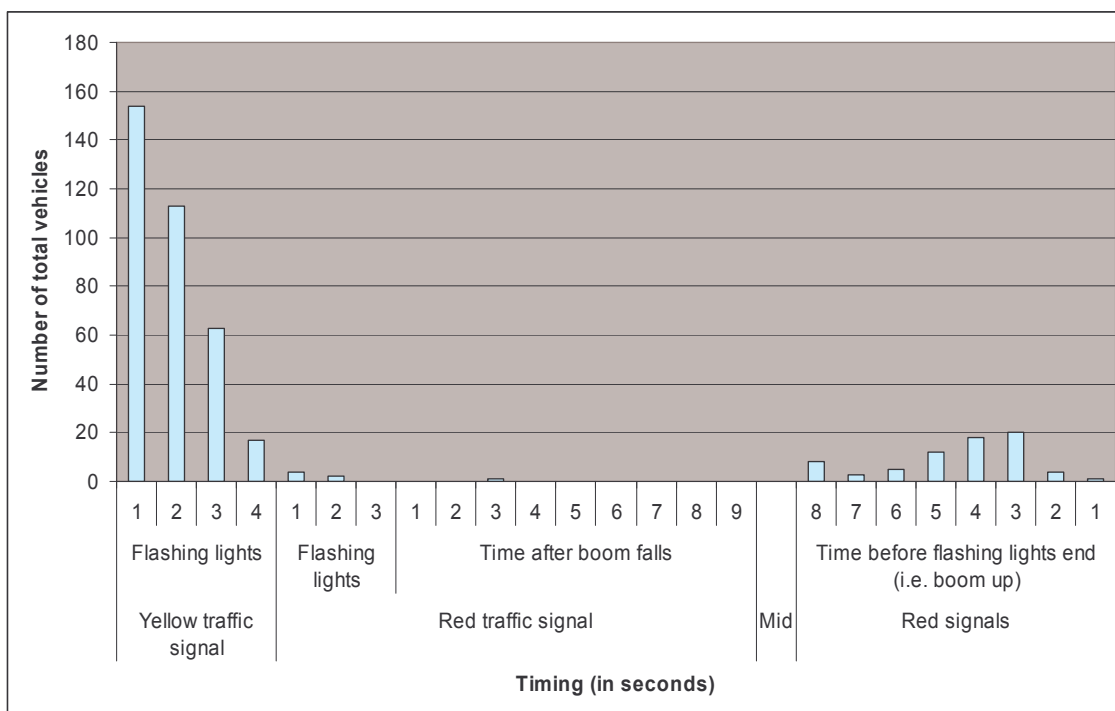
Figure 3.7 shows the pattern of vehicle violations at the Mitcham Road rail level crossing for level crossing operations activated by rail only.

Figure 3.7: Vehicles entering Mitcham Road rail crossing after the onset of the yellow signal – for rail activated operations only

As can be seen from Figure 3.7, the number of violations beyond 4 seconds after the commencement of the flashing lights is very low when compared to level crossing without traffic

lights installed. In addition violations at the end of the operation (e.g. prior to the flashing lights stopping) is much lower than at level crossings controlled without traffic lights. This would suggest that vehicles are more likely to comply with the traffic signal at the end of the phase than the flashing lights of the level crossing.

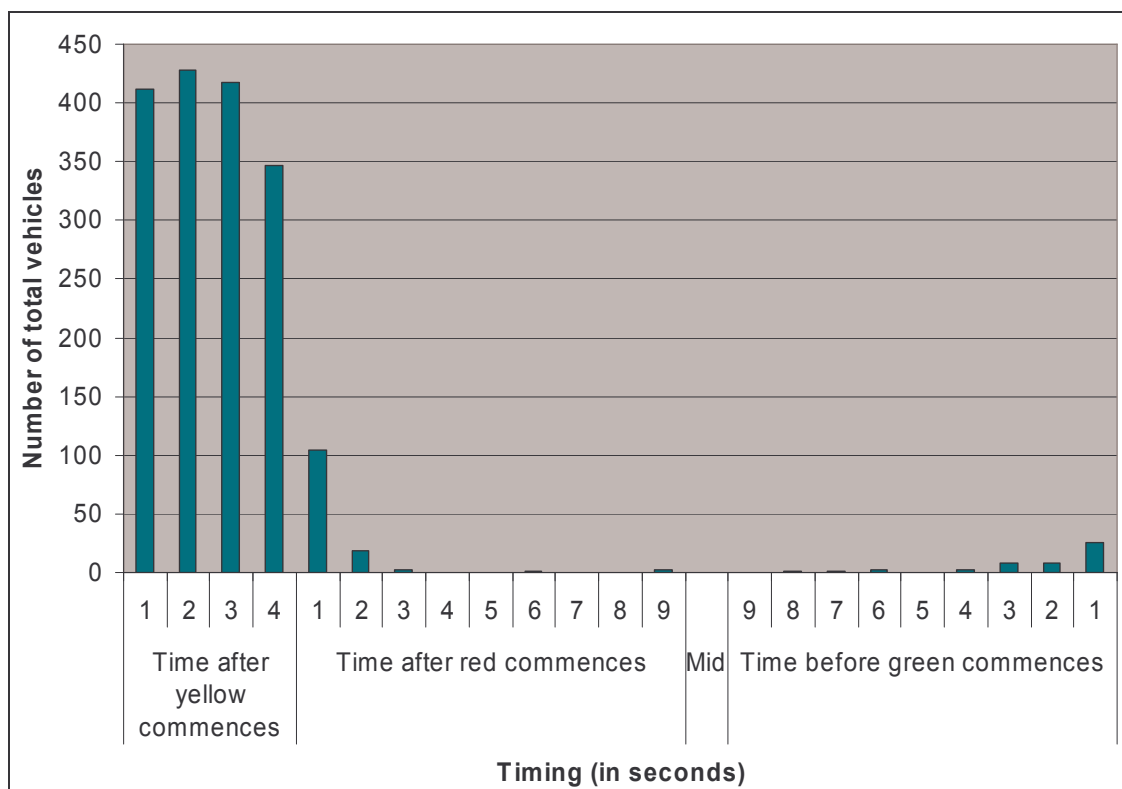
The pattern of traffic violation was determined for the Mitcham Road at the Premier Avenue signalised intersection and shown in Figure 3.8. Other signalised intersections were not further analysed as violations levels were very low with the exception of the Station Street at the Separation Street signalised intersection which reported a high number of violations occurring within the last two seconds of the phase (see Appendix B).

Figure 3.8: Vehicles entering the intersection of Mitcham Road and Premier Avenue after the onset of the yellow signal

As was the case at the Mitcham road rail crossing, the vast majority of vehicles which enter the Mitcham Road/Premier Avenue intersection do so during the yellow signal with few vehicles entering during the red signal. Of the vehicles entering during the yellow signal, most vehicles entered during the first second or the last second of the red signal. This suggests that most either misjudged the end of the yellow time, or anticipated the green signal.
