Contract Report

Evaluation of Active Advance Warning Signs (AAWS) using existing installations

for VicRoads on behalf of the Victorian Railway Crossing Safety Steering Committee (VRCSSC)

VC74957- March 2009

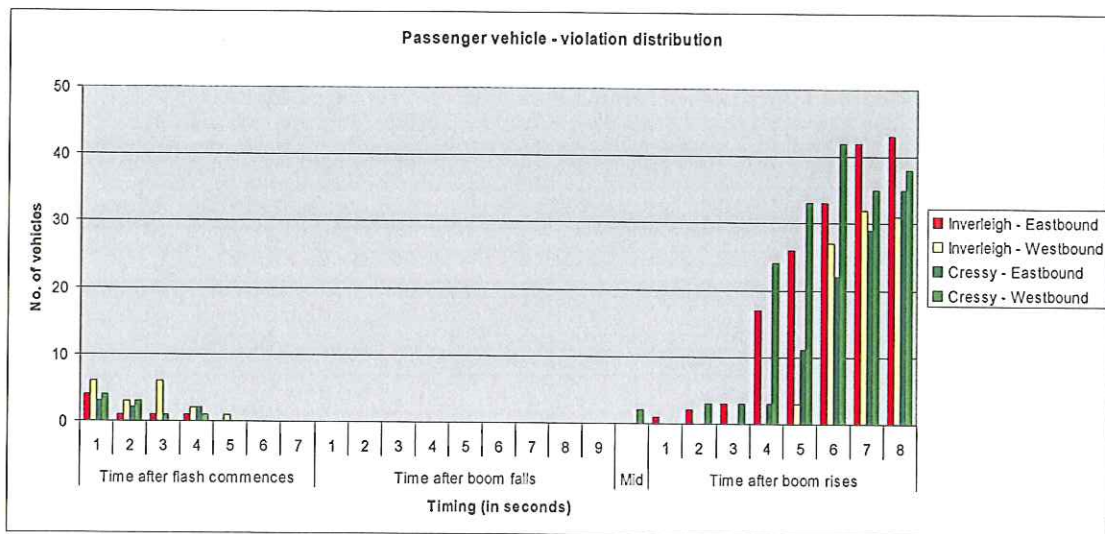
The violation distribution for the two sites for passenger vehicles is outlined in Table C.1 and Figure C.1.

Figure C.1: Passenger vehicle violation distribution

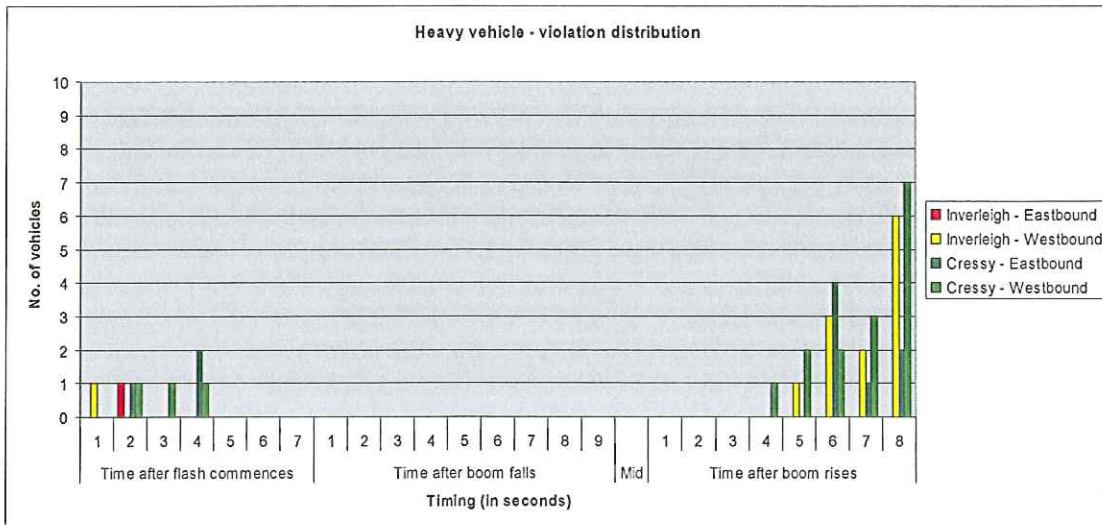
Figure C.2: Heavy vehicle violation distribution
