Before and after evaluation of active  
advance warning signs (AAWS)  
installed at the Cressy railway level  
crossing

for VicRoads on behalf of the Victorian  
Railway Crossing Safety Steering  
Committee (VRCSSC)

001264- February 2010

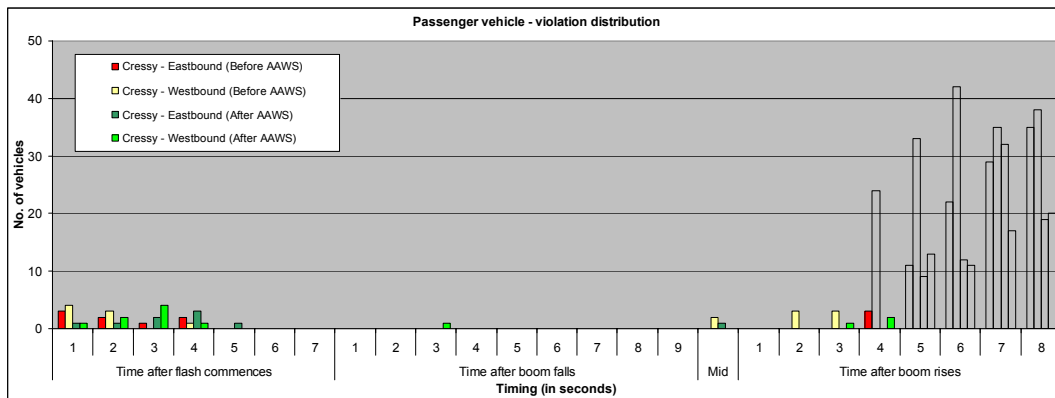
Compliance	At the level crossing.	It was observed from the data that the AAWS did not impact on the number or timing of violations at the level crossing. However, a larger violation sample would be needed to verify this observation.
Timing of violations.	At the level crossing.	Refer to Figure 3.1.  Most violations occurring at the start of the active crossing control phase occurred within the first four seconds of the level crossing activation for both the 'with' and 'without' AAWS scenarios.  While the number of violations in the first two seconds appears lower in the after scenario, the absolute numbers are too low to make the difference statistically significant.  Violations during the 'boom up' phase for the before and after AAWS scenarios follow the same pattern (i.e. primarily in the last four seconds).

Figure 3.1: With AAWS scenario versus without AAWS scenario – violation distribution for passenger vehicles

Lack of consistency in observed speeds between the before and the after scenarios suggests that AAWS may have not affected driver behaviour at the Cressy level crossing (already controlled by boom gates and flashing lights).

Compliance with the level crossing controls, in particular at the start of the phase (i.e. during the flashing lights only or boom down phase) is more likely to be dependent on the attitude of the drivers towards the level crossing controls rather than to their reaction to the activation of the AAWS.
