Braided Flexible Brake Hoses

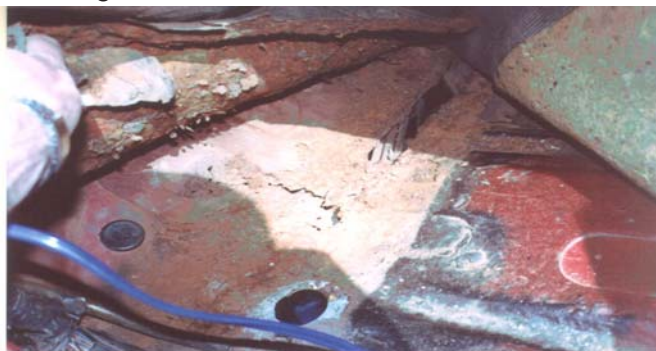
Many of these older vehicles may look OK on the outside but when you look closer and perhaps lift up the carpets as above, it turns out that the "Oldie" is NOT a "Goodie".

You are not expected to pick off the duco or poke or prod likely areas with a screwdriver in cosmetic locations but some gentle tapping in those areas listening for signs of body filler and then examination of the rear of the area may well be required. "Oldies" that have fresh body deadener or deadener in placed that the OEM did not put it are almost a "cert" for hidden rust damage.

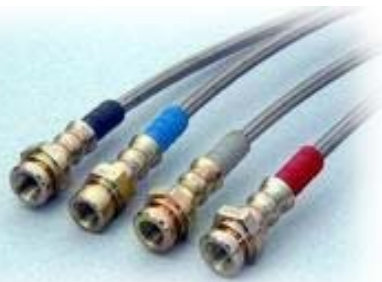
If you look at current braided flexible brake hoses you will note that they are much smaller in diameter than the comparable unbraided hose.

The new designs addressed flexibility and improved the swage system. Consequently, there are now many braided flexible brake hoses that do not have a problem passing the ADR 7 whip test.
