Testing Times

Issue 28

Re-trimming of seats with air bags

LPG tank test marking

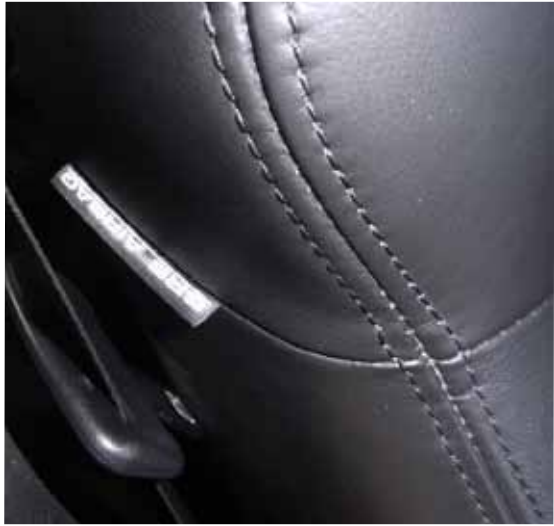
Seat Stitching for Air Bag Deployment

The airbag’s effectiveness is lost if it doesn’t work properly and either of these faults can result in serious injury to the seat occupant if the air bag is incorrectly deployed. In the illustration below, the line of stitching where the air bag tag is attached is stitched internally and as you can see, it is very difficult to see the nature and condition of the stitching.

However, for this particular model, if that stitching had been reinforced externally, like the vertical stitching, then you could be sure it is not original and would need following up.

If you are dealing with automotive upholstery trimmers make sure they understand these two issues and be suspicious of any re-trimmed seats you come across. Most seats with air bags have tags attached. If there are no tags where you expect to see them, this could indicate that the seat cover has been altered.

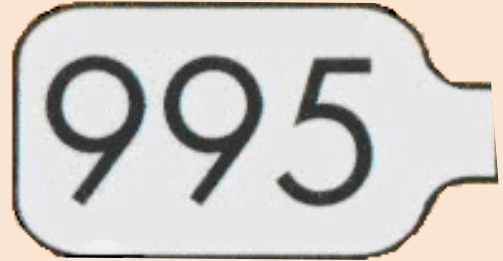
All tank testers must now include a standard logo (image of a gas bottle on its side as shown below) containing their three digit accreditation number.

Note that the logo and test information must not be stamped on the pressure-retaining portion of the tank, but should be stamped onto a permanent attachment to the tank in a position where it will be visible when the tank is installed in the vehicle.

Where the information is marked on a plate or label, in addition to the logo with the tester's number and the date of the test, the serial number of the tank must be included to create a positive identifying link to the tank.

As the identity of the tank tester is a mandatory requirement, any LPG tank with a current date stamp but no tester identification should be rejected as it is quite likely that the tank has not been properly or legally tested.
