Our ref: 26006.loc.1

15 September 2023

ARBORICULTURAL ASSESSMENT – Pruning of 2 street trees, clearance for scaffolding and hoarding for demolition, CHATSWOOD DIVE, 607 Pacific Highway, Chatswood NSW (the site) Sydney Metro City & Southwest Line-wide Works

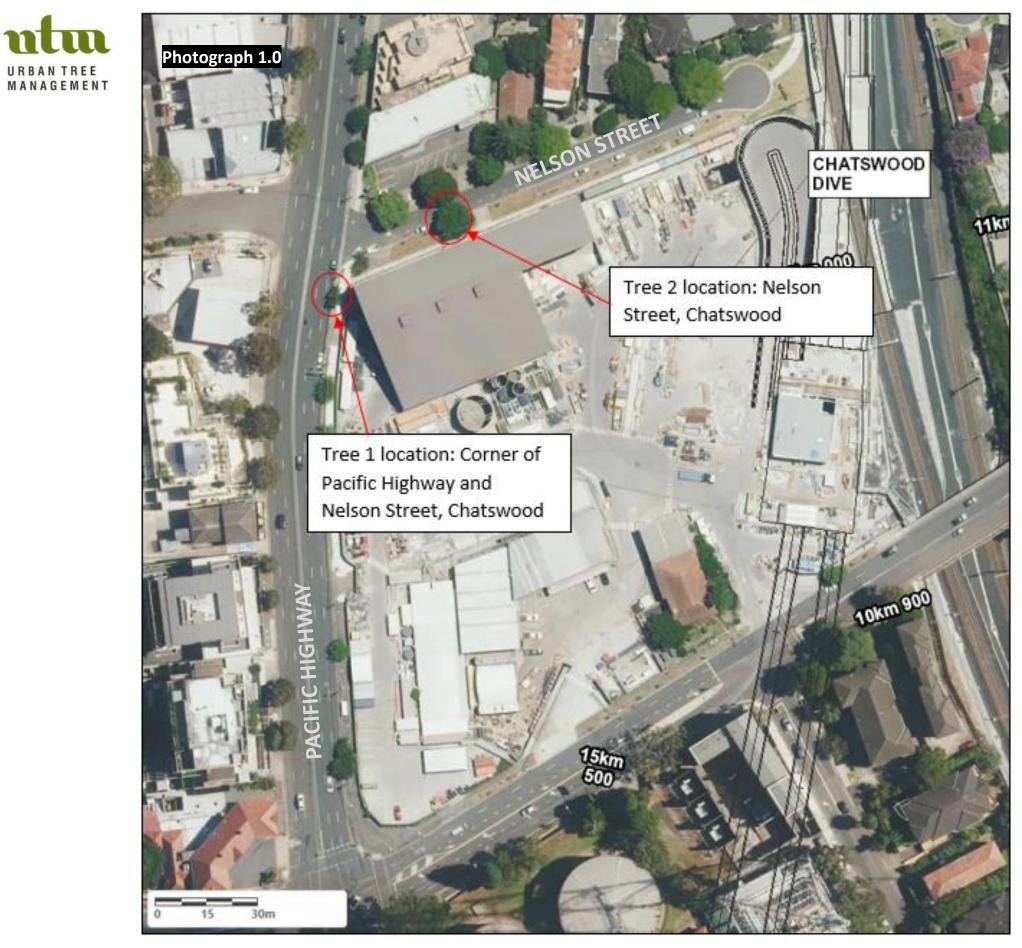
Appendix B – Tree Location Plan (aerial photograph – Photograph 1.0), CHATSWOOD DIVE, 607 Pacific Highway, Chatswood NSW, showing location of Trees 1 and 2 requiring pruning for clearance from scaffolding and hoarding for demolition works. Trees numbered per Appendix A – Tree Assessment. Photograph 1.1 provided by Tristan McCormick, Sydney Metro City & Southwest Line-wide Works. Prepared by Urban Tree Management Australia Pty Ltd, reference 26006 - Loc.1, 15/9/2023.

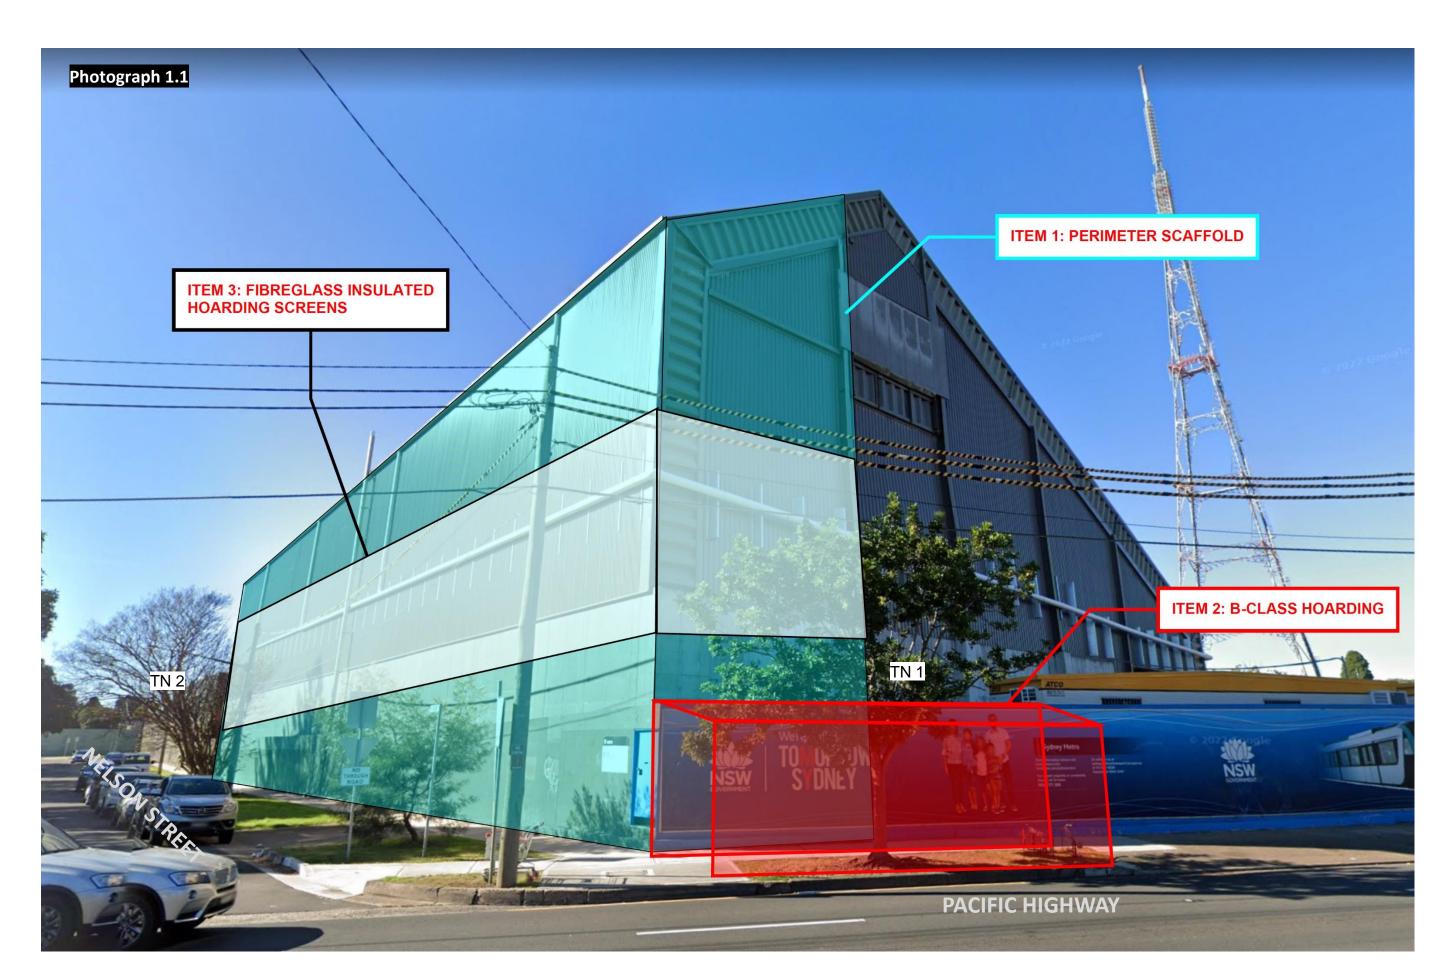
Appendix B – Tree Location Plan, (Photograph 1.1), CHATSWOOD DIVE, 607 Pacific Highway, Chatswood NSW, showing location of Trees 1 and 2 requiring pruning for clearance from the scaffolding and hoarding during demolition works. Trees numbered per Appendix A – Tree Assessment. Photograph 1.1 provided by Tristan McCormick, Sydney Metro City & Southwest Line-wide Works. Prepared by Urban Tree Management Australia Pty Ltd, reference 26006 – Loc.1, 15/9/2023.
