Review of	Construction Monitoring Report Sep 2021-Feb 2022	Document reference:	Construction Monitoring report September 2021 - February 2022 Sydney Metro City & Southwest – Line- wide Works N21063 SMCSWLWC-SYC-CSW-EM-REP-011744 Dated 24 March 2022
Prepared by:	Carl Fokkema Alternate Acoustics Advisor		
Date of issue:	13 May 2022

Construction Monitoring Report September 2021 – February 2022

Sydney Metro City & Southwest – Line-wide Works

Contract Number:	C600
Systems Connect Number	N21063
Document number:	SMCSWLWC-SYC-CSW-EM-REP-011744
Revision date:	24/03/2022
Revision:	0

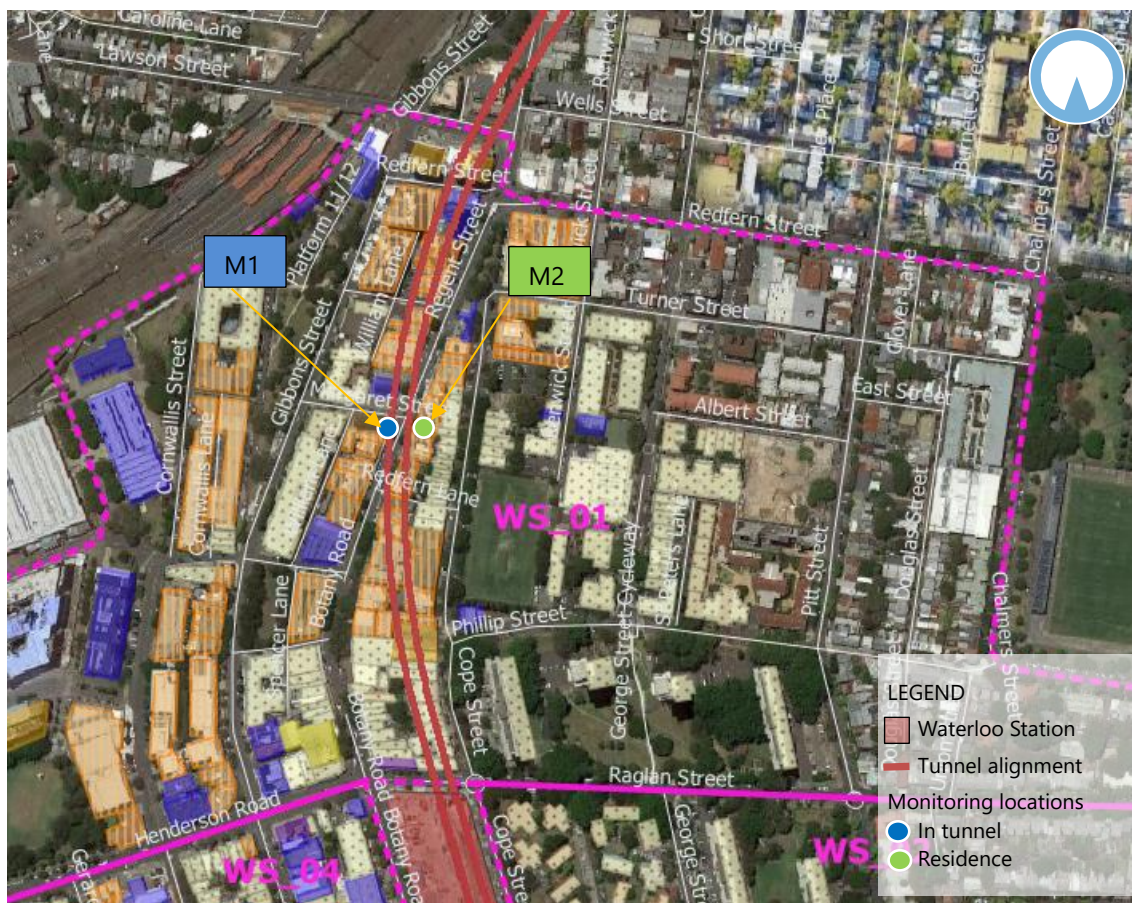
Figure 2-1 – Vibration monitoring locations at Waterloo-Central tunnel and residential receiver

The results of the attended vibration monitoring indicated that vibration levels were well below the “low probability of adverse comment” vibration limit associated with night-time construction activities. The cause of the highest measured vibration events during the monitoring period were light and heavy vehicle passbys on Regent Street.

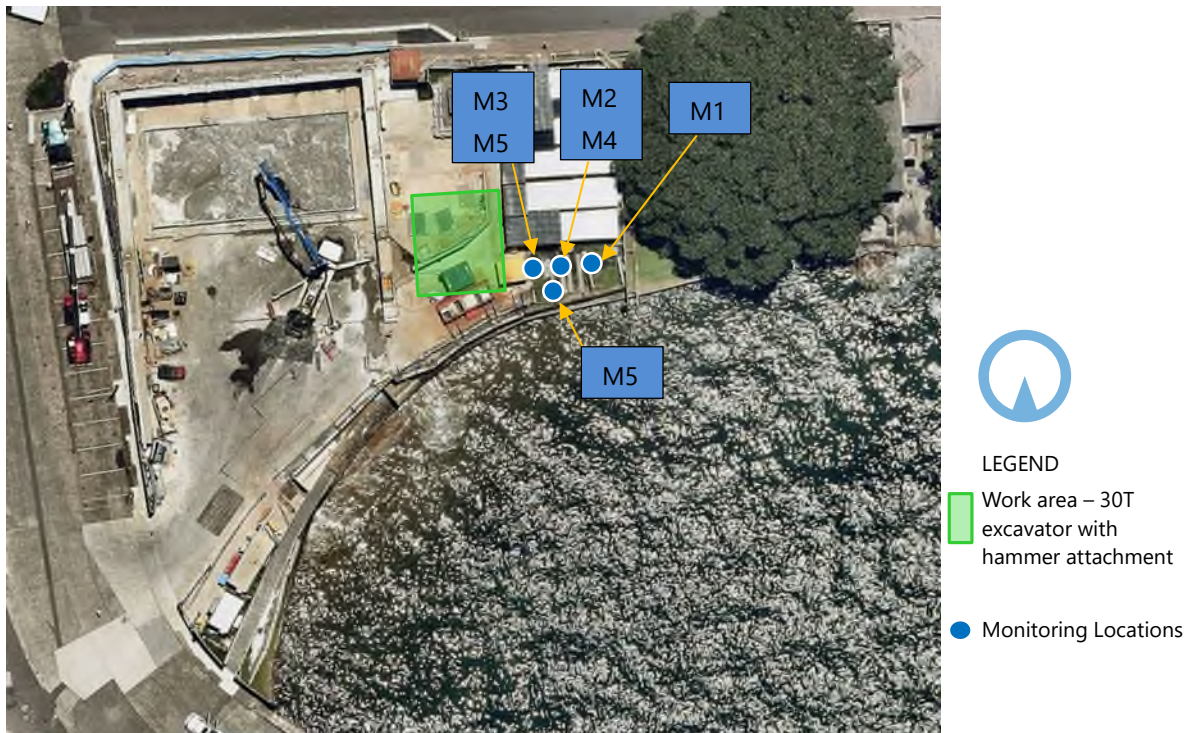
Figure 2-1 - Monitoring locations – Blues Point attended vibration monitoring

Measurement ID	Assessment Point	Date	Time	Measured plant	Approx. distance to measured plant
M6	Heritage seawall (Figure 2-1)	03.02.2022 – 04.02.2022	03:30pm – 03:50pm	30T excavator with hammer attachment	3m - 10m

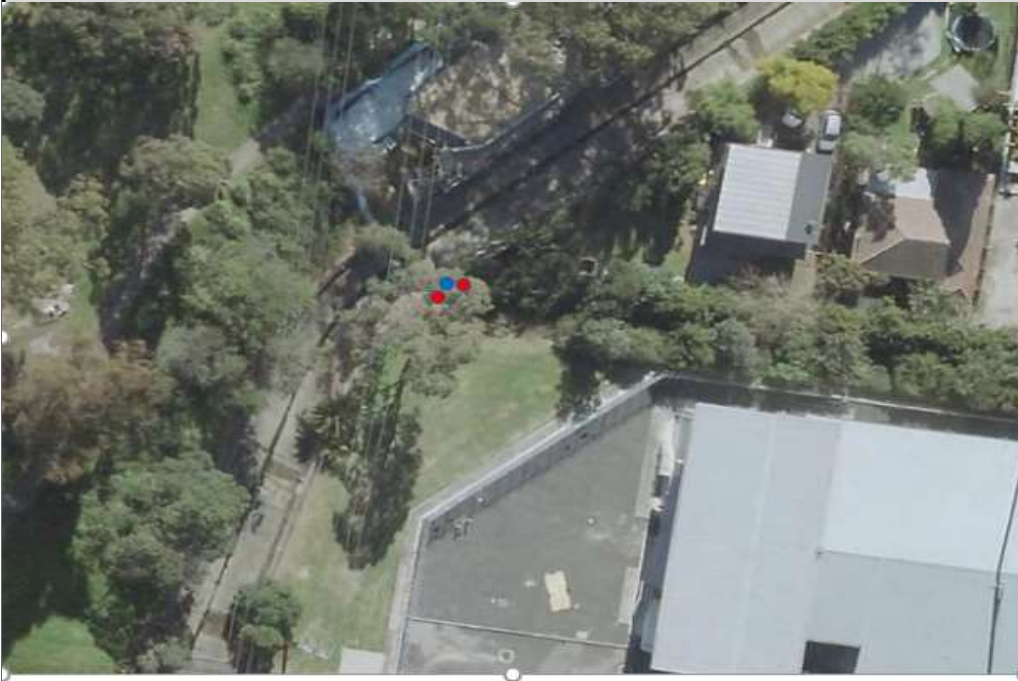
DIAGRAMS

20/09/2021	3:27:00 PM	6.77	0.34	0.76	Auger piling through hard rock at depth
COMPLIANT WITH VIBRATION CRITERIA:			Yes		
MONITORING COMMENTS OR ACTIONS TAKEN TO ADDRESS EXCEEDENCES OF VIBRATION CRITERIA					
No vibration exceedance above the criteria of 10 mm/s during piling works
