Orchard Hills Station Detailed Site Investigation

Sydney Metro Western Sydney Airport Station Boxes and Tunnelling Works

Project number	WSA-200-SBT
Document number	SMWSASBT-CPG-SWD-SW000-GE-RPT-040514
Revision date	26/09/2022
Revision	A.05

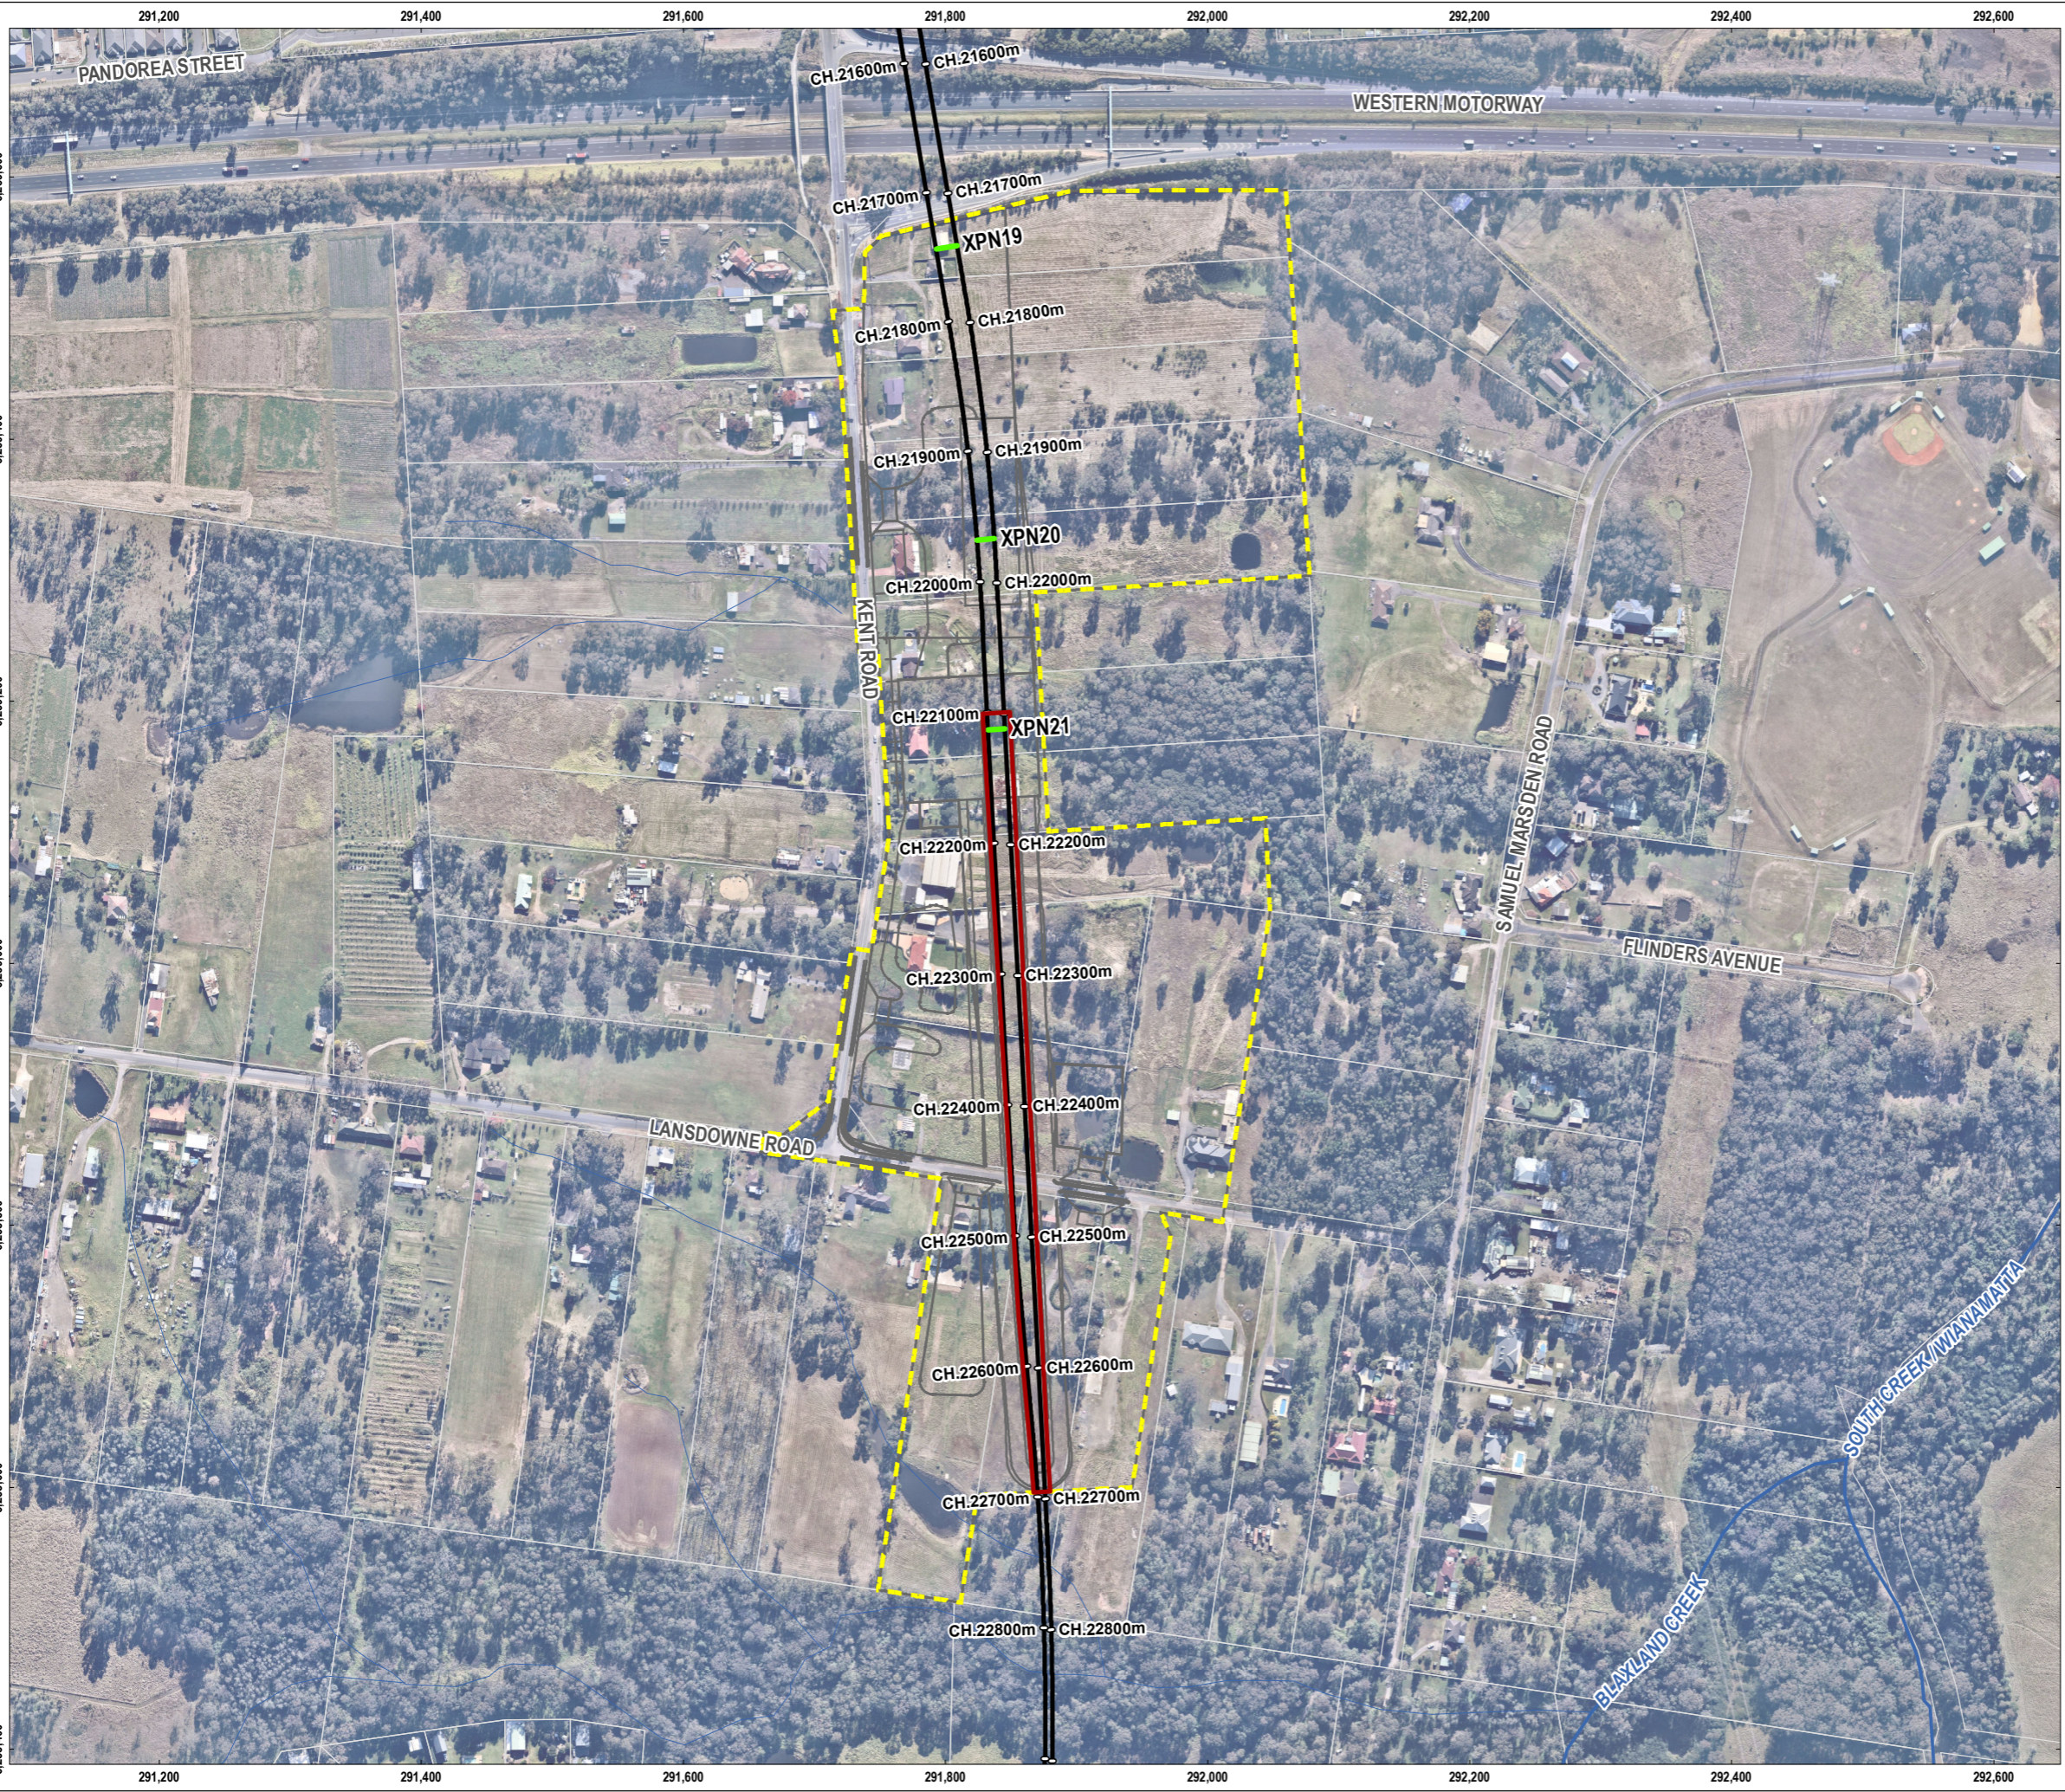
FIGURE 3
 Site Observations - Orchard Hills
 Station and Portal Dive Structure

The following provides a summary of the observations made at each property. Key observations are also shown in **Figure 3, Appendix 1**.

Table 4 outlines the AECs that were previously identified in the EIS Technical Paper, cross referenced with observations made by TTMP during the site walkover. The location and extent of the AEC is shown in **Figure 3, Appendix 1**.
