# Distribution Overhead Defect Handbook

**Document No. MMI 0002**

**Amendment No. 3**

30/04/25

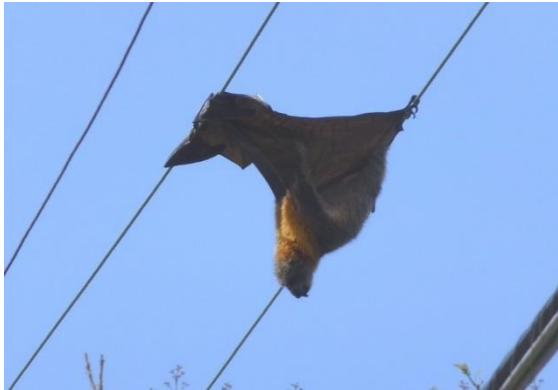
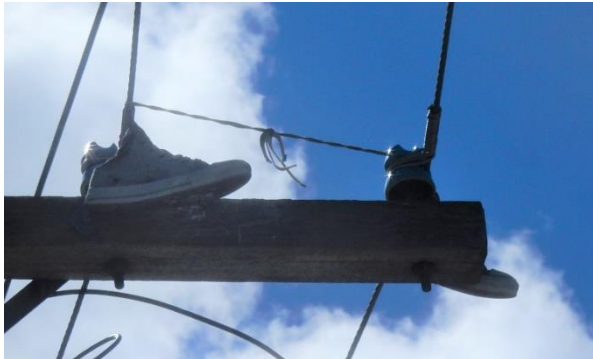
| Defect Description | Defect Photo | Task Details |
|---|---|---|
| <u>Conductor Clearances - Compromised Due to Foreign Objects</u> | <br> | <u>Priority</u><br>SAP Priority 6<br>1 Month |
| <b>Indicators:</b><br><br>- Phase to phase separation compromised due to foreign objects being attached to the mains or laying across the mains. | | <u>Bushfire Defect</u><br>Yes |

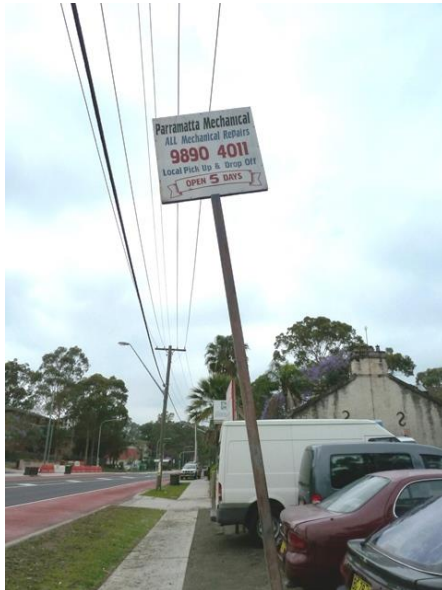
| Defect Description | Defect Photo | Task Details |
|---|---|---|
| <b><u>Conductor - Clearances to Structures Are Compromised</u></b> | | <b><u>Priority</u></b><br><b>SAP Priority 6</b><br>1 Month |
| <b>Indicators:</b> <ul style="list-style-type: none"><li>- Clearances to buildings or structures have been compromised due to unauthorised erection of structures or buildings.</li><li>- Storage of earthworks beneath powerlines.</li><li>- Ground level has been raised beneath powerlines.</li></ul> | | <b><u>Bushfire Defect</u></b><br>Yes |

| Defect Description | Defect Photo | Task Details |
|---|---|---|
| | | <b><u>Standard Job</u></b> <ul style="list-style-type: none"><li>- Encroachment on Easement (1ENCRO)</li></ul> |

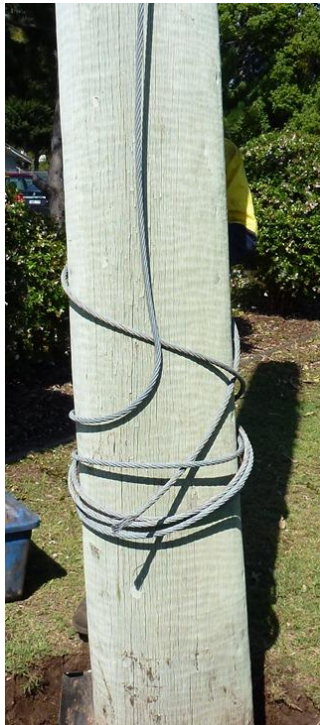
| Defect Description | Defect Photo | Task Details |
|---|---|---|
| <u>Conductor - Obsolete</u> | | <u>Priority</u><br>SAP Priority 9<br>Observation |
| <b>Indicators:</b><br><br>- Excess conductor or conductor hanging, which is not connected to mains. | | <u>Bushfire Defect</u><br>No |

| Defect Description | Defect Photo | Task Details |
|---|---|---|
| | | <u>Standard Job</u><br>- LV Conductor (1LVCDR)<br>- HV Conductor (1HVCDR)<br>- Transmission Conductor (1TRCDR)<br>- Service Conductor (1SECDR)<br>- Streetlight Conductor (1SLCDR) |

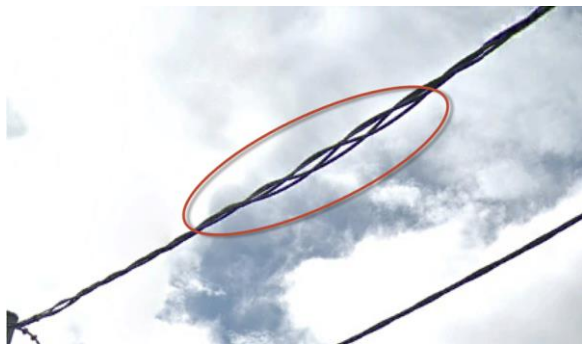
| Defect Description | Defect Photo | Task Details |
|---|---|---|
| <p><b><u>Bundled Conductor - Cable Loose</u></b></p> | <p><b><u>High voltage (HVABC)</u></b></p> <p><i>(Note the above is not a defect)</i></p> <p><b><u>Low voltage (LVABC)</u></b></p> | <p><b><u>Priority</u></b><br/>SAP Priority 9<br/>Observation</p> |
| | | <p>LV – Not a defect</p> |

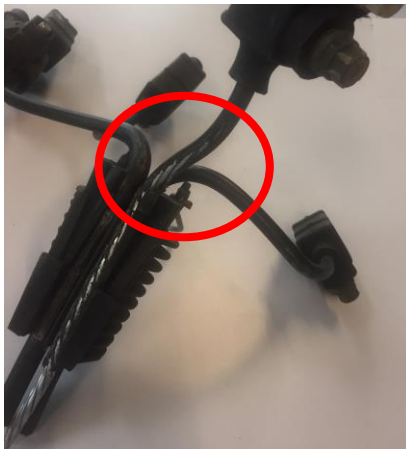
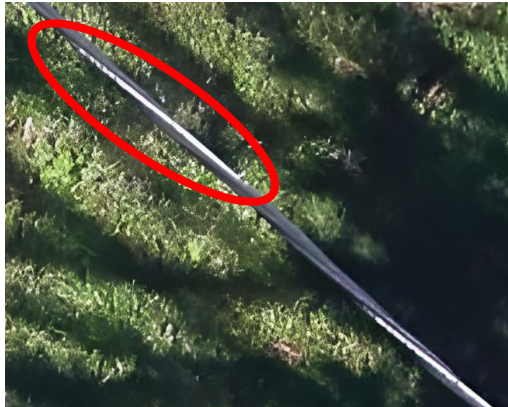
| Defect Description | Defect Photo | Task Details |
|---|---|---|
| <u>LVABC - Insulation Damaged</u> | <br> | <u>Priority</u><br>SAP Priority 7<br>3 Months |
| <p><b>Indicators:</b></p> <ul style="list-style-type: none"><li>- Conductor can be seen through the XLPE insulation.</li><li>- Defect applies to both LVABC services and mains.</li></ul> | | <u>Bushfire Defect</u><br>Yes |

| Defect Description | Defect Photo | Task Details |
|---|---|---|
| | | <u>Standard Job</u><br><ul style="list-style-type: none"><li>- LV Conductor (1LVCDR)</li><li>- Service Conductor (1SECDR)</li></ul> |

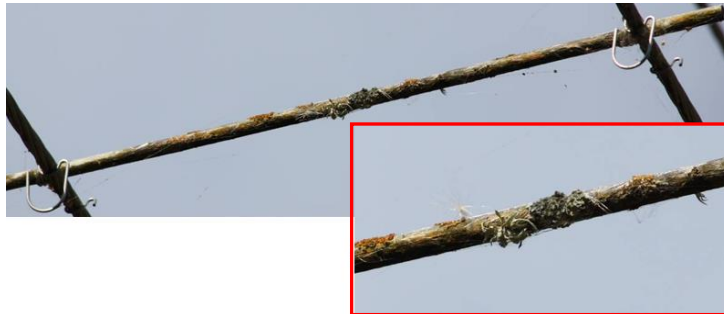
| Defect Description | Defect Photo | Task Details |
|---|---|---|
| <u>Spreader - Deteriorated</u> | | <u>Priority</u><br>SAP Priority 7<br>6 Months |
| <b>Indicators:</b> <ul style="list-style-type: none"><li>- Spreader damaged or broken.</li><li>- Spreader does not have a "smooth" appearance.</li></ul> | | <u>Bushfire Defect</u><br>Yes |

| Defect Description | Defect Photo | Task Details |
|---|---|---|
| | | <u>Standard Job</u><br>- Install LV Spreader (1LVSPR) |

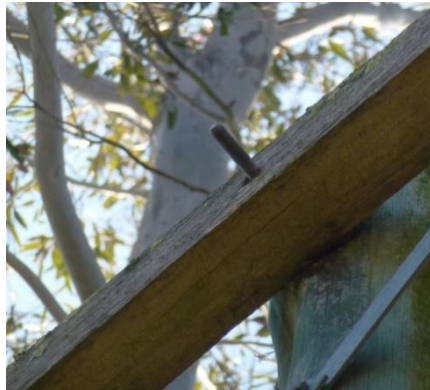
| Defect Description | Defect Photo | Task Details |
|---|---|---|
| <u>Crossarm – Loose (Nut Missing)</u> | | <u>Priority</u><br><br>SAP Priority 2<br>Immediate/48 hrs |
| <b>Indicators:</b><br><br>- No Nut on kingbolt through crossarm | | <u>Bushfire Defect</u><br><br>Yes |

| Defect Description | Defect Photo | Task Details |
|---|---|---|
| | | <u>Standard Job</u><br>- Replace LV Hardware (1LVHAR)<br>- Replace HV Hardware (1HVHAR)<br>- Transmission Hardware (1TRHAR) |

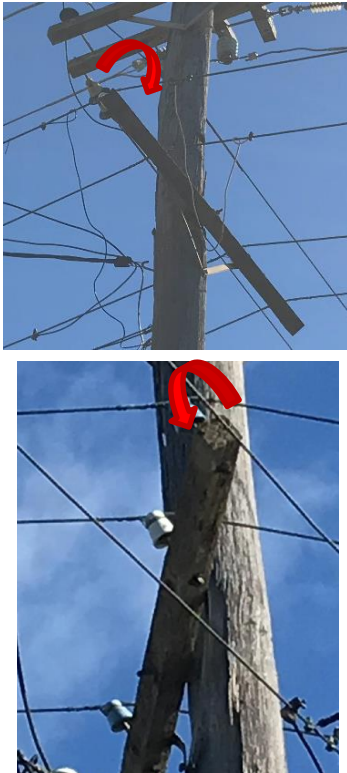
| Defect Description | Defect Photo | Task Details |
|---|---|---|
| <u>Crossarm - Twisted</u> | | <u>Priority</u><br>SAP Priority 7<br>6 Months |
| <b>Indicators:</b> <ul style="list-style-type: none"><li>- Crossarm has rotated and no longer parallel with ground.</li><li>- Wires are under high tension</li></ul> | | <u>Bushfire Defect</u><br>Yes |

| Defect Description | Defect Photo | Task Details |
|---|---|---|
| | | <u>Standard Job</u> <ul style="list-style-type: none"><li>- Replace LV Hardware (1LVHAR)</li><li>- Replace HV Hardware (1HVHAR)</li><li>- Transmission Hardware (1TRHAR)</li></ul> |

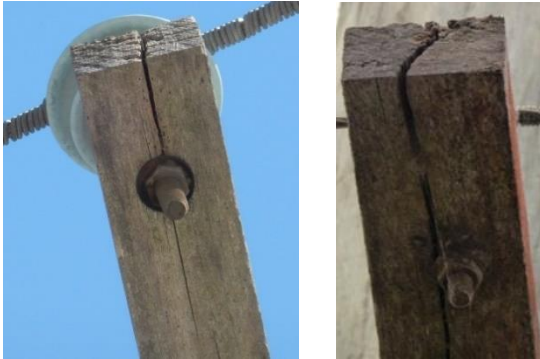
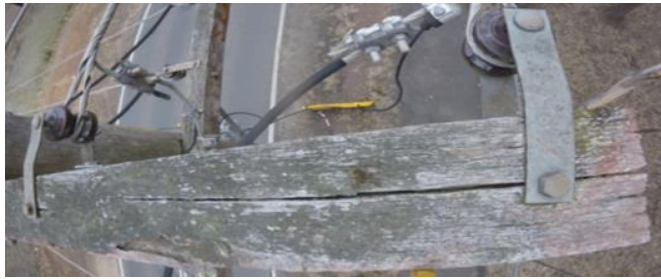
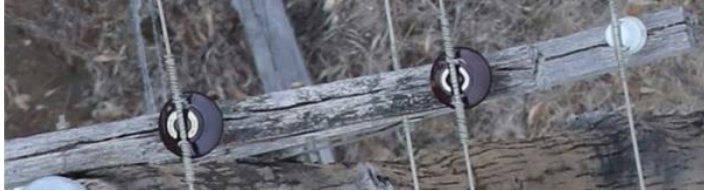
| <p><b><u>Crossarm - Splitting (Moderate)</u></b><br/><b><u>Near Hardware</u></b></p> | | <p><b><u>Priority</u></b><br/><b>SAP Priority 7</b><br/>6 Months</p> |
| <p><b>Indicators:</b></p> <ul style="list-style-type: none"><li>- Split/s extending through cross-section</li><li>- <u>No</u> separation of timber (daylight <u>cannot</u> be seen).</li><li>- Split/s meet or extend through hardware (e.g. kingbolt, shackle bolt, insulator pin).</li><li>- Hardware <u>not</u> at imminent risk of falling out.</li></ul> | <br> | <p><b><u>Bushfire Defect</u></b><br/>Yes</p> |

| | | <p><b><u>Standard Job</u></b></p> <ul style="list-style-type: none"><li>- Replace LV Crossarm (1LVARM)</li><li>- Replace HV Crossarm (1HVARM)</li><li>- Replace Transmission Crossarm (1TRARM)</li><li>- Replace Service Crossarm (1SEARM)</li></ul> |

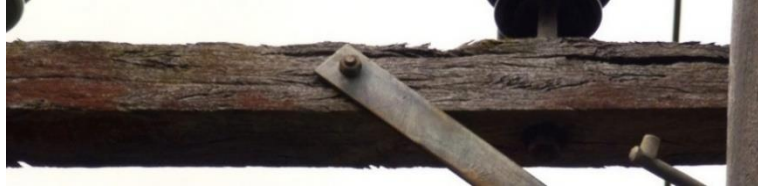
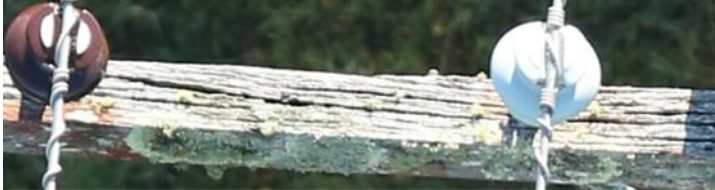
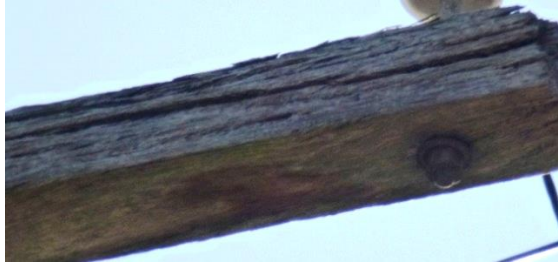
| <p><b><u>Crossarm - Splitting (Moderate)</u></b></p> <p><b><u>Not Near Hardware</u></b></p> | | <p><b><u>Priority</u></b></p> <p><b>No Defect</b></p> |
| <p><b>Indicators:</b></p> <ul style="list-style-type: none"><li>- Split/s extending through cross-section.</li><li>- No separation of timber (daylight cannot be seen).</li><li>- Split/s <u>do not</u> meet or extend through hardware (e.g. kingbolt, shackle bolt, insulator pin).</li><li>- Hardware not at risk of falling out (strain of conductor not in same direction as split)</li></ul> | | <p><b><u>Bushfire Defect</u></b></p> <p><b>No</b></p> |

| <p><b><u>Scope of Rectification Works</u></b></p> <p>No action required.</p> | | |

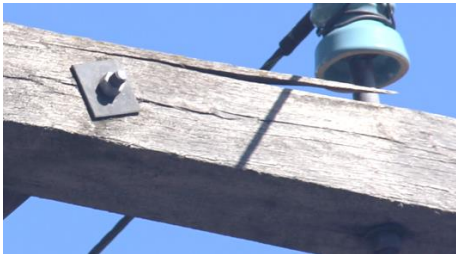
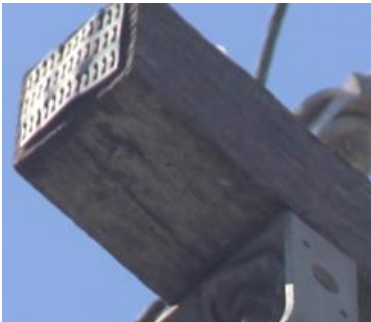
| <u>Crossarm - Splitting (Minor)</u> | | <u>Priority</u><br>No Defect |
| <b>Indicators:</b> <ul style="list-style-type: none"><li>- Small splits and cracks.</li><li>- Confined to surface or ends of crossarm (flaking / splintering).</li><li>- Splits which are indications of general weathering.</li></ul> | | <u>Bushfire Defect</u><br>No |

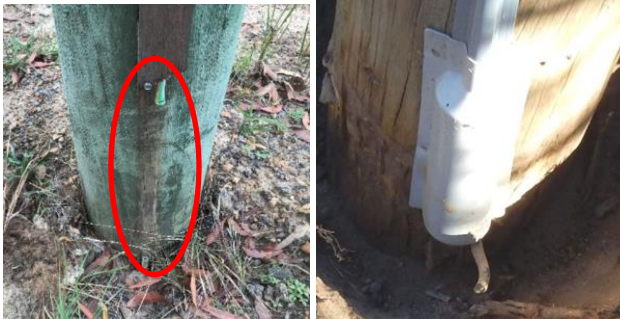
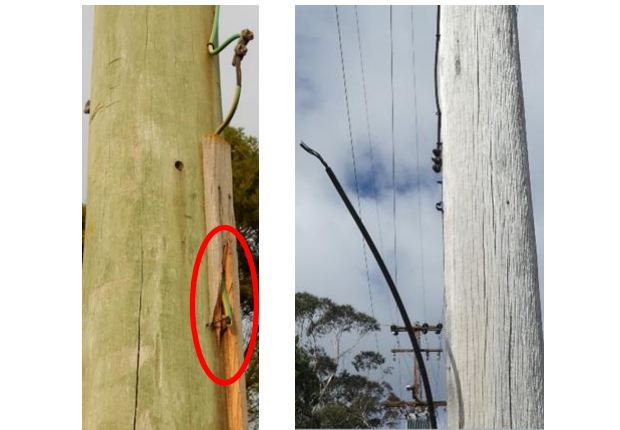
| Defect Description | Defect Photo | Task Details |
|---|---|---|
| <u>Earth Downlead – Broken or Damaged</u> | | <u>Priority</u> |
| | | <u>Pole Substation / Regulator / SWER – SAP 2 (Immediate/48)</u> |
| <u>Indicators:</u><br><br>- Earth conductor showing signs of damage (frayed / broken strands). | | <u>ABS / UGOH / Recloser / LBS / OHEW - SAP 7 (6 Months)</u> |
| | | <u>Transmission down-lead – SAP 8 (1 Year)</u> |

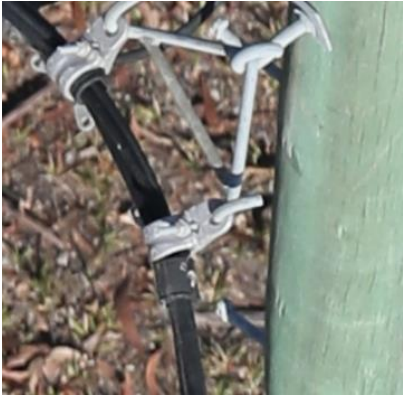
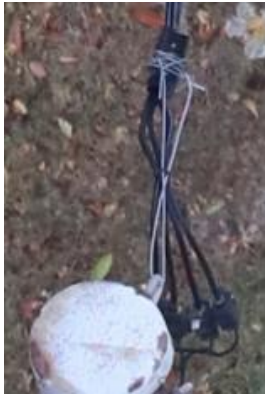
| Defect Description | Defect Photo | Task Details |
|---|---|---|
| <p><u>LVABC Hardware (Clamp, Suspension) – Broken / Damaged</u></p> | <br><br> | <p><u>Priority</u><br/>SAP Priority 6<br/>1 Month</p> |
| <p><b>Indicators:</b></p> <ul style="list-style-type: none"><li>- LVABC Clamp showing signs of rust and general signs of deterioration.</li><li>- Insert of LVABC has come loose.</li><li>- J-Hooks damaged / broken.</li><li>- Wedge Clamp broken.</li></ul> | | <p><u>Bushfire Defect</u><br/>No</p> |

| Defect Description | Defect Photo | Task Details |
|---|---|---|
| | | <p><u>Standard Job</u><br/>- Repair/Replace LV Hardware (1LVHAR)</p> |

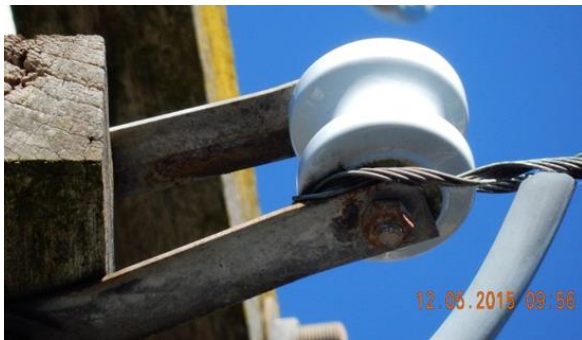
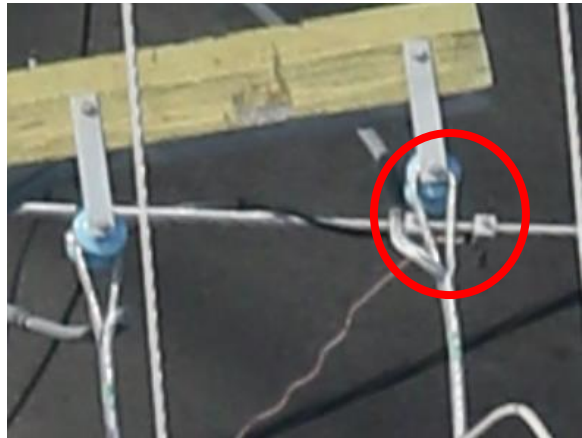
| Defect Description | Defect Photo | Task Details |
|---|---|---|
| <u>Dead-End Grip - Dislodged from Insulator</u> | | <div><u>Priority</u><br/>SAP Priority 6<br/>1 Month</div> |
| <div>Indicators:</div> <ul style="list-style-type: none"><li>- Dead-end not correctly seated around insulator.</li><li>- Has slipped off insulator or never correctly installed.</li></ul> | | <div><u>Bushfire Defect</u><br/>Yes</div> |

| Defect Description | Defect Photo | Task Details |
|---|---|---|
| | | <div><u>Standard Job</u><ul style="list-style-type: none"><li>- LV Conductor (1LVCDR)</li><li>- HV Conductor (1HVCDR)</li><li>- Transmission Conductor (1TRCDR)</li></ul></div> |

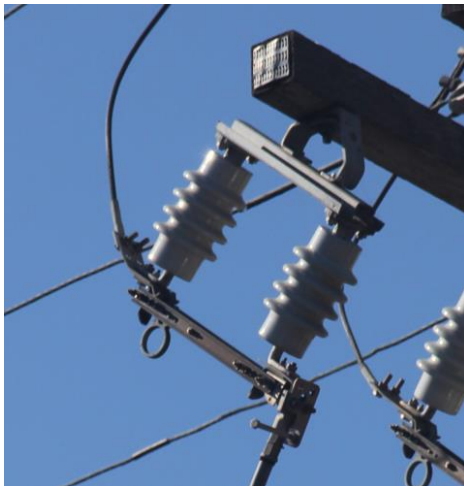
| Defect Description | Defect Photo | Task Details |
|---|---|---|
| <u>Underslung Link ('USL') - Loose</u> | | <u>Priority</u><br>SAP Priority 6<br>1 Month |
| <b>Indicators:</b> <ul style="list-style-type: none"><li>- USL has rotated / out of alignment when compared to other phases.</li><li>- Gap between USL and crossarm.</li><li>- General indications that it is not secure.</li></ul> | | <u>Bushfire Defect</u><br>No |

| Defect Description | Defect Photo | Task Details |
|---|---|---|
| | | <u>Standard Job</u> <ul style="list-style-type: none"><li>- LV: Replace LV Link (1LVLIN)</li><li>- HV: Repair/Replace USL (1USLRP)</li></ul> |
| <u>Scope of Rectification Works</u><br>Secure USL to crossarm. Check alignment with other phases.<br><b>For 1USLRP, send email to, or call, system control identifying the Network Limiting Defect (NLD) <a href="mailto:NetworkAccess@endeavourenergy.com.au">NetworkAccess@endeavourenergy.com.au</a>.</b> | | |

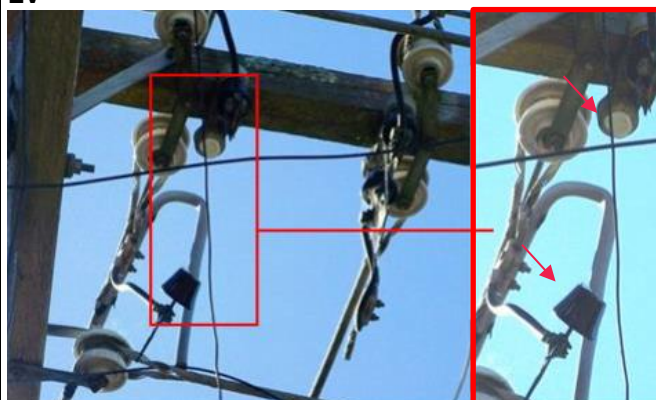
| Defect Description | Defect Photo | Task Details |
|---|---|---|
| <u>Underslung Link ('USL') – Damaged or Broken</u> | <div>LV</div> | <div><u>Priority</u><br/>SAP Priority 6<br/>1 Month</div> |
| <div>Indicators:</div> <ul style="list-style-type: none"><li>- USL has separated from crossarm / hanging</li><li>- USL is broken, insulators cracked.</li></ul> | <div>HV</div> | <div><u>Bushfire Defect</u><br/>Yes</div> |

| Defect Description | Defect Photo | Task Details |
|---|---|---|
| | | <div><u>Standard Job</u></div> <ul style="list-style-type: none"><li>- LV: Replace LV Link (1LVLIN)</li><li>- HV: Replace USL (1USL)</li></ul> |

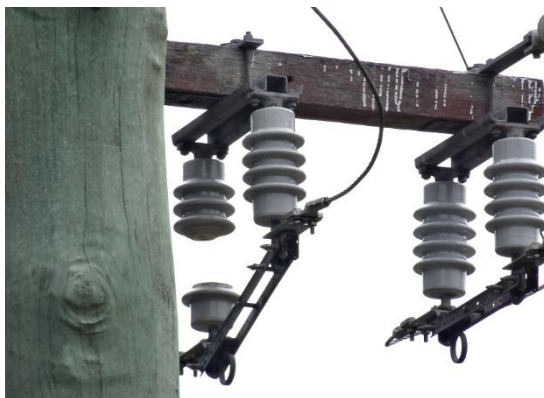
| Defect Description | Defect Photo | Task Details |
|---|---|---|
| <div><u>Cause</u></div> <ul style="list-style-type: none"><li>- Normal Operation (NO) / Lightning Damage (LD)</li></ul> | | |

| Defect Description | Defect Photo | Task Details |
|---|---|---|
| <div><u>Scope of Rectification Works</u></div> <p>Replace all USLs, regardless of condition of the other phases. If the age of the pole is greater than 20 years old, replace the crossarm and all fittings also.</p> <p><u>For 1USL, send email to, or call, system control identifying the Network Limiting Defect (NLD) <a href="mailto:NetworkAccess@endeavourenergy.com.au">NetworkAccess@endeavourenergy.com.au</a>.</u></p> | | |

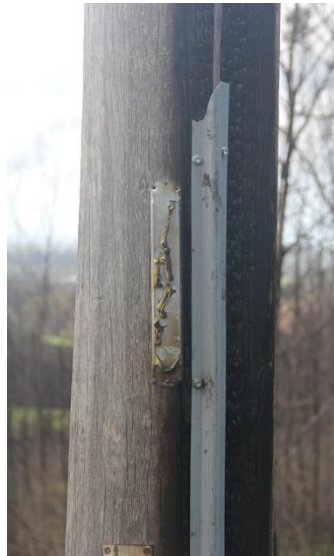
| Defect Description | Defect Photo | Task Details |
|---|---|---|
| <b><u>Pole Signage - Missing or Damaged</u></b> | | <b><u>Priority</u></b><br><b>SAP Priority 9</b><br>Observation |
| <b>Indicators:</b><br>- Pole labelling damaged, not legible or missing.<br><br><b>NOTE:</b> Pole Inspectors are to rectify pole numbering defects at the time of pole inspection. However, a pole signage defect must still be raised and closed, and defect photos captured, to record the defect. | | <b><u>Bushfire Defect</u></b><br>No |
| | | <b><u>Cause</u></b><br>- Deterioration (DG) / Vandalism (VA) |

| Defect Description | Defect Photo | Task Details |
|---|---|---|
| | | <b><u>Standard Job</u></b><br>- Replace Structure/Fdr Number (PLSIGN) |
| <b><u>Scope of Rectification Works</u></b><br>Replace signage. | | |

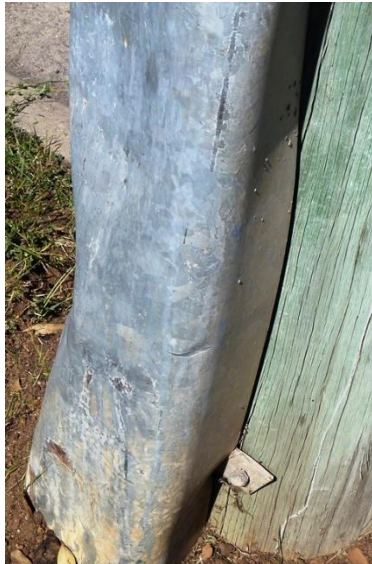
| Defect Description | Defect Photo | Task Details |
|---|---|---|
| <u>Cable Guard - Minor Damage</u> | | <u>Priority</u><br>No Defect |
| <b>Indicators:</b><br><ul style="list-style-type: none"><li>- Cable guard having dents which are less than a 5 cms in depth.</li></ul> | | <u>Bushfire Defect</u><br>No |

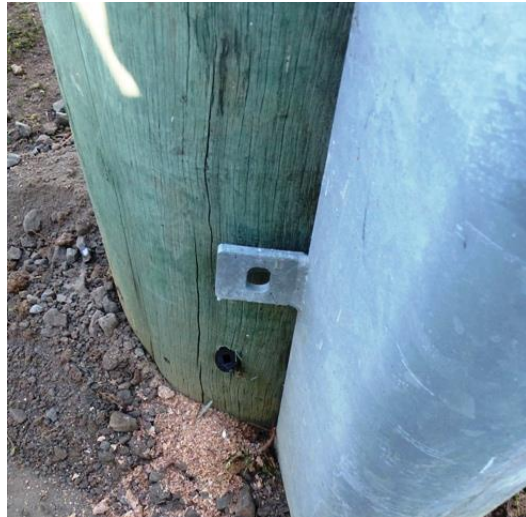
| Defect Description | Defect Photo | Task Details |
|---|---|---|
| <u>Cable Guard - Loose or Not Secure to Pole</u> | | <u>Priority</u><br>SAP Priority 9<br>Observation |
| <b>Indicators:</b> <ul style="list-style-type: none"><li>- Cable guard is not fully secure to pole.</li><li>- One or more bolts or straps are missing.</li></ul> | | <u>Bushfire Defect</u><br>No |
| | | <u>Cause</u><br>- Corrosion (CO) / Deterioration (DG) |

| Defect Description | Defect Photo | Task Details |
|---|---|---|
| | | <u>Standard Job</u><br>- Replace Cable Guard (1CAGR) |

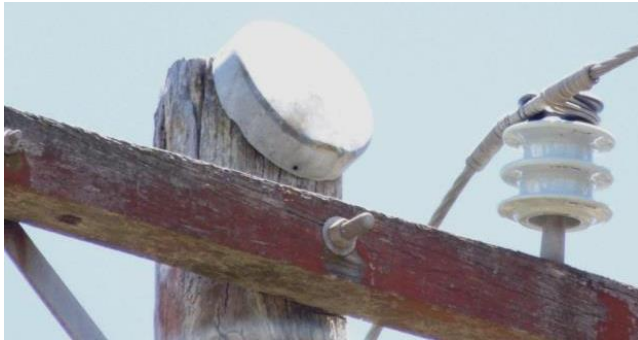
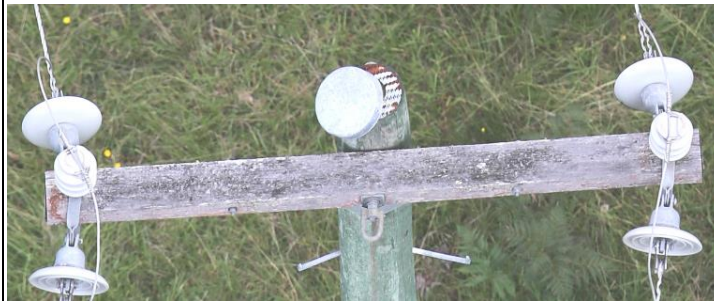
| Defect Description | Defect Photo | Task Details |
|---|---|---|
| <p><u>Pole Cap – Loose / Hanging</u><br/><u>NOT Compromising Clearances</u></p> <p><b>Indicators:</b></p> <ul style="list-style-type: none"><li>- Pole cap is loose / hanging, but</li><li>- <u>NOT compromising clearances</u> to bare conductor/s.</li></ul> | <br> | <p><u>Priority</u><br/>SAP Priority 9<br/>Observation</p> |
| <p><u>Cause</u><br/>- Installation Error (IE)</p> | | |

| Defect Description | Defect Photo | Task Details |
|---|---|---|
| | | <p><u>Standard Job</u><br/>- Hanging Pole Cap (1PCAPH)</p> |

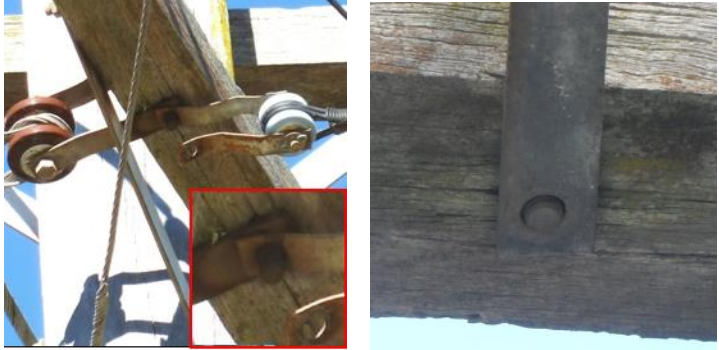
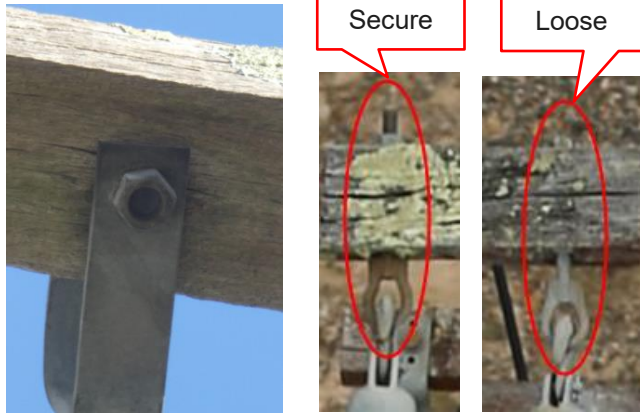
| Defect Description | Defect Photo | Task Details |
|---|---|---|
| <p><b><u>Insulator - Nut Loose or Missing</u></b><br/> <b><u>(Termination / Strain / Suspension)</u></b></p> | | <p><b><u>Priority</u></b><br/> <b>SAP Priority 6</b><br/> 1 Month</p> |
| <p><b>Indicators:</b></p> <ul style="list-style-type: none"> <li>- Nut missing / non-existent.</li> <li>- Nut loose (i.e. thread of bolt/pin not flush with or extending beyond nut).</li> <li>- Only applies to termination / strain / suspension constructions.</li> <li>- Strain of termination warrants replacement</li> </ul> | <p>Secure      Loose</p> | <p><b><u>Bushfire Defect</u></b><br/> Yes</p> <p><b><u>Standard Job</u></b></p> <ul style="list-style-type: none"> <li>- Replace LV Insulator (1LVINS)</li> <li>- Replace HV Insulator (1HVINS)</li> <li>- Transmission Insulator (1TRINS)</li> </ul> <p><b><u>Component</u></b></p> <ul style="list-style-type: none"> <li>- Insulator (IN)</li> </ul> <p><b><u>Failure Type</u></b></p> <ul style="list-style-type: none"> <li>- Not secure (NS)</li> </ul> <p><b><u>Cause</u></b></p> <ul style="list-style-type: none"> <li>- Missing (MI)</li> </ul> |

| Defect Description | Defect Photo | Task Details |
|---|---|---|
| <p><b><u>Scope of Rectification Works</u></b></p> <p>Replace/tighten nuts, install spring washer.</p> | | |

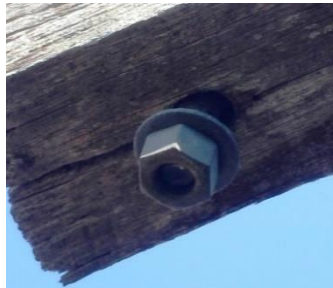
| Defect Description | Defect Photo | Task Details |
|---|---|---|
| <u>Insulator - Nut Loose</u><br><u>(Pin / Intermediate)</u> | | <u>Priority</u><br>SAP Priority 9<br>Observation |
| <b>Indicators:</b> <ul style="list-style-type: none"><li>- Nut still present but loose</li><li>- Minimal amount of thread remaining past the nut or end of the thread can not be seen.</li><li>- Only applies to pin / intermediate constructions.</li></ul> | | <u>Bushfire Defect</u><br>No |

| Defect Description | Defect Photo | Task Details |
|---|---|---|
| | | <u>Standard Job</u> <ul style="list-style-type: none"><li>- Replace LV Insulator (1LVINS)</li><li>- Replace HV Insulator (1HVINS)</li><li>- Transmission Insulator (1TRINS)</li></ul> |

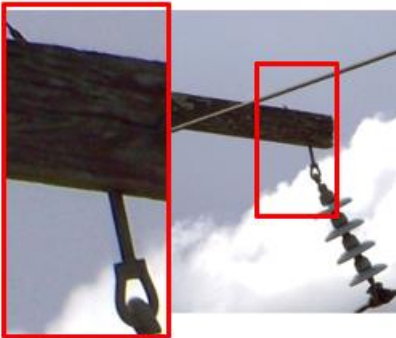
| Defect Description | Defect Photo | Task Details |
|---|---|---|
| <p><u>Insulator - Not Secure (Slipping) Due to Crossarm Degradation</u></p> | <p>Slipping out</p> | <p><u>Priority</u><br/><b>SAP Priority 2</b><br/>Immediate/48 hrs</p> |
| <p><b>Indicators:</b></p> <ul style="list-style-type: none"><li>- Hole for insulator (disc, long rod or shackle) has enlarged and bolt is slipping through.</li><li>- Hardware at imminent risk of falling out.</li></ul> | | <p><u>Bushfire Defect</u><br/>Yes</p> |

| Defect Description | Defect Photo | Task Details |
|---|---|---|
| | | <p><u>Standard Job</u></p> <ul style="list-style-type: none"><li>- Replace LV Crossarm (1LVARM)</li><li>- Replace HV Crossarm (1HVARM)</li><li>- Replace Transmission Crossarm (1TRARM)</li></ul> |

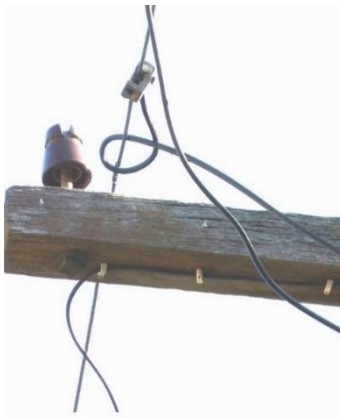
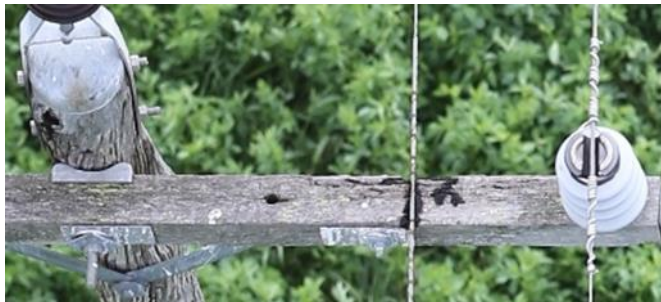
| Defect Description | Defect Photo | Task Details |
|---|---|---|
| <u>Tie Wire – Broken or Missing</u> | <br> | <u>Priority</u><br>SAP Priority 2<br>Immediate |
| <b>Indicators:</b> <ul style="list-style-type: none"><li>- Conductor is no longer attached to the insulator.</li><li>- Conductor is resting on the crossarm.</li><li>- Tie wire may or may not be present, but is no longer securing conductor.</li></ul> | | <u>Bushfire Defect</u><br>Yes |

| Defect Description | Defect Photo | Task Details |
|---|---|---|
| | | <u>Standard Job</u> <ul style="list-style-type: none"><li>- Repair broken LV tie (1LVTIE)</li><li>- Repair broken HV tie (1HVTIE)</li></ul> |

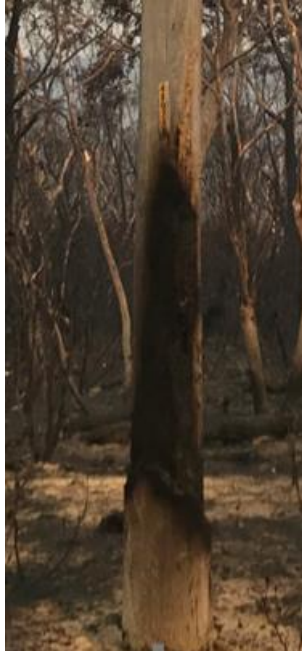
| Defect Description | Defect Photo | Task Details |
|---|---|---|
| <p><b><u>Pole – Burnt (Major)</u></b></p> | | <p><b><u>Priority</u></b><br/><b>SAP Priority 7</b><br/>3 Months</p> |
| <p><b>Indicators:</b></p> <ul style="list-style-type: none"><li>- Fire damage which has penetrated the sapwood and damaged heartwood,</li><li>- ≥40mm of pole diameter lost.</li></ul> | | <p><b><u>Bushfire Defect</u></b><br/>Yes</p> |

| Defect Description | Defect Photo | Task Details |
|---|---|---|
| | | <p><b><u>Standard Job</u></b><br/>- Condemn Pole Refer to clause 4.4.</p> |

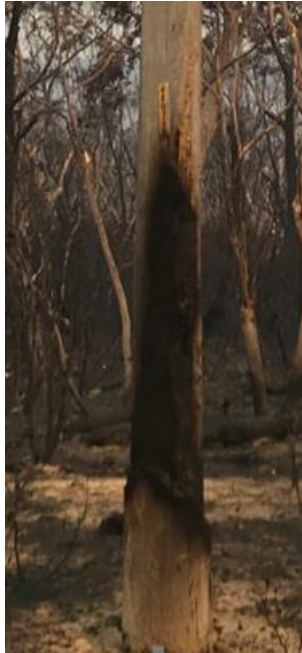
| Defect Description | Defect Photo | Task Details |
|---|---|---|
| <p><b><u>Pole – Burnt (Moderate)</u></b></p> | | <p><b><u>Priority</u></b><br/><b>SAP Priority 7</b><br/>6 Months</p> |
| <p><b>Indicators:</b></p> <ul style="list-style-type: none"><li>- Fire damage to the pole/CCA and requires removal of burnt CCA material</li><li>- Fire damage not extensive enough to warrant replacement of pole (ie, lost pole diameter width &lt; 40mm)</li></ul> | | <p><b><u>Bushfire Defect</u></b><br/>No</p> |

| Defect Description | Defect Photo | Task Details |
|---|---|---|
| | | <p><b><u>Standard Job</u></b></p> <p>- Burnt Pole (1BPOLE)</p> |

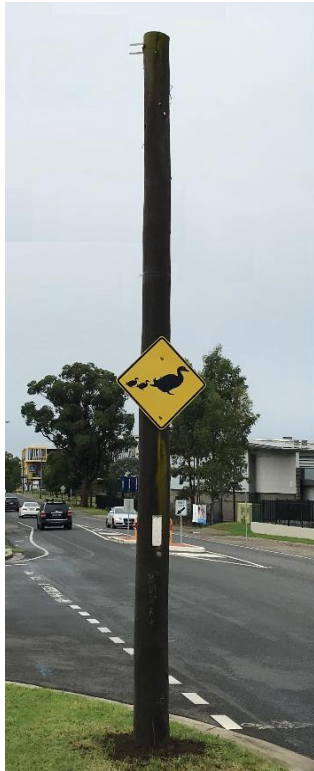
| Defect Description | Defect Photo | Task Details |
|---|---|---|
| <p><u>Pole – Redundant / Obsolete</u></p> | | <p><u>Priority</u><br/>SAP Priority 9<br/>Observation</p> |
| <p><b>Indicators:</b></p> <ul style="list-style-type: none"><li>- An Endeavour Energy pole that has no circuits, attachments, stay wires, and is no longer being used.</li><li>- Pole remains serviceable (not condemned).</li></ul> <p><b>NOTE:</b> pole is still to be inspected in accordance with OLI/GLI inspection program:</p> <ul style="list-style-type: none"><li>- If serviceable, a ‘Remove Pole’ defect is to be raised.</li><li>- If unserviceable, a ‘Condemned Pole’ defect is to be raised with the appropriate priority for the pole condition.</li></ul> | | <p><u>Bushfire Defect</u><br/>No</p> |

| Defect Description | Defect Photo | Task Details |
|---|---|---|
| | | <p><u>Standard Job</u></p> <p>- Remove Pole (PLREM)</p> |
| <p><u>Scope of Rectification Works</u></p> <p>Remove pole.</p> | | |

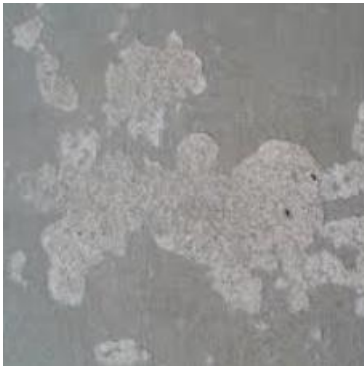
| Defect Description | Defect Photo | Task Details |
|---|---|---|
| <u>Concrete Pole - Spalling</u> | | <u>Priority</u><br>SAP Priority 7<br>6 Months |
| <b>Indicators:</b> <ul style="list-style-type: none"><li>- Concrete flaking off the pole.</li><li>- Pole no longer has smooth surface.</li><li>- Reinforcement could be exposed.</li></ul> | | <u>Bushfire Defect</u><br>No |

| Defect Description | Defect Photo | Task Details |
|---|---|---|
| | | <u>Standard Job</u><br>- Use condemn pole workorders - See Clause 4.4. |

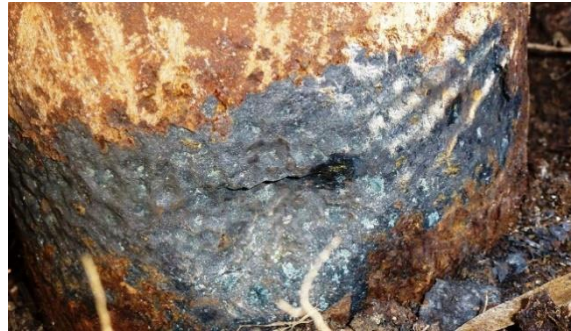
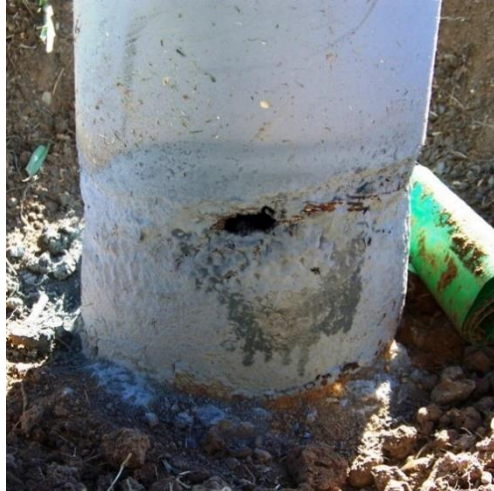
| Defect Description | Defect Photo | Task Details |
|---|---|---|
| <p><u>Steel pole - Corrosion (Major)</u></p> | <br> | <p><u>Priority</u><br/>SAP Priority 7<br/>3 Months</p> |
| <p><b>Indicators:</b></p> <ul style="list-style-type: none"><li>- Rust has damaged galvanising to more than 10% of the circumference.</li><li>- Rust hole between 10 mm and 75 mm in total length.</li><li>- Rust does not extend below 350 mm from groundline.</li><li>- Signs of pitting.</li><li>- Flaking of the galvanising.</li><li>- Holes in the steel</li></ul> | | <p><u>Bushfire Defect</u><br/>Yes</p> |

| Defect Description | Defect Photo | Task Details |
|---|---|---|
| | | <p><u>Standard Job</u><br/>Endeavour Network Pole – Refer to clause 4.4.<br/>Private Service Pole – Customer Defect (1CUSDF)</p> |

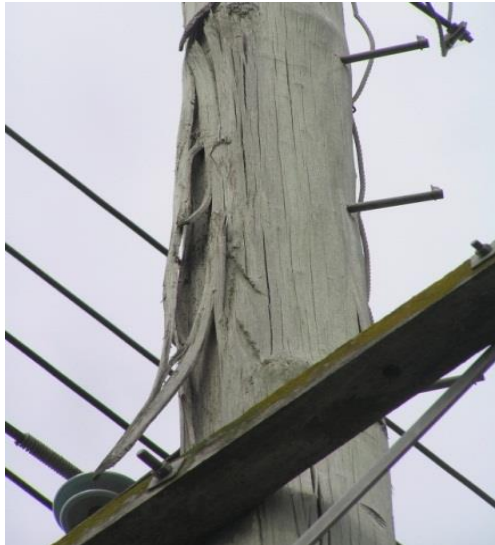
| Defect Description | Defect Photo | Task Details |
|---|---|---|
| <u>Sapwood – Compromising Clearances</u> | | <u>Priority</u><br><b>SAP Priority 7</b><br>3 Months |
| <b>Indicators:</b><br><br>- Pole sapwood is separated from timber and is <u>compromising clearances to bare conductor/s</u> . | | <u>Bushfire Defect</u><br>Yes |

| Defect Description | Defect Photo | Task Details |
|---|---|---|
| | | <u>Standard Job</u><br>- Desap Pole (1PLSAP) |

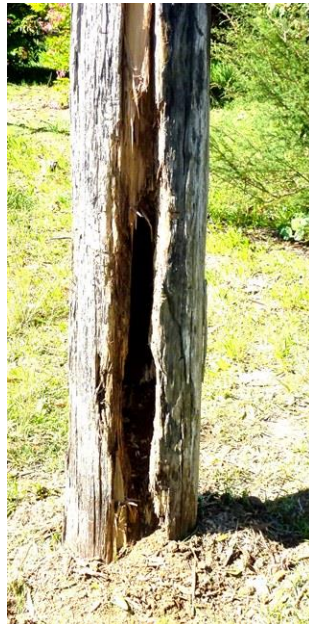
| Defect Description | Defect Photo | Task Details |
|---|---|---|
| <p><b><u>Pole – Splitting (Major)</u></b></p> | | <p><b><u>Priority</u></b><br/><b>SAP Priority 7</b><br/>3 Months</p> |
| <p><b>Indicators:</b></p> <ul style="list-style-type: none"><li>- Separation of the timber which is greater than 2cm wide.</li><li>- Split can be vertical or horizontal.</li></ul> | | <p><b><u>Bushfire Defect</u></b><br/>No</p> |

| Defect Description | Defect Photo | Task Details |
|---|---|---|
| | | <p><b><u>Standard Job</u></b><br/>- Use condemn pole workorders - See Clause 4.4.</p> |

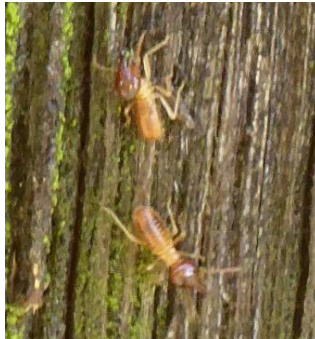
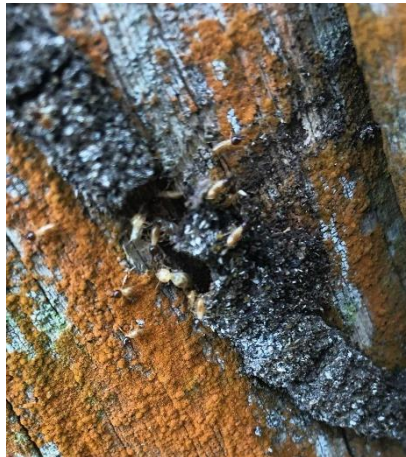
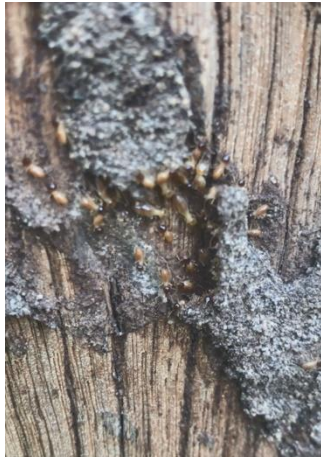
| Defect Description | Defect Photo | Task Details |
|---|---|---|
| <p><b><u>Termites – Nasutitermes</u></b></p> | <div><p><i>Soldier of Nasutitermes</i></p></div> <div></div> <div></div> <div></div> | <p><b><u>Priority</u></b><br/><b>SAP Priority 7</b><br/>3 Month</p> |
| <p><b>Indicators:</b></p> <ul style="list-style-type: none"><li>- Evidence of termite mud tracks / galleries on the pole's external surface.</li><li>- Termites may be visible by breaking open a gallery.</li><li>- Nasutitermes have a 'tear-drop' shaped head.</li><li>- Refer to MMI0001 for further details.</li></ul> <p><b>NOTE:</b></p> <ul style="list-style-type: none"><li>- If there are active termites, or fresh signs of termite activity, a termite treatment defect is to be raised.</li><li>- This applies regardless of whether the pole is serviceable or condemned following inspection.</li></ul> | | <p><b><u>Bushfire Defect</u></b><br/>No</p> |

| Defect Description | Defect Photo | Task Details |
|---|---|---|
| | | <p><b><u>Standard Job</u></b></p> <p>- Termites – Nasutitermes (1PLTER)</p> |

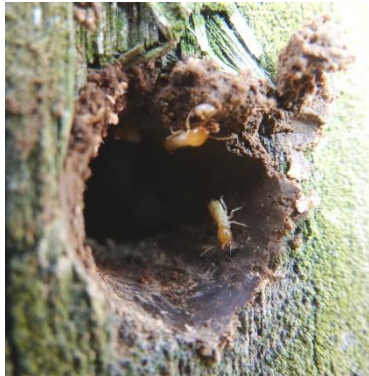
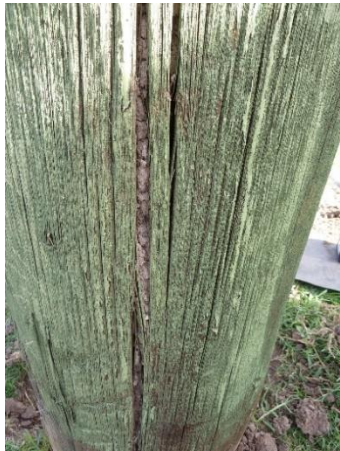
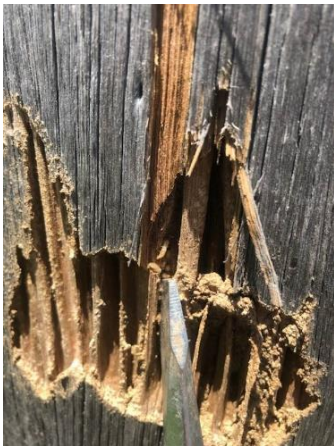
| Defect Description | Defect Photo | Task Details |
|---|---|---|
| <p><u><b>Termites – Coptotermes (or Other)</b></u></p> | <p>Soldier of Coptotermes</p> | <p><u><b>Priority</b></u><br/><b>SAP Priority 7</b><br/>3 Months</p> |
| <p><b>Indicators:</b></p> <ul style="list-style-type: none"><li>- Evidence of termite mud tracks / galleries on the pole's external surface, inside cracks, behind loose sapwood.</li><li>- Termites may be visible by breaking open a gallery, peeling back loose sapwood, removing plug holes.</li><li>- Refer to MMI0001 for further details.</li></ul> <p><b>NOTE:</b></p> <ul style="list-style-type: none"><li>- If there are active termites, or fresh signs of termite activity, a termite treatment defect is to be raised.</li><li>- This applies regardless of whether the pole is serviceable or condemned following inspection.</li></ul> | | <p><u><b>Bushfire Defect</b></u><br/>No</p> |

| Defect Description | Defect Photo | Task Details |
|---|---|---|
| | | <p><u><b>Standard Job</b></u></p> <p>- Termites – Coptotermes (1PLTR2)</p> |

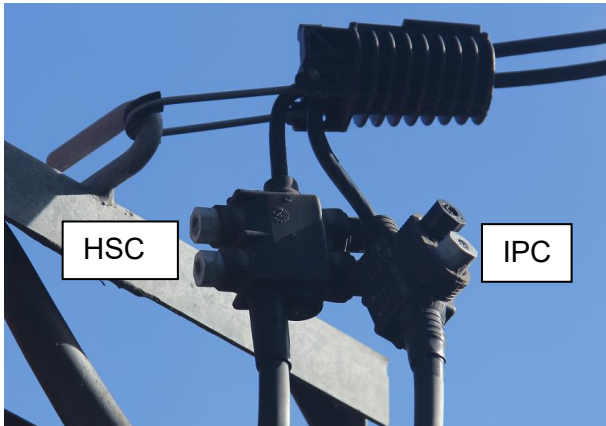
| Defect Description | Defect Photo | Task Details |
|---|---|---|
| <u>HSC/IPC – Minor Damage</u> | <p>(Photo for reference. No defect is shown in the photo)</p> | <u>Priority</u><br>SAP Priority 8<br>12 Months |
| <b>Indicators:</b> <ul style="list-style-type: none"><li>- IPC general damage.</li><li>- General cracking in housing.</li></ul> | | <u>Bushfire Defect</u><br>No |

| Defect Description | Defect Photo | Task Details |
|---|---|---|
| | | <u>Standard Job</u><br>- Repair/Replace Service Connections (1SERCO) |

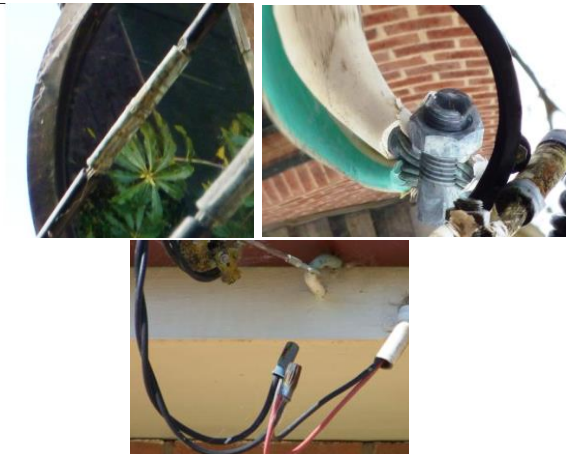
| Defect Description | Defect Photo | Task Details |
|---|---|---|
| <u>Service Connector - Bare</u> | | <u>Priority</u><br>SAP Priority 6<br>1 Month |
| <p><b>Indicators:</b></p> <ul style="list-style-type: none"><li>- Insulation of service connector is damaged, and metal can be seen (insulink, line tap or crimp sleeve).</li><li>- Blue point connector present (bottom photo).</li></ul> <p><i>Note: This is a customer defect, and to be managed as per the customer defect process.</i></p> | | <u>Bushfire Defect</u><br>No |

| Defect Description | Defect Photo | Task Details |
|---|---|---|
| | | <u>Standard Job</u><br>- Customer Defect (1CUSDF) |

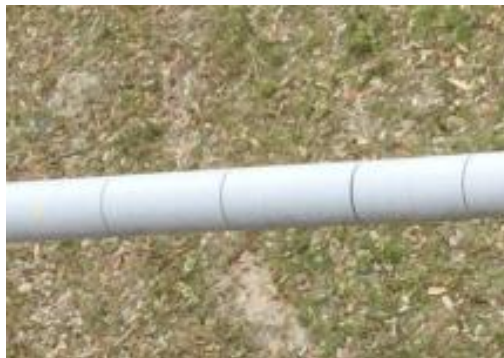
| Defect Description | Defect Photo | Task Details |
|---|---|---|
| <u>Service Wire - Minor Damaged</u> | <p><i>Note: CCT cracking shown.</i></p> | <u>Priority</u><br>SAP Priority 9<br>Observation |
| <p><b>Indicators:</b></p> <ul style="list-style-type: none"><li>- General cracking along insulation, but conductor can NOT be seen through the XLPE insulation.</li><li>- Defect applies to both LVABC services and mains.</li></ul> | | <u>Bushfire Defect</u><br>Yes |
| | | <u>Failure Type</u><br>- Cracking (CR) |
| | | <u>Cause</u><br>- Abrasion (AB), Damage (D1), Deterioration (DG), UV Degradation (DG) |

| Defect Description | Defect Photo | Task Details |
|---|---|---|
| <u>Scope of Rectification Works</u><br>Replace conductor / temporary rectification maybe achieved by increasing vegetation management clearances to bare conductor standards | | |

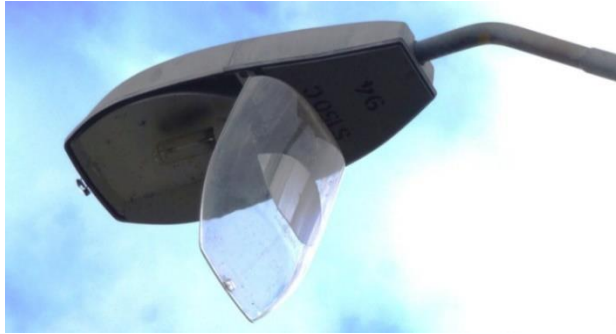
| Defect Description | Defect Photo | Task Details |
|---|---|---|
| <u>Streetlight Cover - Hanging</u> | | <u>Priority</u><br>SAP Priority 6<br>1 Month |
| <b>Indicators:</b><br>- Plastic cover of lantern is not closed and is hanging. | | <u>Bushfire Defect</u><br>No |
| | | <u>Failure Type</u><br>- Broken (BR) |
| | | <u>Cause</u><br>- Installation Error (IE) |

| Defect Description | Defect Photo | Task Details |
|---|---|---|
| <u>Scope of Rectification Works</u><br>Reaffix cover if possible. | | |

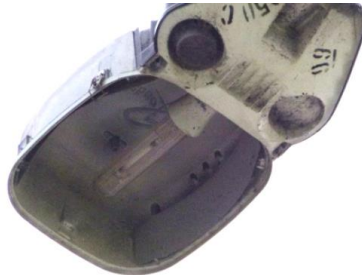
| Defect Description | Defect Photo | Task Details |
|---|---|---|
| <u>Streetlight Cover – Missing</u> | | <u>Priority</u><br>SAP Priority 9<br>Observation |
| <b>Indicators:</b><br>- Streetlight cover is no longer affixed to lantern. | | <u>Bushfire Defect</u><br>No |
| | | <u>Failure Type</u><br>- Missing (MI) |
| | | <u>Cause</u><br>- Deterioration (DG) |

| Defect Description | Defect Photo | Task Details |
|---|---|---|
| <u>Scope of Rectification Works</u><br>Replace cover only. | | |

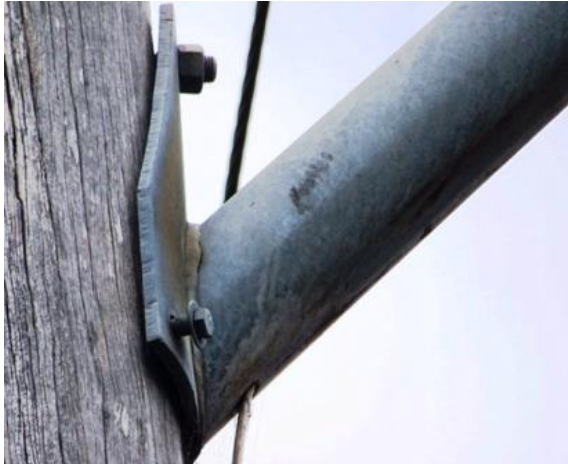
| Defect Description | Defect Photo | Task Details |
|---|---|---|
| <p><u>Streetlight Outreach – Not Secure</u></p> | <p>(Image for reference, no defect pictured)</p> | <p><u>Priority</u><br/>SAP Priority 8<br/>12 Months</p> |
| <p><b>Indicators:</b></p> <p>- One or more securing screws missing.</p> <p>NOTE: If securing screws are loose/thread can be seen, this is not a defect.</p> | | <p><u>Bushfire Defect</u><br/>No</p> |
| | | <p><u>Failure Type</u></p> <p>- Not secure (NS)</p> |
| | | <p><u>Cause</u></p> <p>- Deterioration (DG)</p> |

| Defect Description | Defect Photo | Task Details |
|---|---|---|
| <p><u>Scope of Rectification Works</u></p> <p>Replace screw.</p> | | |

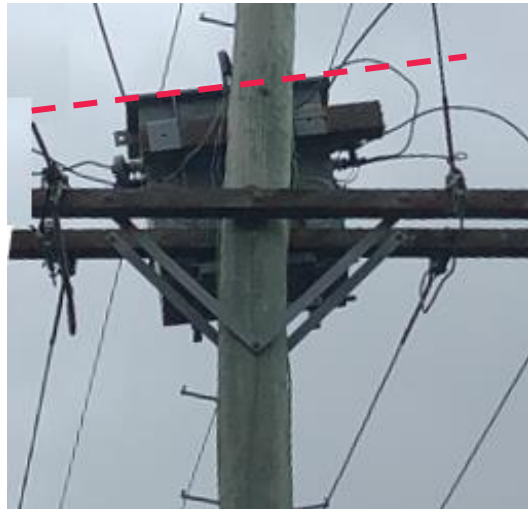
| Defect Description | Defect Photo | Task Details |
|---|---|---|
| <u>Transformer Tank – Not Secure</u> | | <u>Priority</u><br>SAP Priority 6<br>1 Month |
| <b>Indicators:</b> <ul style="list-style-type: none"><li>- Leaning transformer.</li><li>- Transformer not secure to pole mounting.</li></ul> | | <u>Bushfire Defect</u><br>No |
| | | <u>Failure Type</u><br>- Not secure (NS) |
| | | <u>Cause</u><br>- Installation error (IE) |

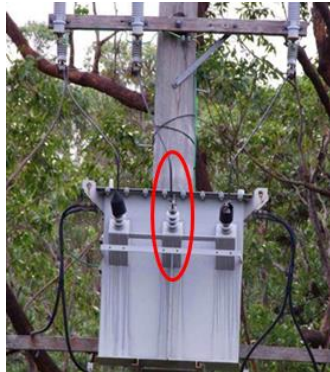
| Defect Description | Defect Photo | Task Details |
|---|---|---|
| <u>Shroud (Possum Guard) - Missing</u> | | <div><u>Priority</u><br/>SAP Priority 9<br/>Observation</div> |
| <div>Indicators:</div> <ul style="list-style-type: none"><li>- Adjacent phases have covers and a cover is no longer present</li><li>- Applies to transformer only.</li></ul> | | <div><u>Bushfire Defect</u><br/>No</div> |
| | | <div><u>Failure Type</u><br/>- Missing (MI)</div> |
| | | <div><u>Cause</u><br/>- Missing Component (MC) / Installation Error (IE)</div> |

| Defect Description | Defect Photo | Task Details |
|---|---|---|
| <div><u>Scope of Rectification Works</u><br/>Replace bushing shroud.</div> | | |

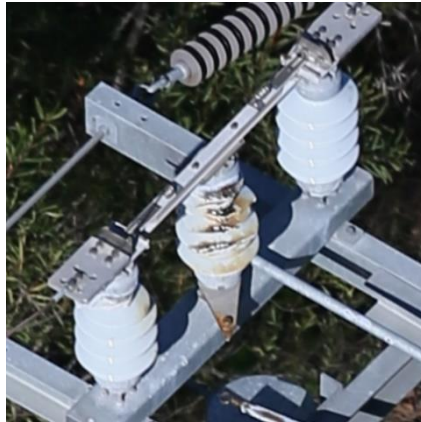
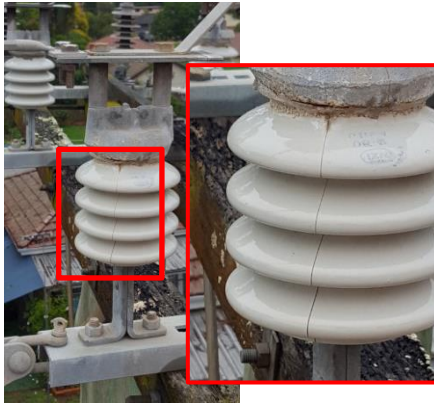
| Defect Description | Defect Photo | Task Details |
|---|---|---|
| <u>ABS Insulators - Damaged</u> | <br> | <u>Priority</u><br><b>SAP Priority 6</b><br>1 Month |
| <b>Indicators:</b><br>- General damage to insulators including: chips to the porcelain. Cracks in the mounting insulators, burn marks to the polymer. | | <u>Bushfire Defect</u><br>Yes |

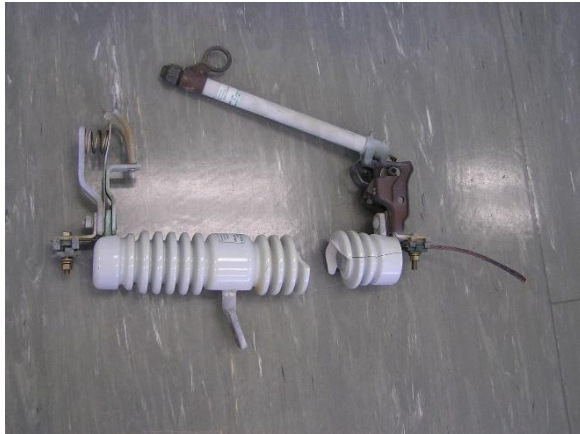
| <p><b><u>DOF Assembly – Damaged</u></b></p> | | <p><b><u>Priority</u></b><br/><b>SAP Priority 6</b><br/>1 Month</p> |
| <p><b>Indicators:</b></p> <ul style="list-style-type: none"><li>- Visual signs of damage.</li><li>- Significant cracking, chips or broken.</li></ul> | | <p><b><u>Bushfire Defect</u></b><br/>Yes</p> |

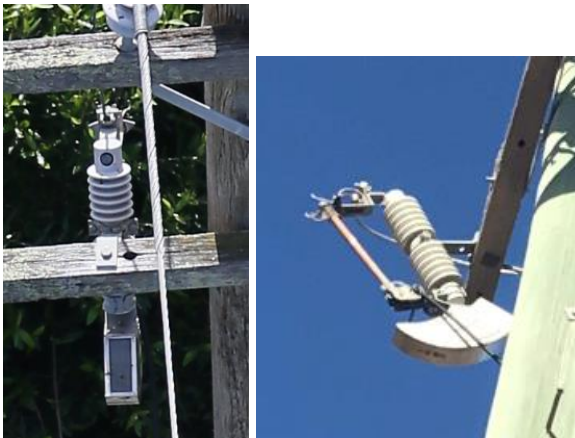
| Defect Description | Defect Photo | Task Details |
|---|---|---|
| <p><u>DOF - Spark Catchers Installed</u></p> | | <p><u>Priority</u></p> <p>SAP Priority 7</p> <p>6 Months</p> |

| Defect Description | Defect Photo | Task Details |
|---|---|---|
| | | <p><u>Standard Job</u></p> <p>- Remove Spark Arresters (1RMSPA)</p> |

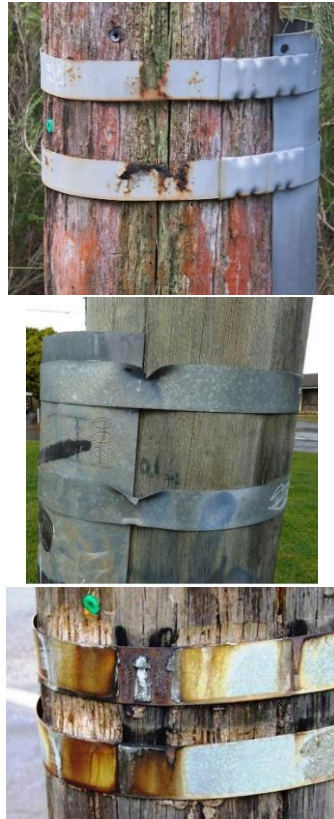
| Defect Description | Defect Photo | Task Details |
|---|---|---|
| <p><u>Reinstated Pole - Bands Damaged or Deteriorated</u></p> | | <p><u>Priority</u><br/>SAP Priority 7<br/>6 Months</p> |
| <p><b>Indicators:</b></p> <ul style="list-style-type: none"><li>- Reinstatement pole bands showing signs of rusting.</li><li>- Pole bands damaged / split / broken.</li></ul> | | <p><u>Bushfire Defect</u><br/>Yes</p> |

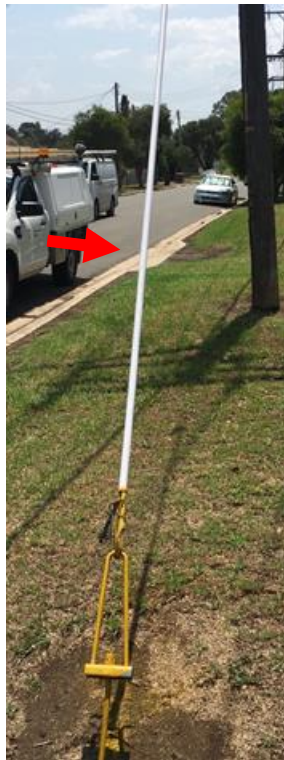
| Defect Description | Defect Photo | Task Details |
|---|---|---|
| <u>Stay Guard – Damaged, Broken or Missing</u> | | <u>Priority</u><br>SAP Priority 9<br>Observation |
| <b>Indicators:</b> <ul style="list-style-type: none"><li>- Stay wire can be seen through cracks in guard.</li><li>- No stay guard present.</li></ul> | | <u>Bushfire Defect</u><br>No |

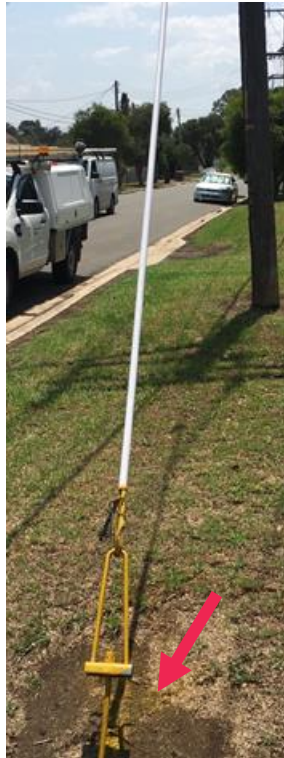
| Defect Description | Defect Photo | Task Details |
|---|---|---|
| <u>Ground Anchor - Damaged or Broken</u> | | <u>Priority</u><br>SAP Priority 7<br>3 Months |
| <b>Indicators:</b><br>- Ground anchor system showing signs of damage or corrosion. | | <u>Bushfire Defect</u><br>Yes |

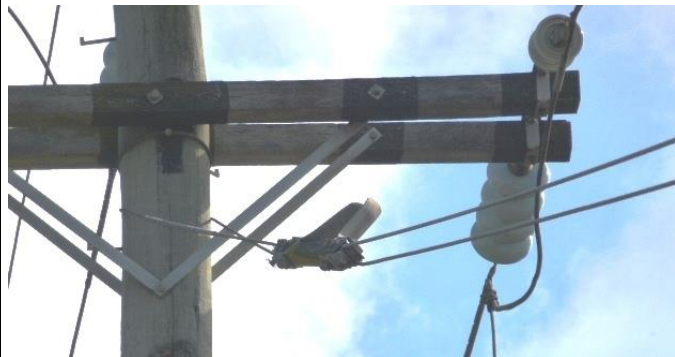
| Defect Description | Defect Photo | Task Details |
|---|---|---|
| <p><u>Stay Wire - Loose</u></p> | | <p><u>Priority</u><br/>SAP Priority 7<br/>6 Months</p> |

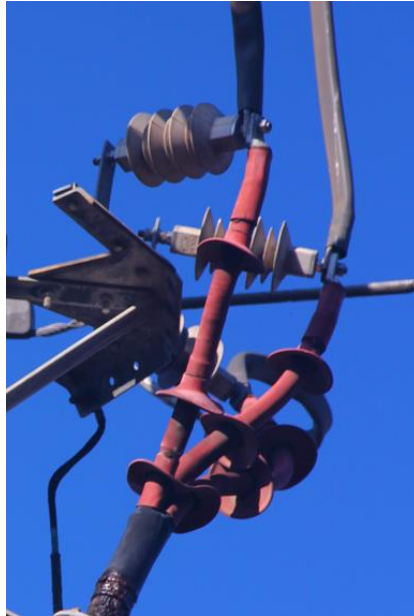
| Defect Description | Defect Photo | Task Details |
|---|---|---|
| <u>UGOH Polymeric - Insulation Deteriorated</u> | <p>(Image for reference, no defect pictured)</p> | <u>Priority</u><br>SAP Priority 7<br>6 Months |
| <b>Indicators:</b> <ul style="list-style-type: none"><li>- Polymer faded/discolouration.</li><li>- Showing signs of cracks/splits.</li></ul> | | <u>Bushfire Defect</u><br>Yes |
