AEC 44: 1793 Elizabeth Drive, Badgerys Creek

Audit Number: MP181_9

Site Audit Report

Senversa Pty Ltd

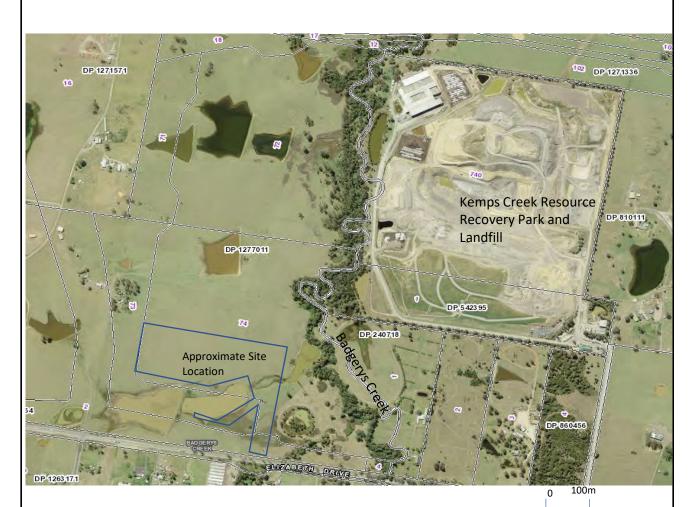
Landfill	PROJECT:	204814.01
Douglas Partners	Sydney Metro Western Sydney Airport-SCAW, Elizabeth Drive, Badgerys Creek	DWG No:	AEC44-02
Geotechnics Environment Groundwater		REV:	0
	CLIENT: CPBUI JV	DATE:	12-Oct-22
