# **Chillventa Specialist Forums 2022**

# HRS Company profile

# A seven steps Process

# Compressors failure analysis

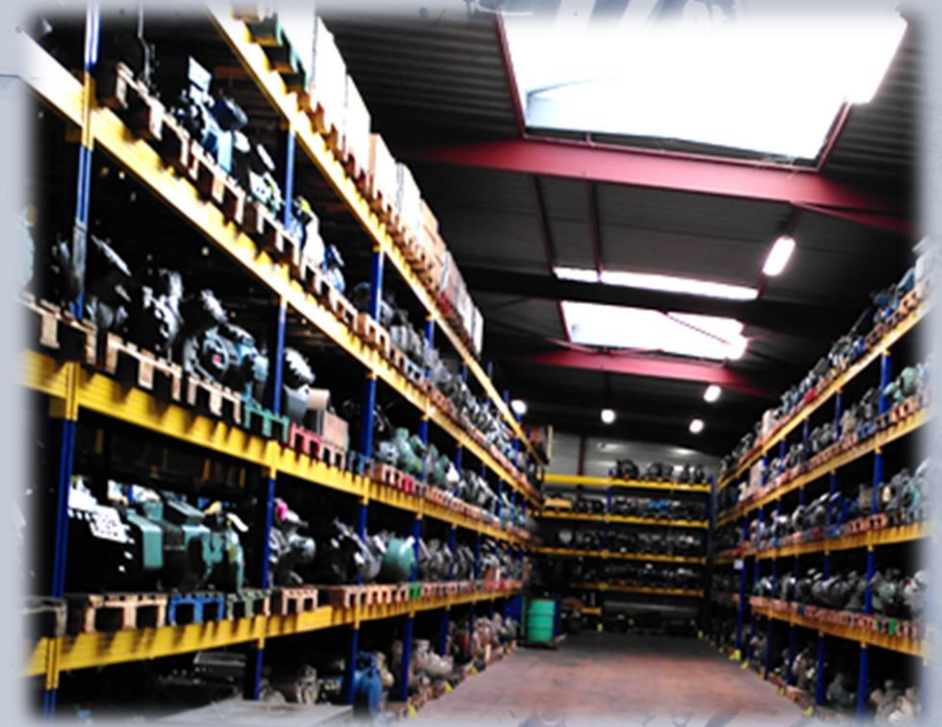
## ► 1 Reception

- The compressor and its accessories are identified and given a number
- The compressor is stored or send to the workshop

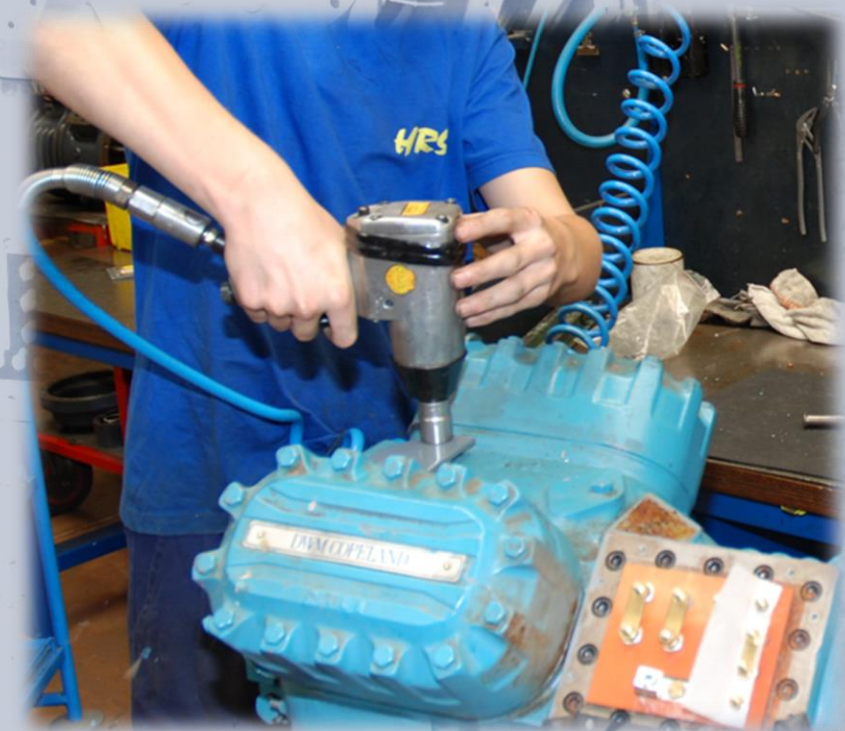
- ▶ **2 disassembly and cleaning**
- ▶ The compressor is completely dismantled and cleaned
- ▶ All defects are recorded

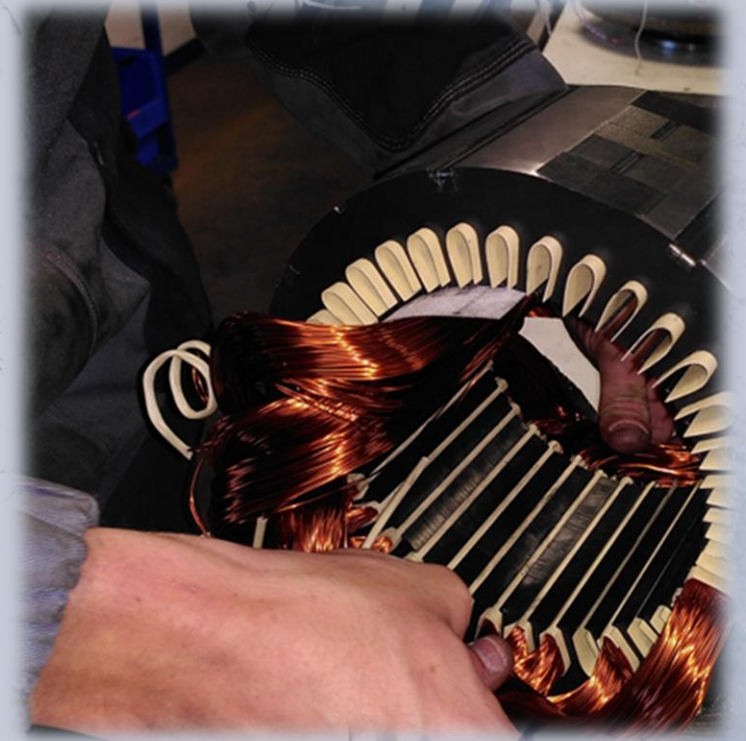
- ▶ **4 Motor rewinding**
- ▶ Extracted during dismantling the motor is rewinds
- ▶ Special test is performed

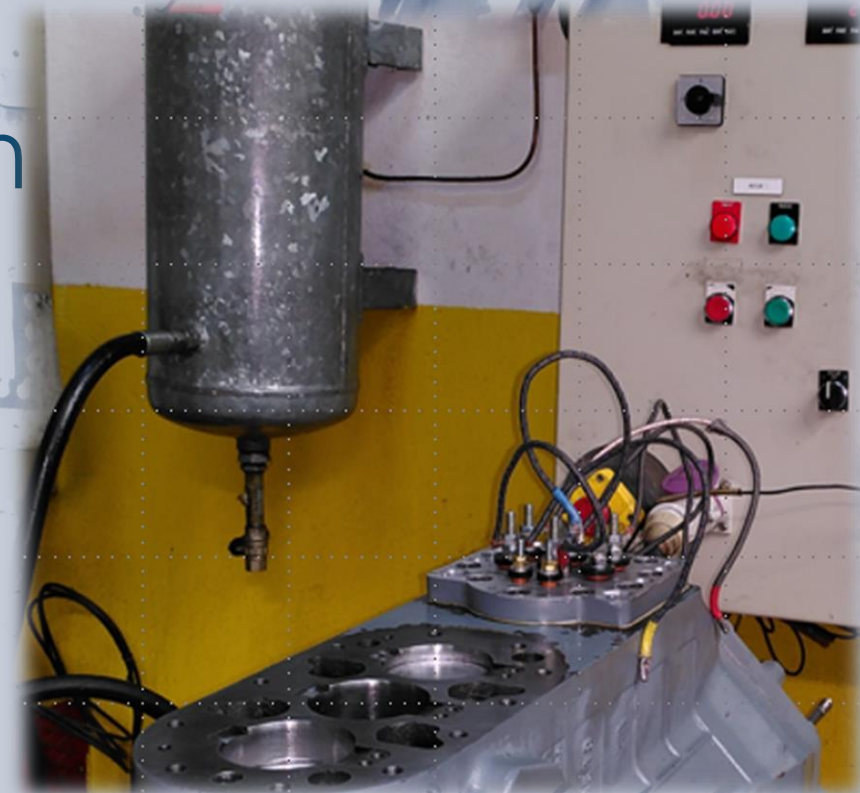
- ▶ **6 Testing and running-in**
- ▶ mechanical test and running-in
- ▶ Performance test
- ▶ Checking and measuring
- ▶ leakage test
- ▶ dehydration and inerting
- ▶ Data are recorded

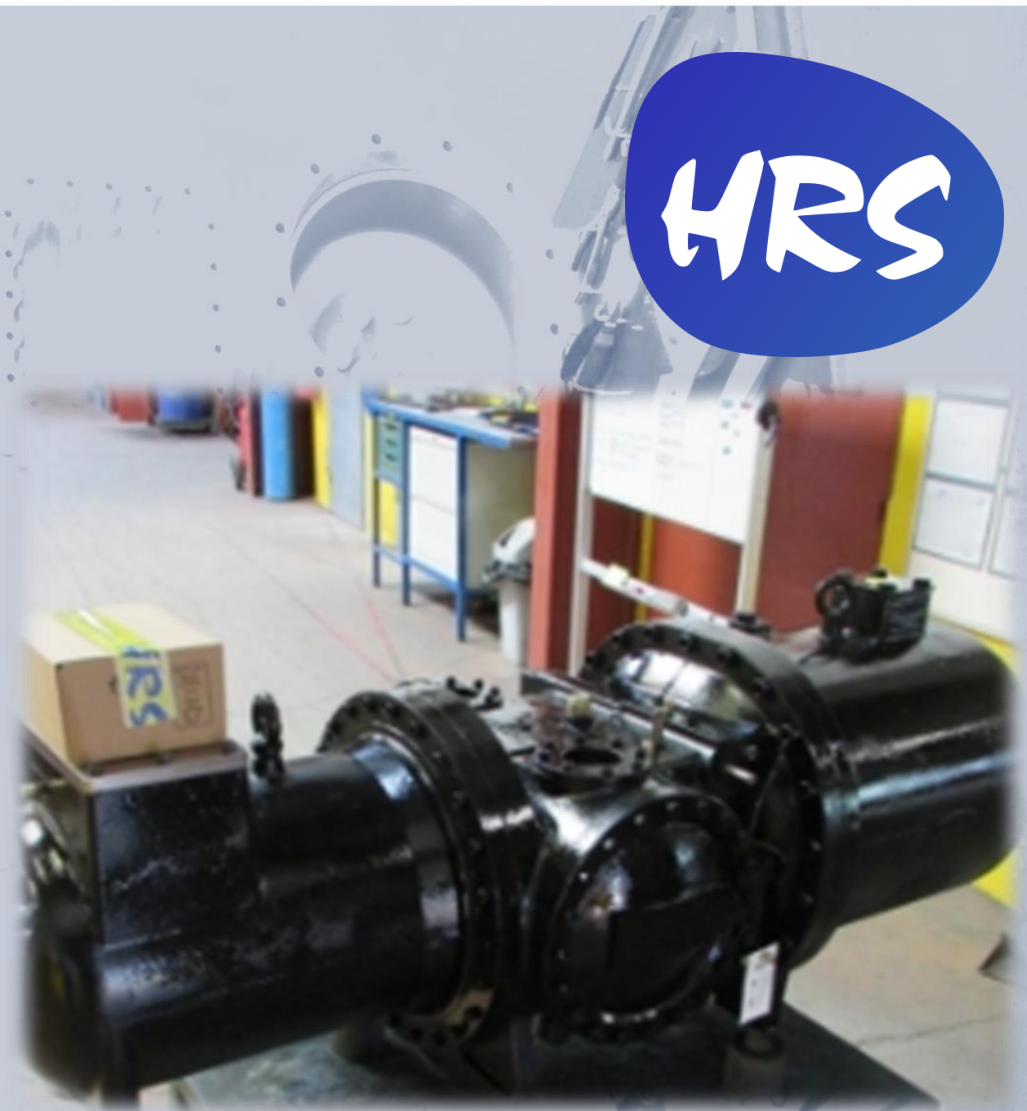
- ▶ **7 Finishing**
- ▶ Painting
- ▶ identification plate
- ▶ Fitting of accessories
- ▶ Final checks

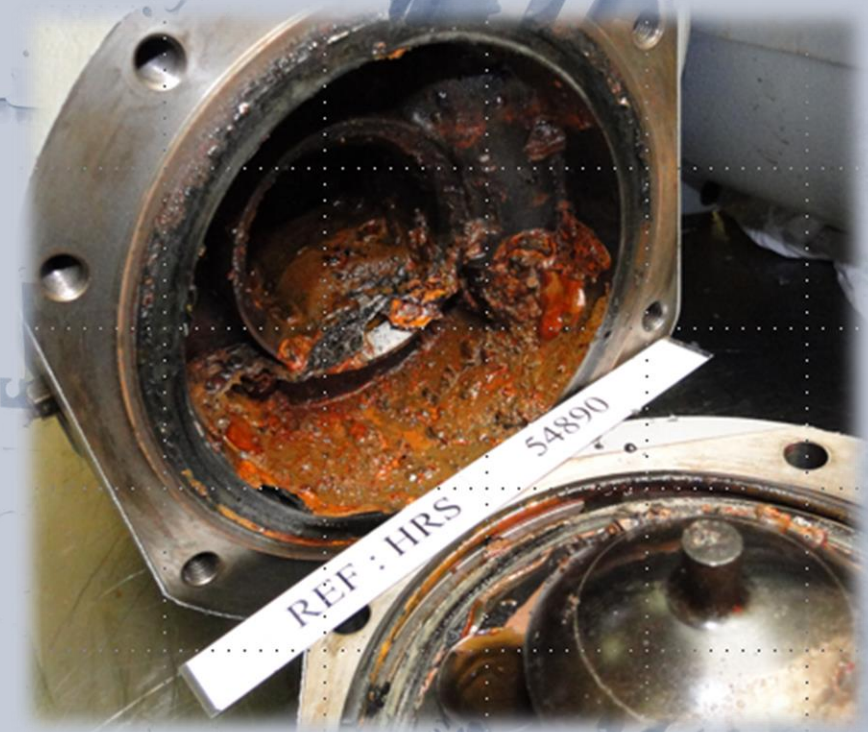
- ▶ **Contamination of the circuit**
- ▶ By foreign particles, water, water vapour, air, soldering waste, oxides, chips, joint compound, etc.
- ▶ Water is the number one enemy of the refrigeration circuit.
- ▶ This leads to direct contamination by sludge and oxide

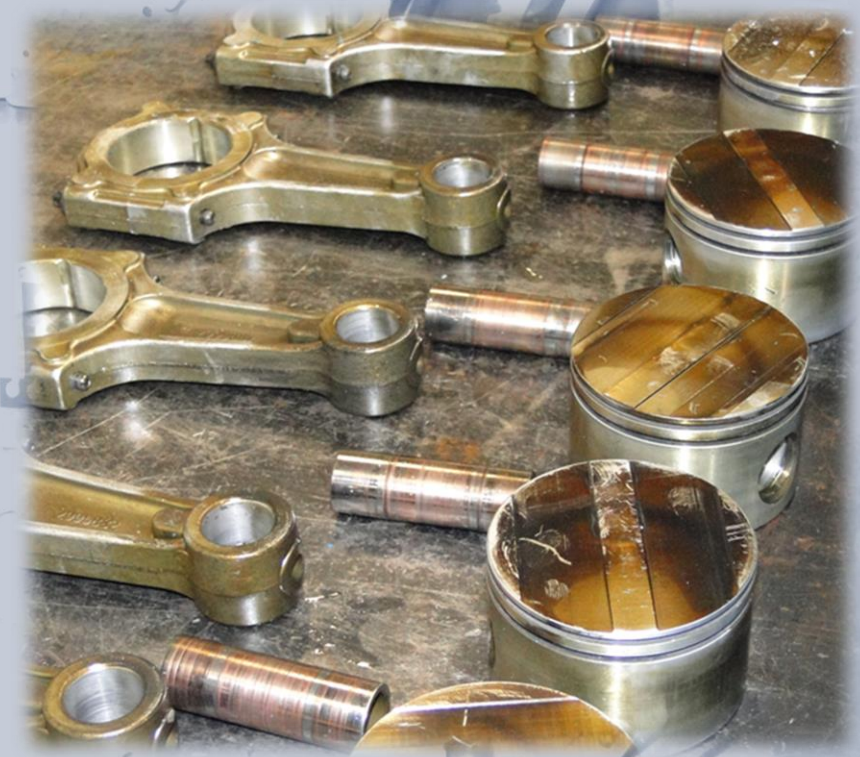
- ▶ **Compressor overheating**
- ▶ The main cause is low mass flow at the compressor suction
- ▶ Lack of refrigeration gas
- ▶ Long running with power reduction of more than 50%.
- ▶ Or abnormal suction overheating

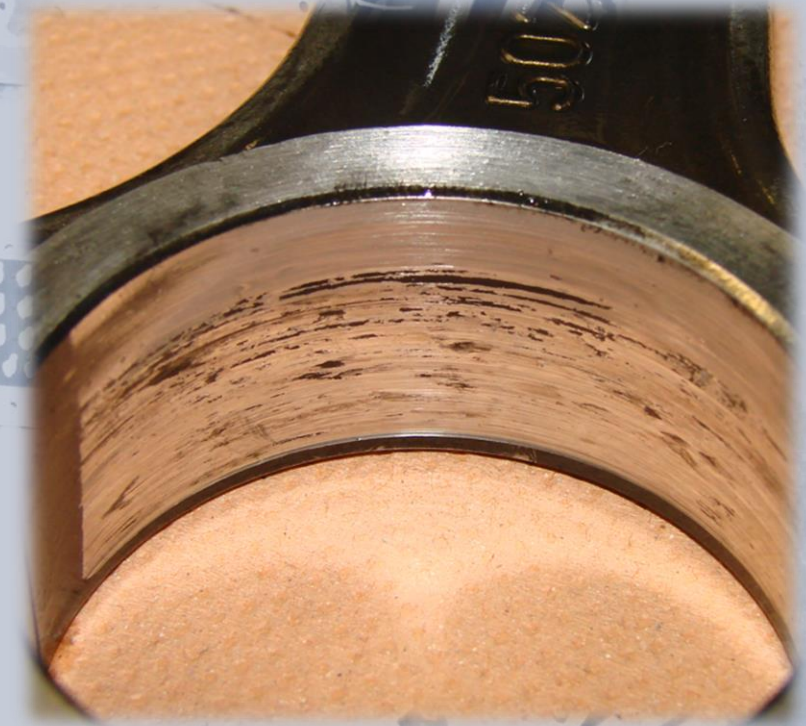
- ▶ **Lubrication failure**
- ▶ Lack of oil, excessive oil temperature, dilution of oil with liquid fluid
- ▶ Operation with too low a speed control
- ▶ Very rarely, oil pump failure.
