## **BUILDING ENVELOPE SCOPING GUIDELINES**

#### **2.1. Introduction**

The following ‘Scoping Guidelines’ are provided to clarify the intended scope of assigned Capital Improvement Program (CIP) projects related to the Exterior Modernization/Building Envelope/Water Infiltration Work and provide direction on how to approach the investigation and scoping of the work for the ‘DOE Referred Items’ as well as ‘SCA Additional Recommended Items’ in Scope Reports. These guidelines are intended to supplement the General Scoping Guidelines and the requirements of the Scoping Process outlined in the CIP Project Manual.

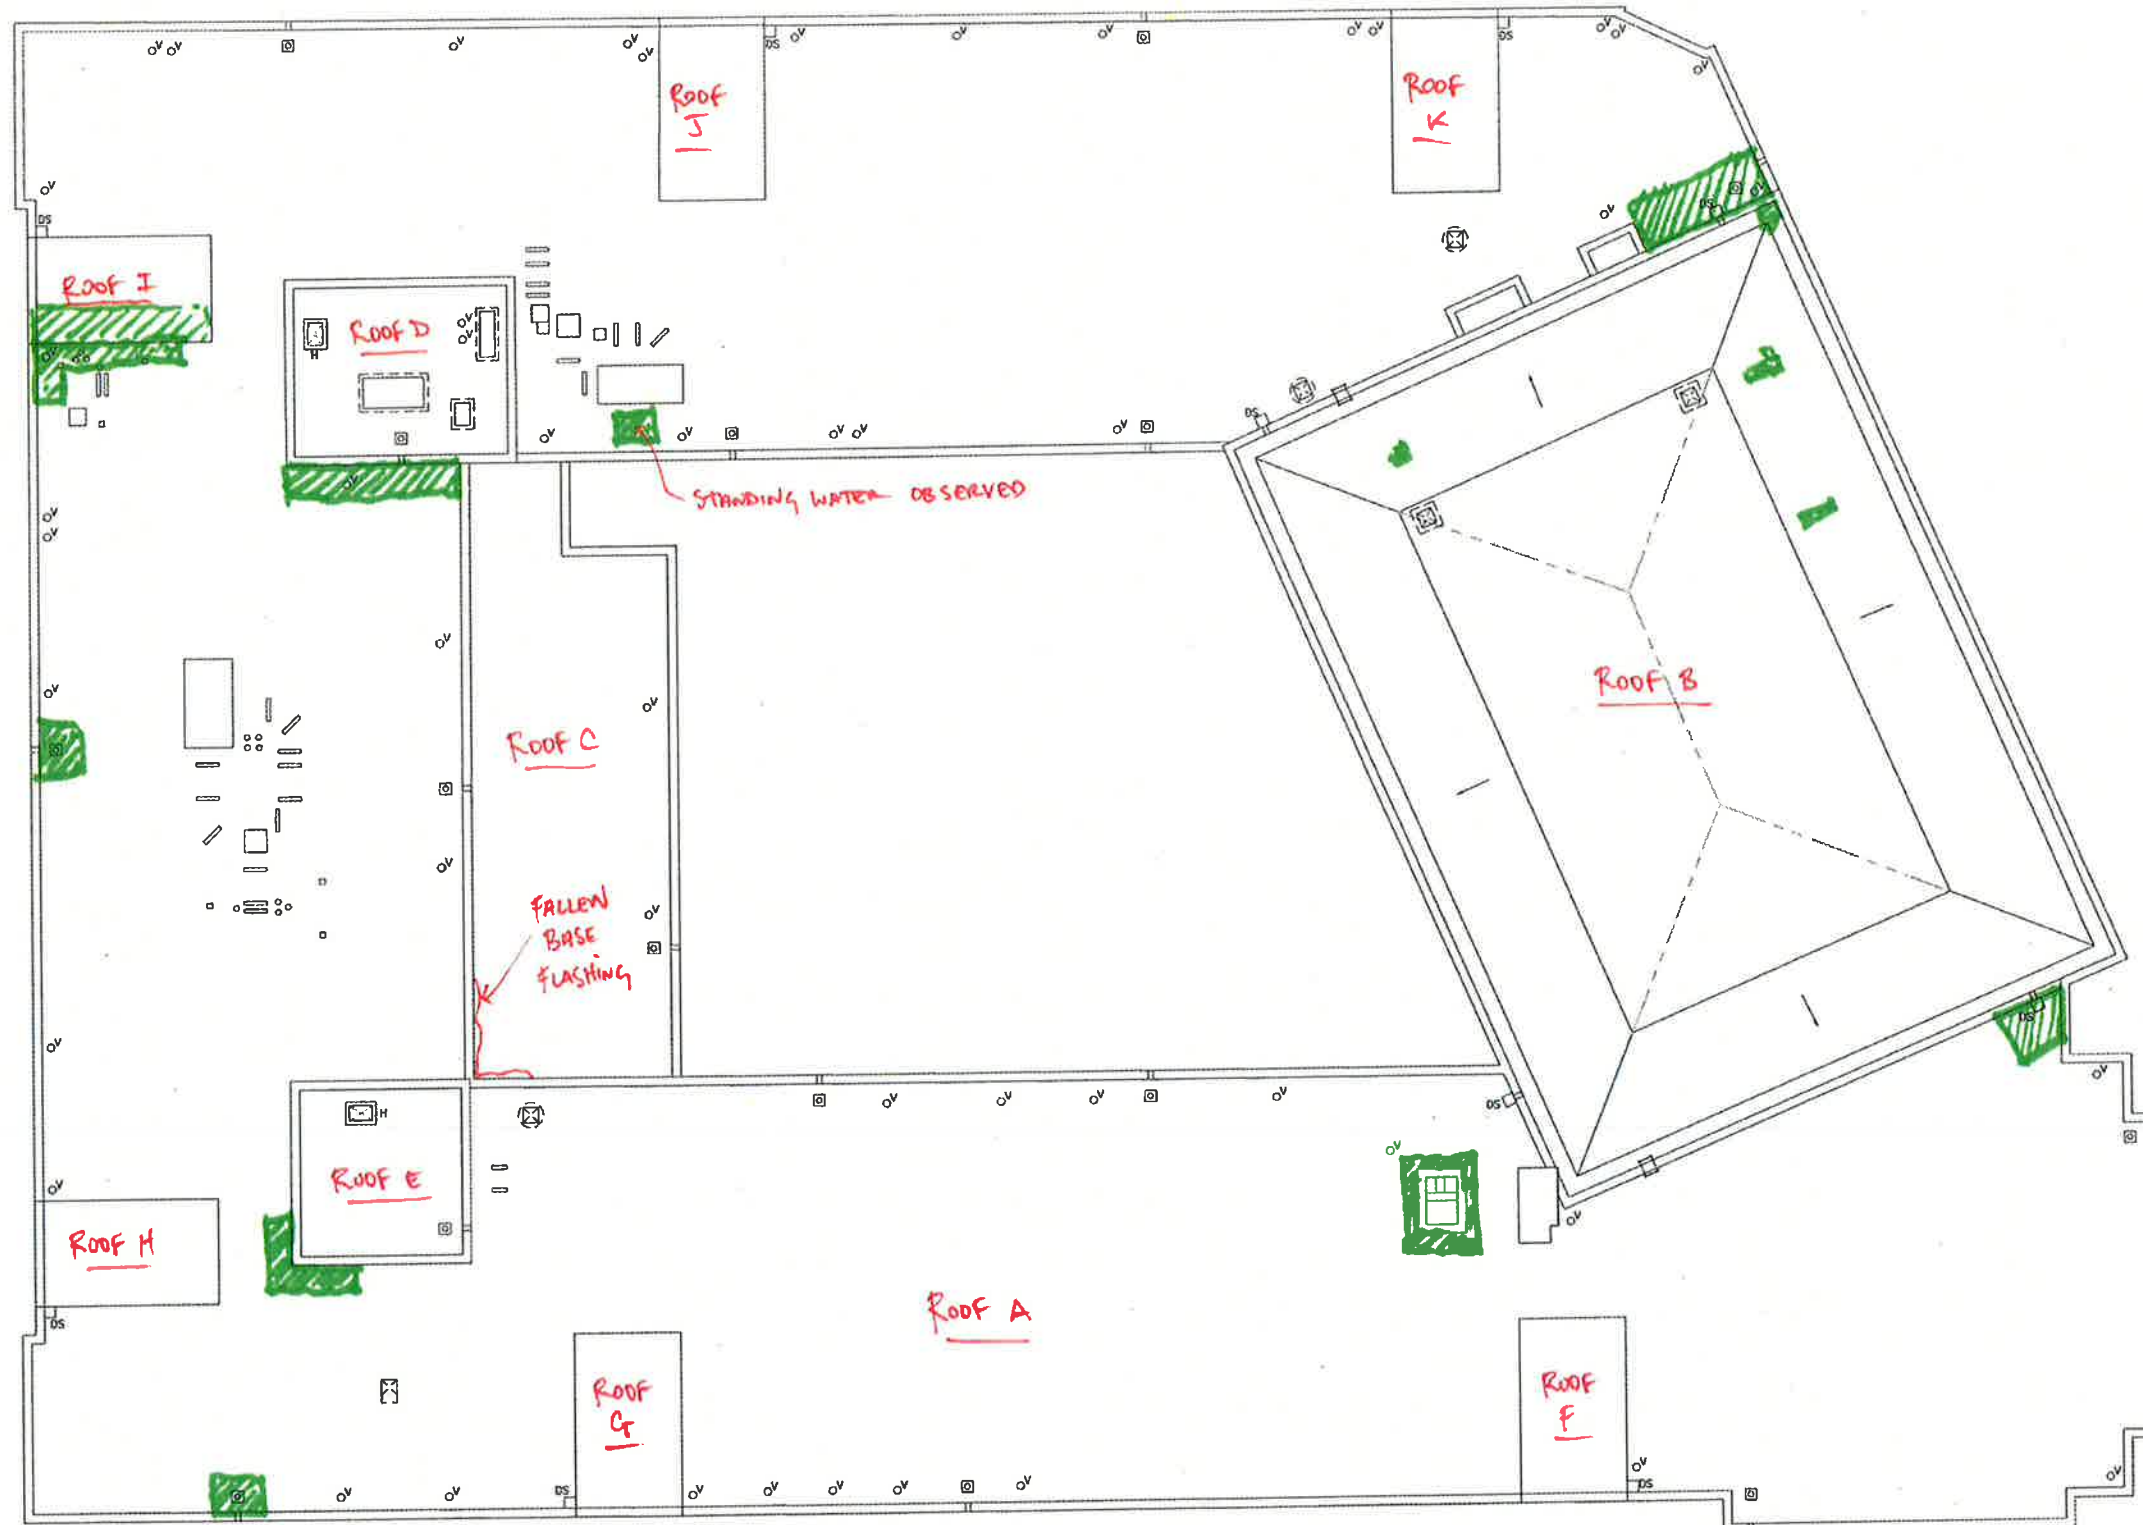
**ROOF PLAN**  
**DAMAGE MAP**

NOTE: SEE 4<sup>TH</sup> FLOOR PLAN FOR INTERIOR DAMAGE

Drawing Title:  
 ROOF PLAN  
 DAMAGE MAP

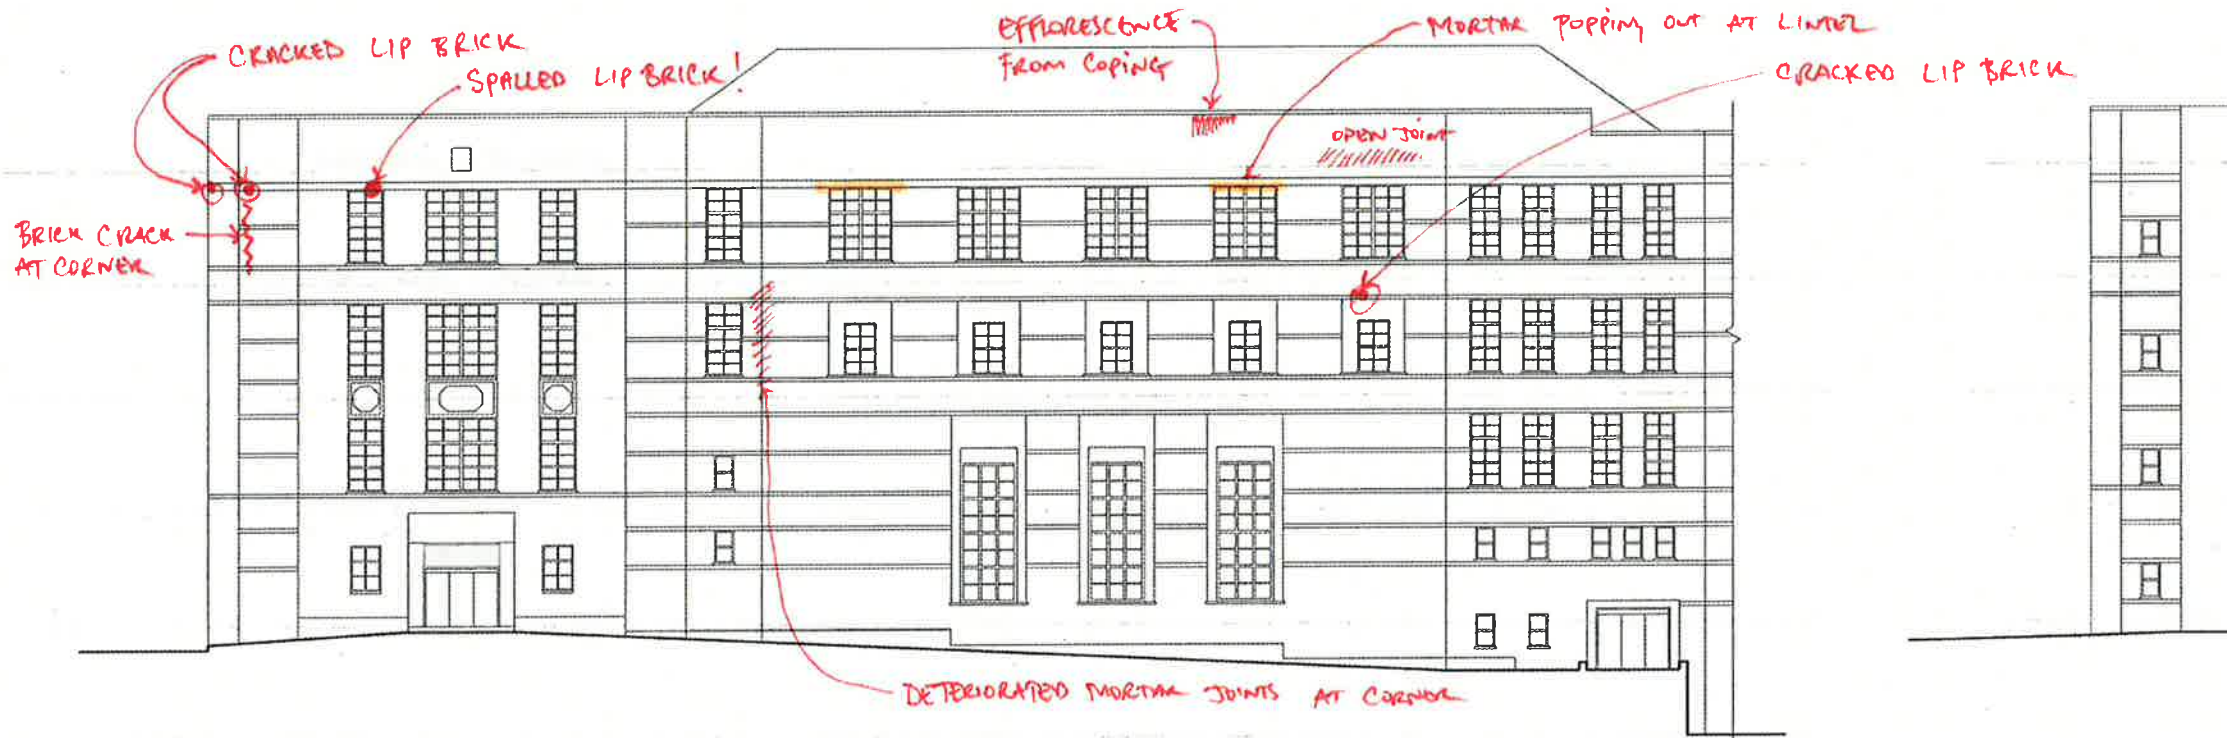
**WEST ELEVATION**  
DAMAGE MAP

NOTE: NO LEAKS OBSERVED ON INTERIOR WALLS

**WEST RETURN**  
DAMAGE MAP

Drawing Title:  
ELEVATIONS - 1  
DAMAGE MAP

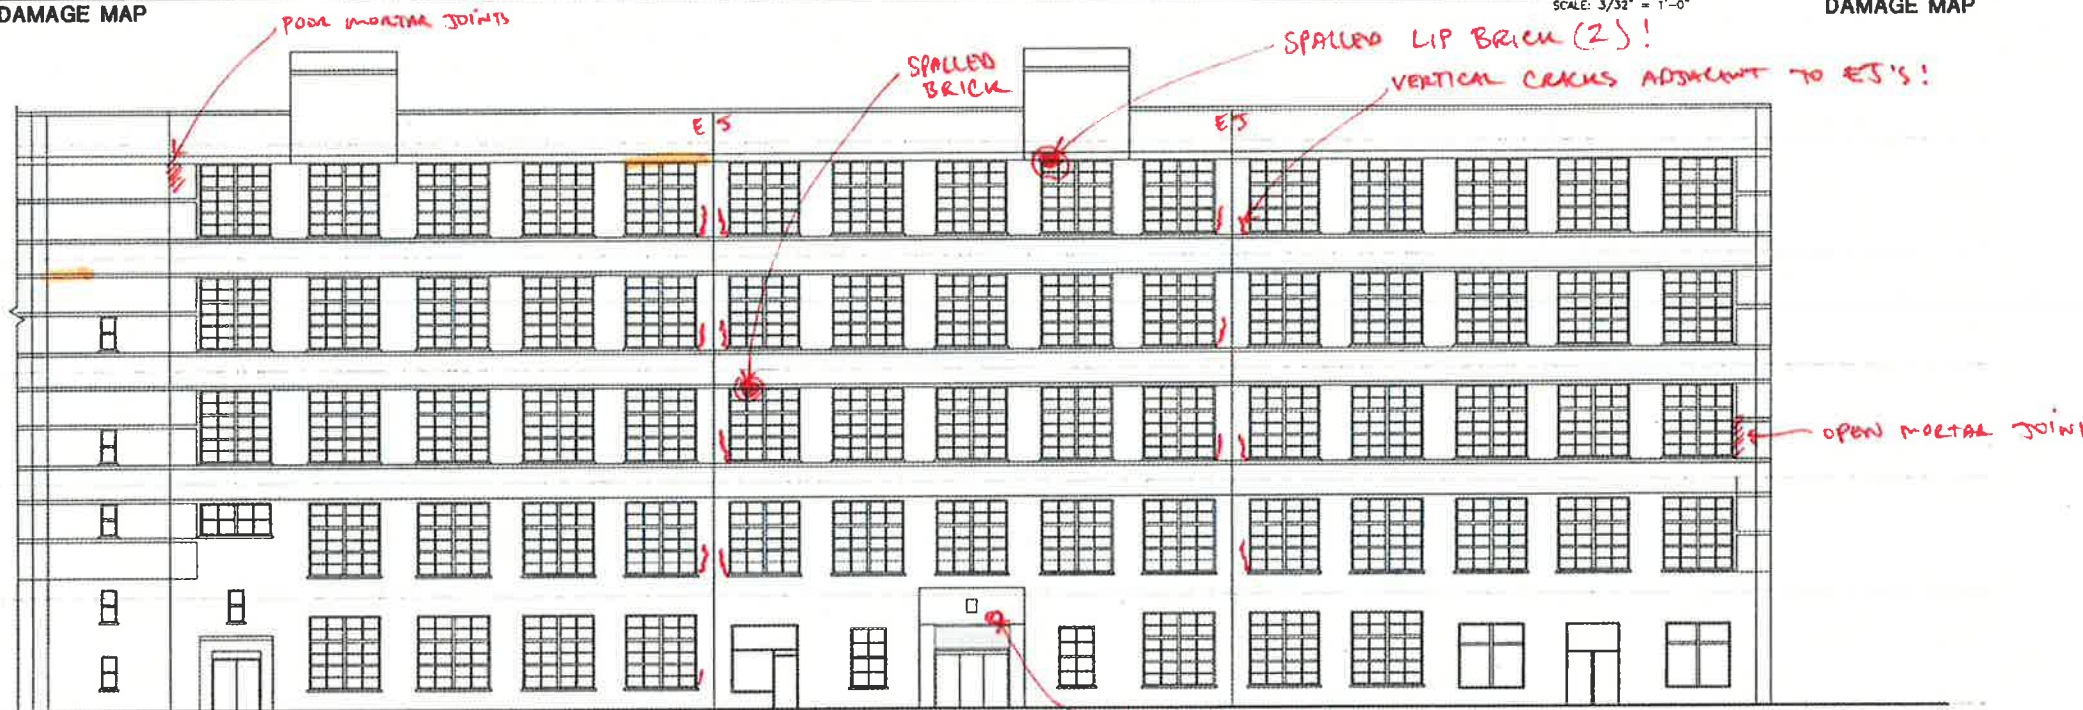
**SOUTH ELEVATION**  
DAMAGE MAP

NOTE: NO LEAKS OBSERVED ON INTERIOR WALLS

**KEY**  
[Yellow brushstroke] = CORROSION AT LINTEL

MISALIGNED BRICK / BULGE AT RELIEVING ANGLES, SOME PRIOR REPAIRS

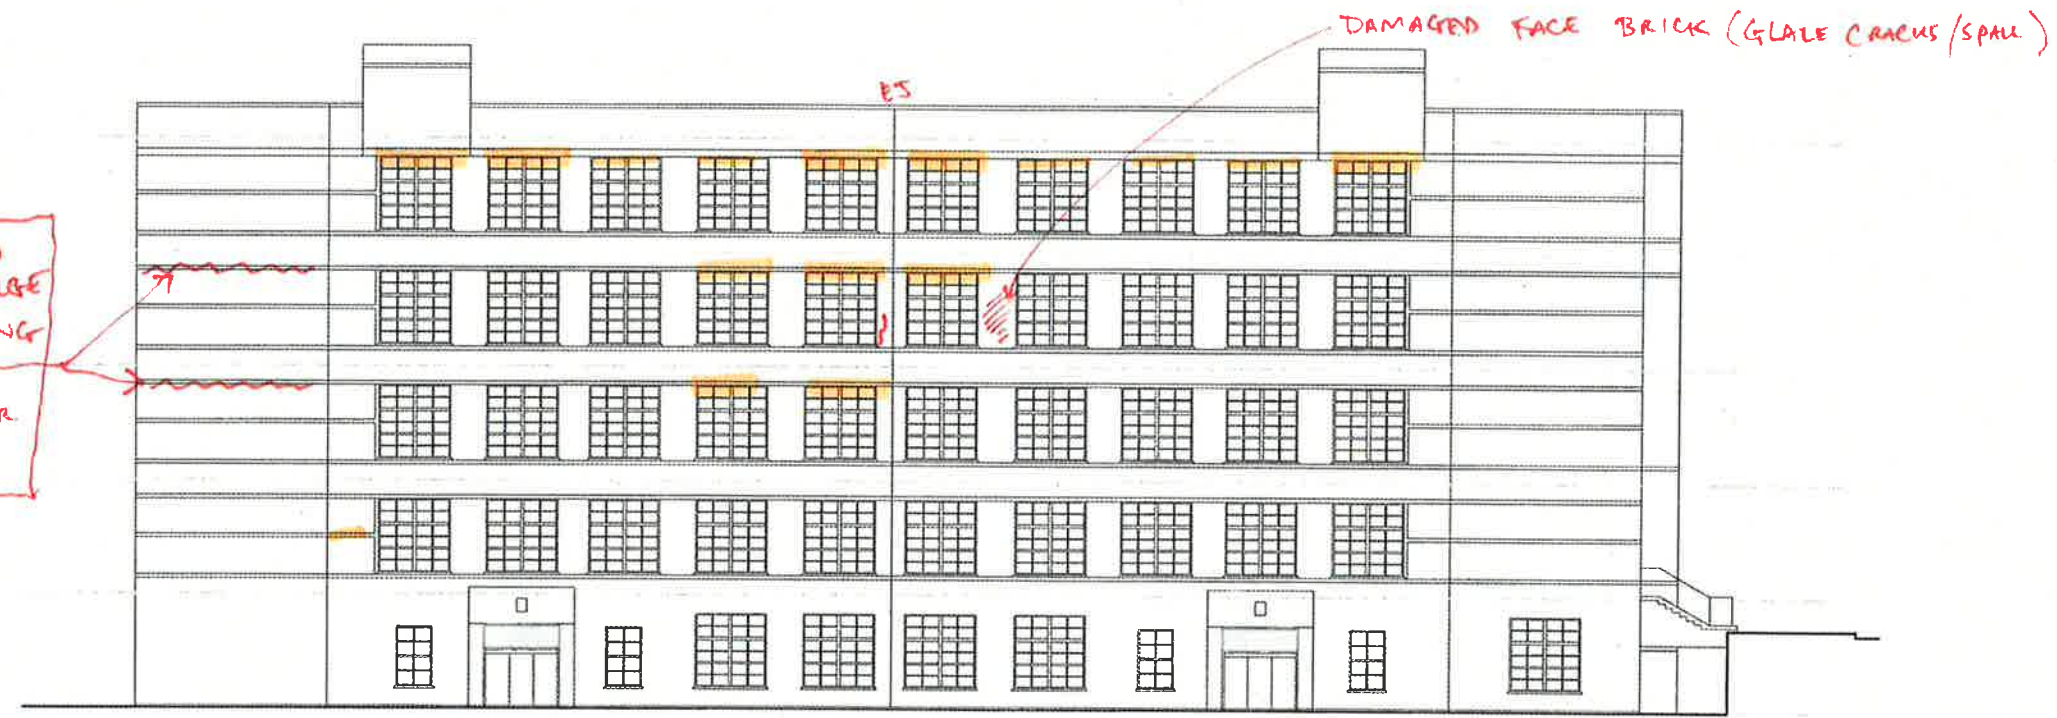
**EAST ELEVATION**  
DAMAGE MAP

NOTE: NO LEAKS OBSERVED ON INTERIOR WALLS

Drawing Title:  
ELEVATIONS - 2  
DAMAGE MAP

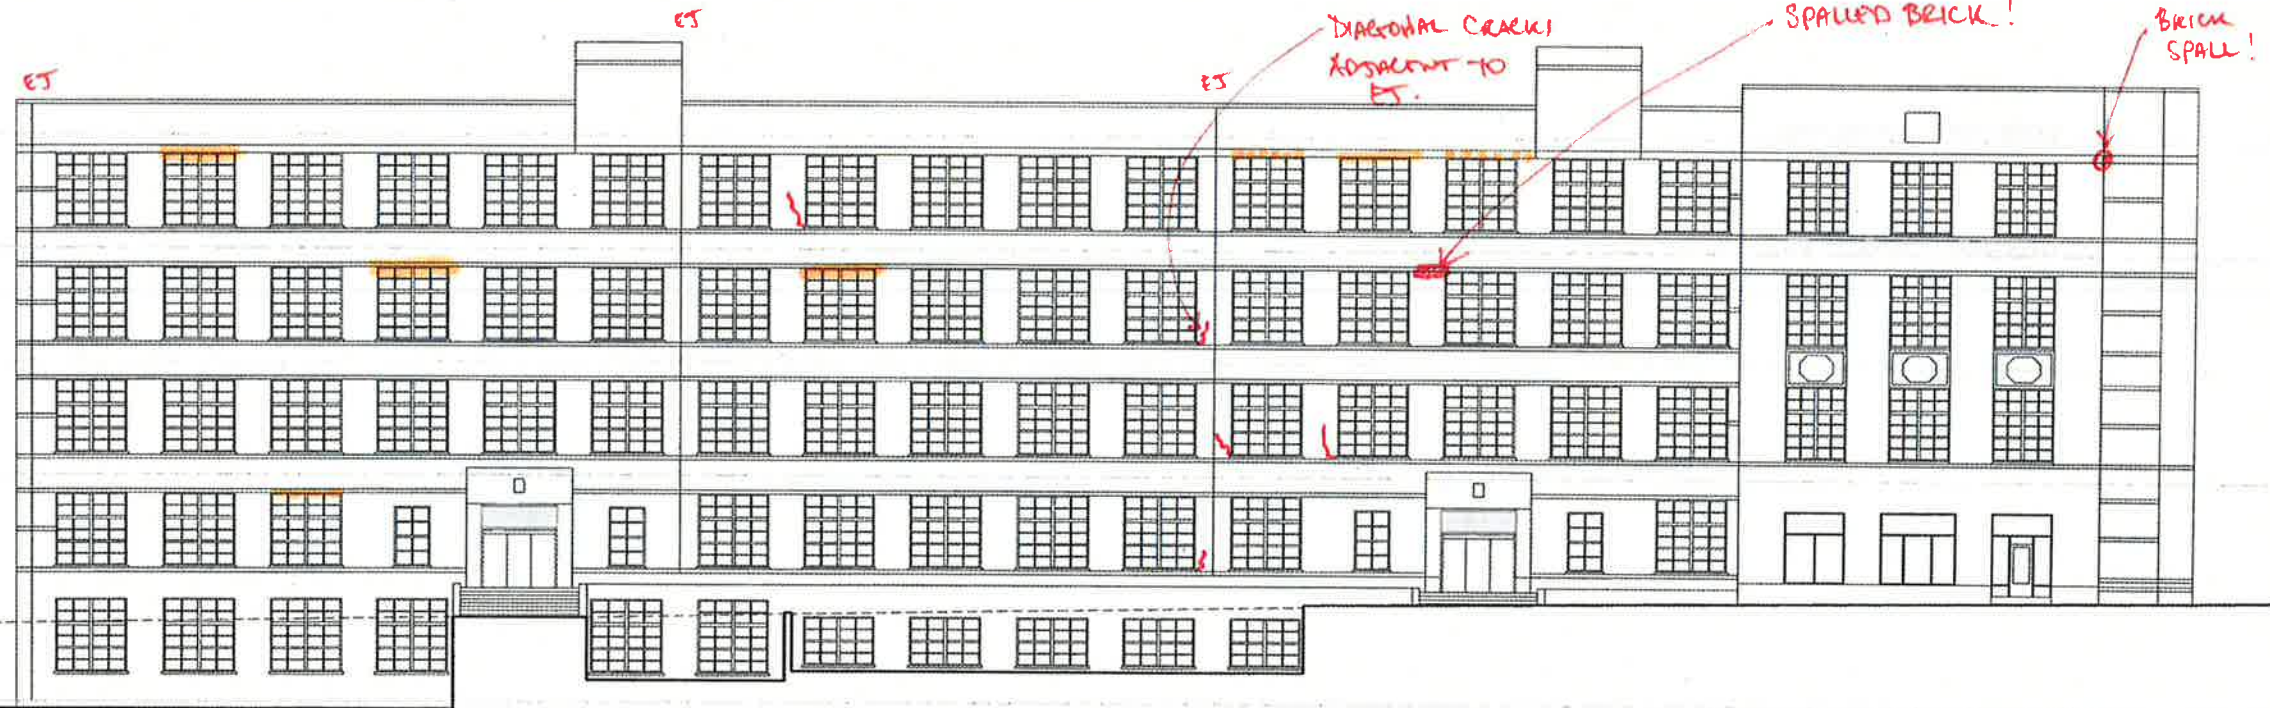
**NORTH ELEVATION**  
DAMAGE MAP

NOTE: NO LEAKS OBSERVED ON INTERIOR WALLS

**KEY**  
CORROSION AT LINTEL

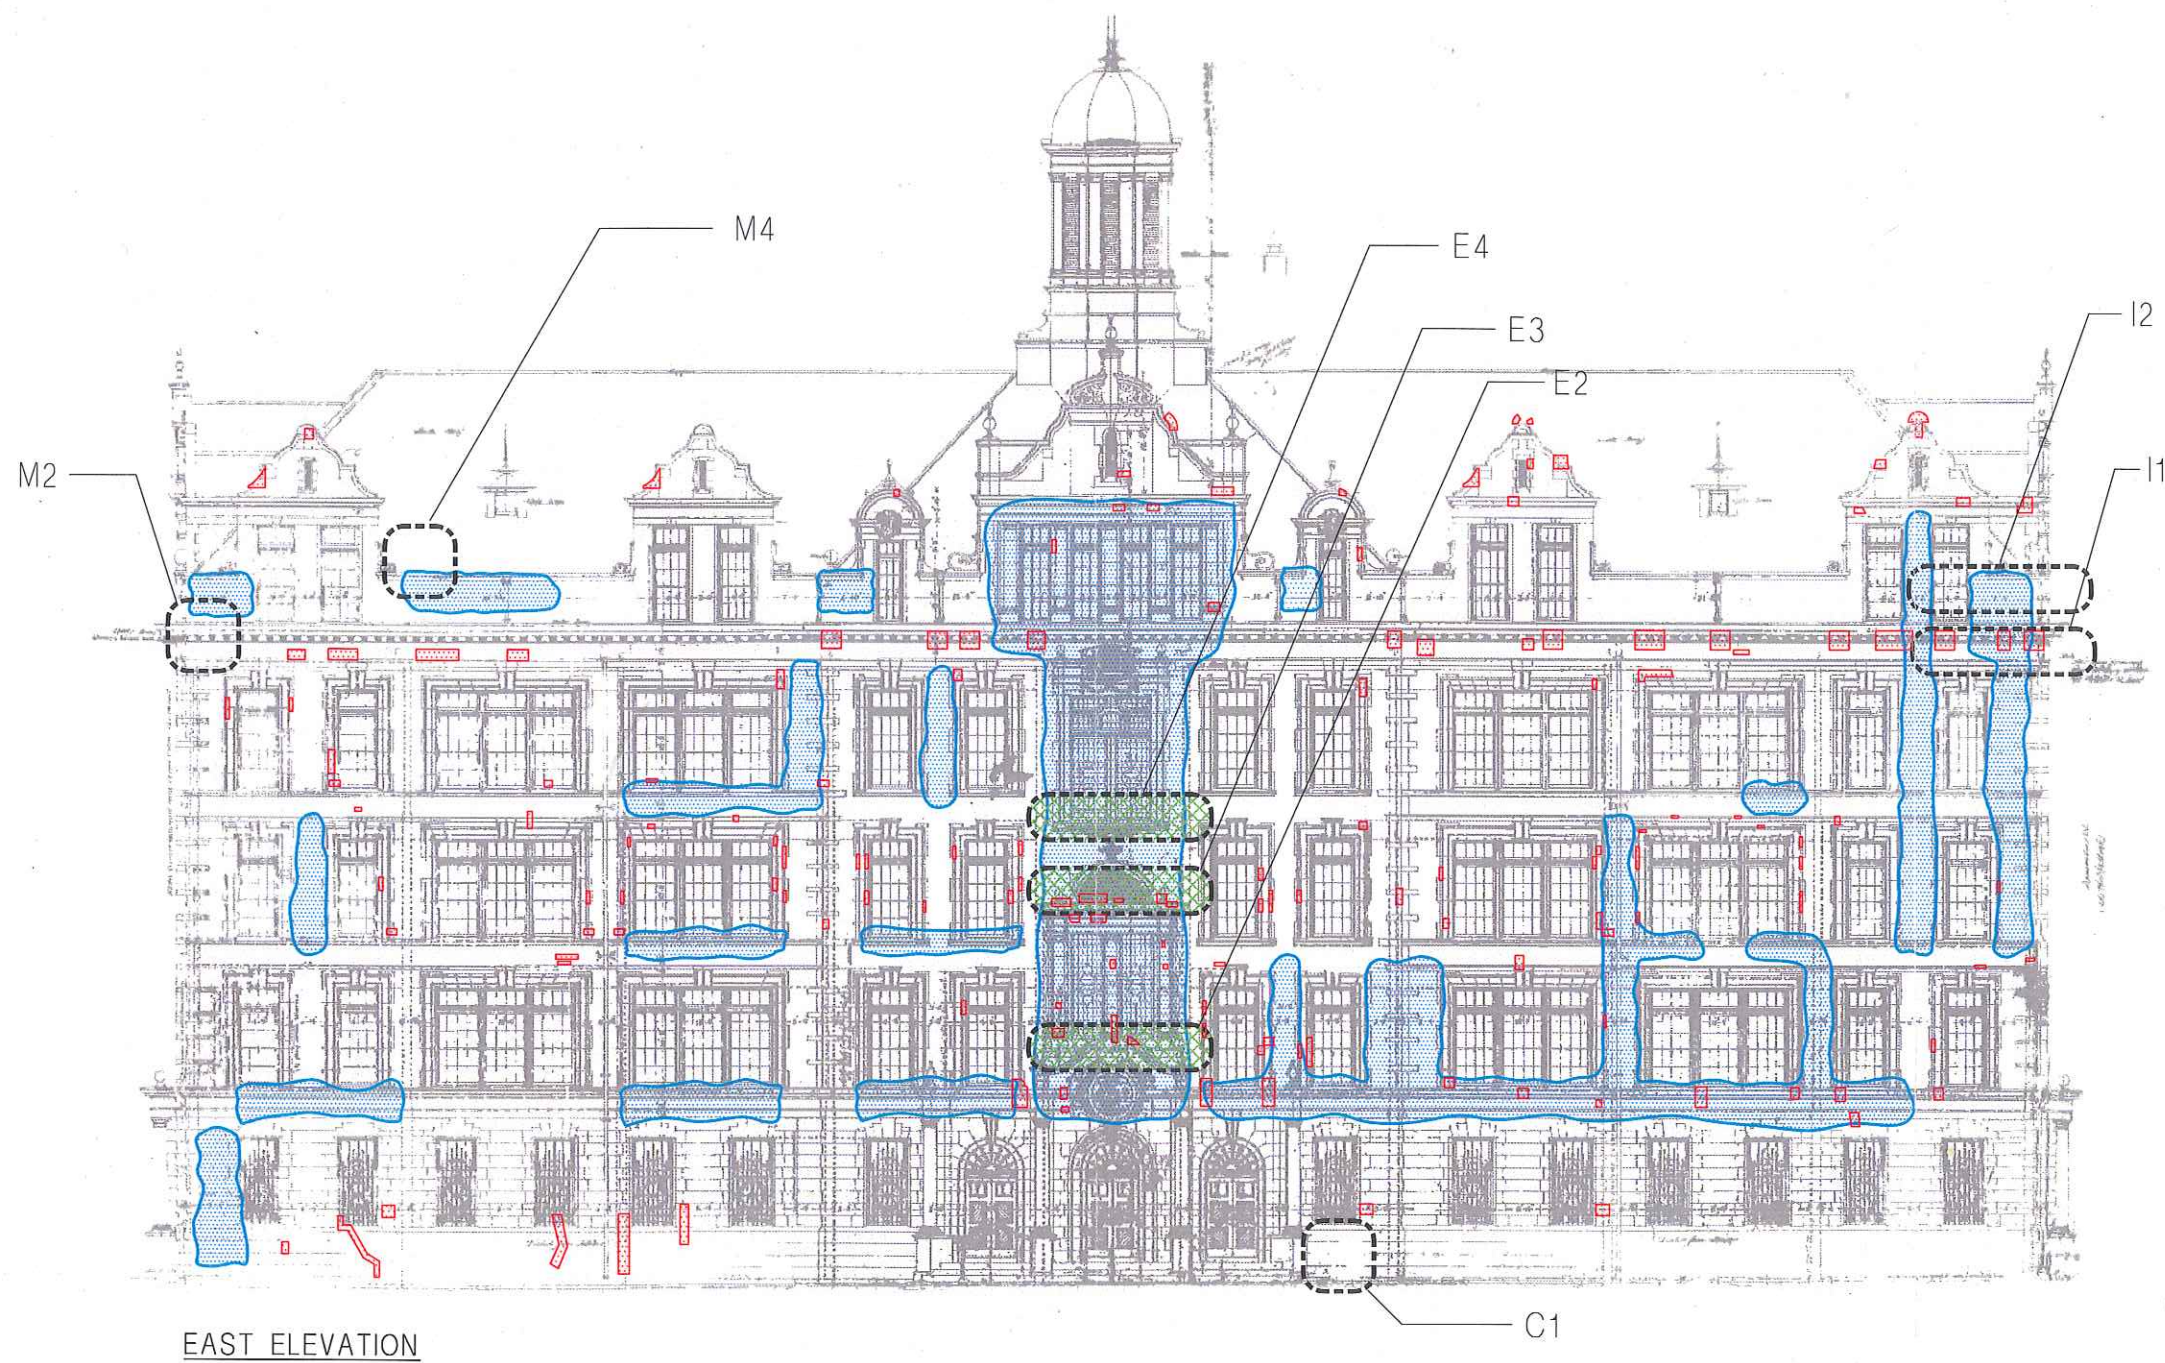
INTERIOR DAMAGE AT WALL

EXTERIOR MASONRY CRACK

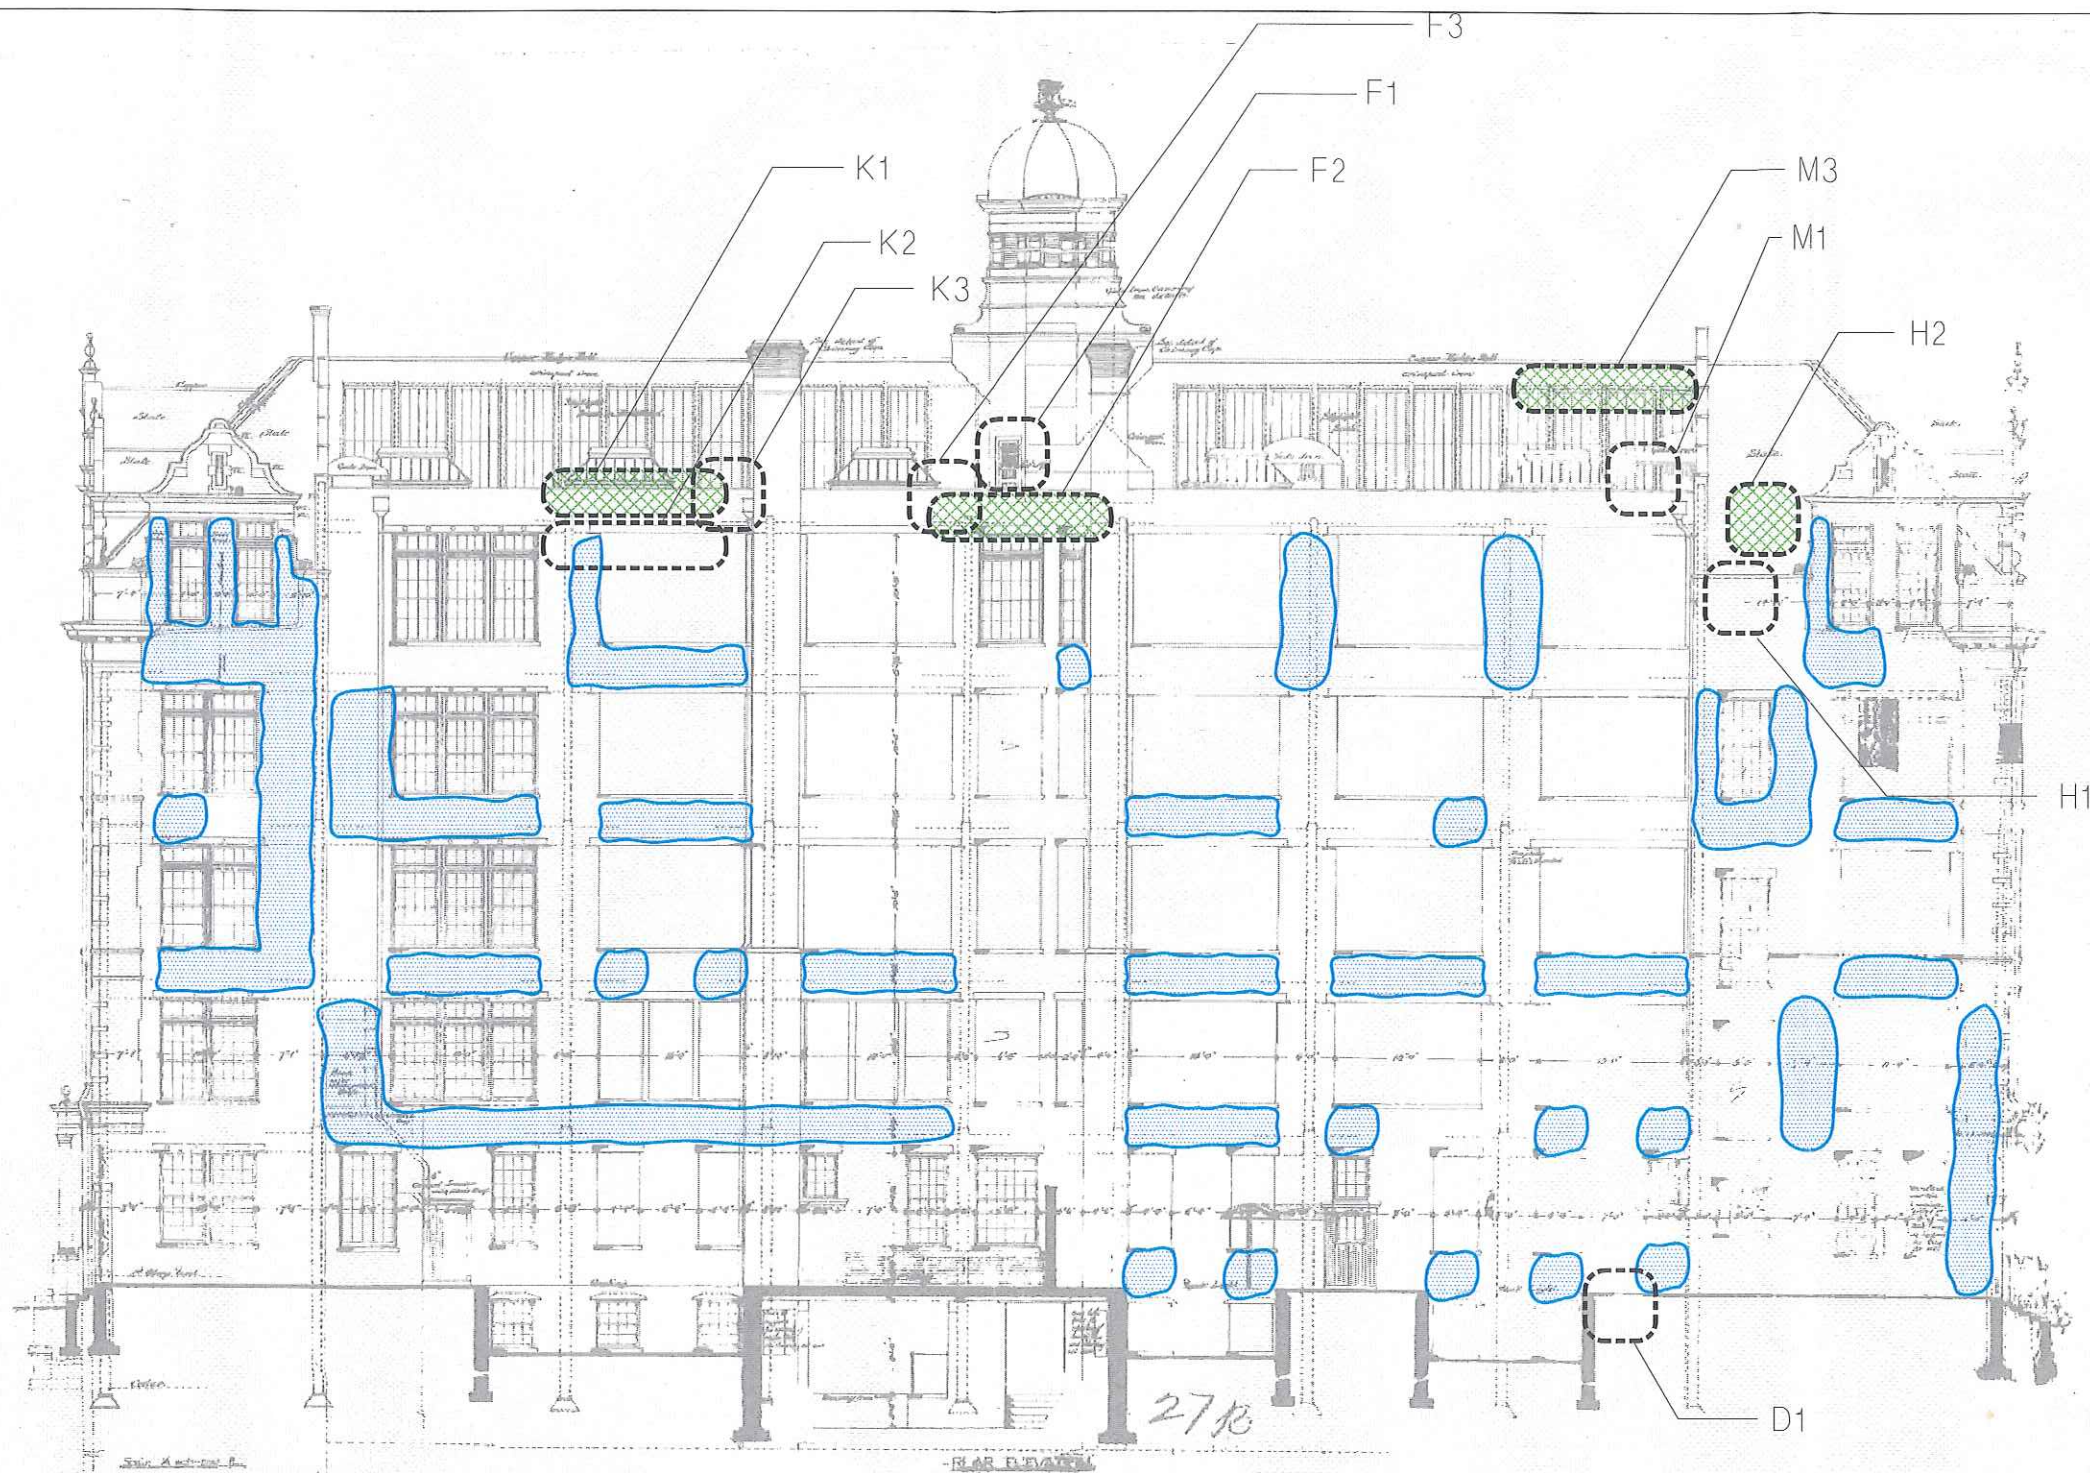
REAR ELEVATION

INTERIOR DAMAGE AT WALL

EXTERIOR MASONRY CRACK

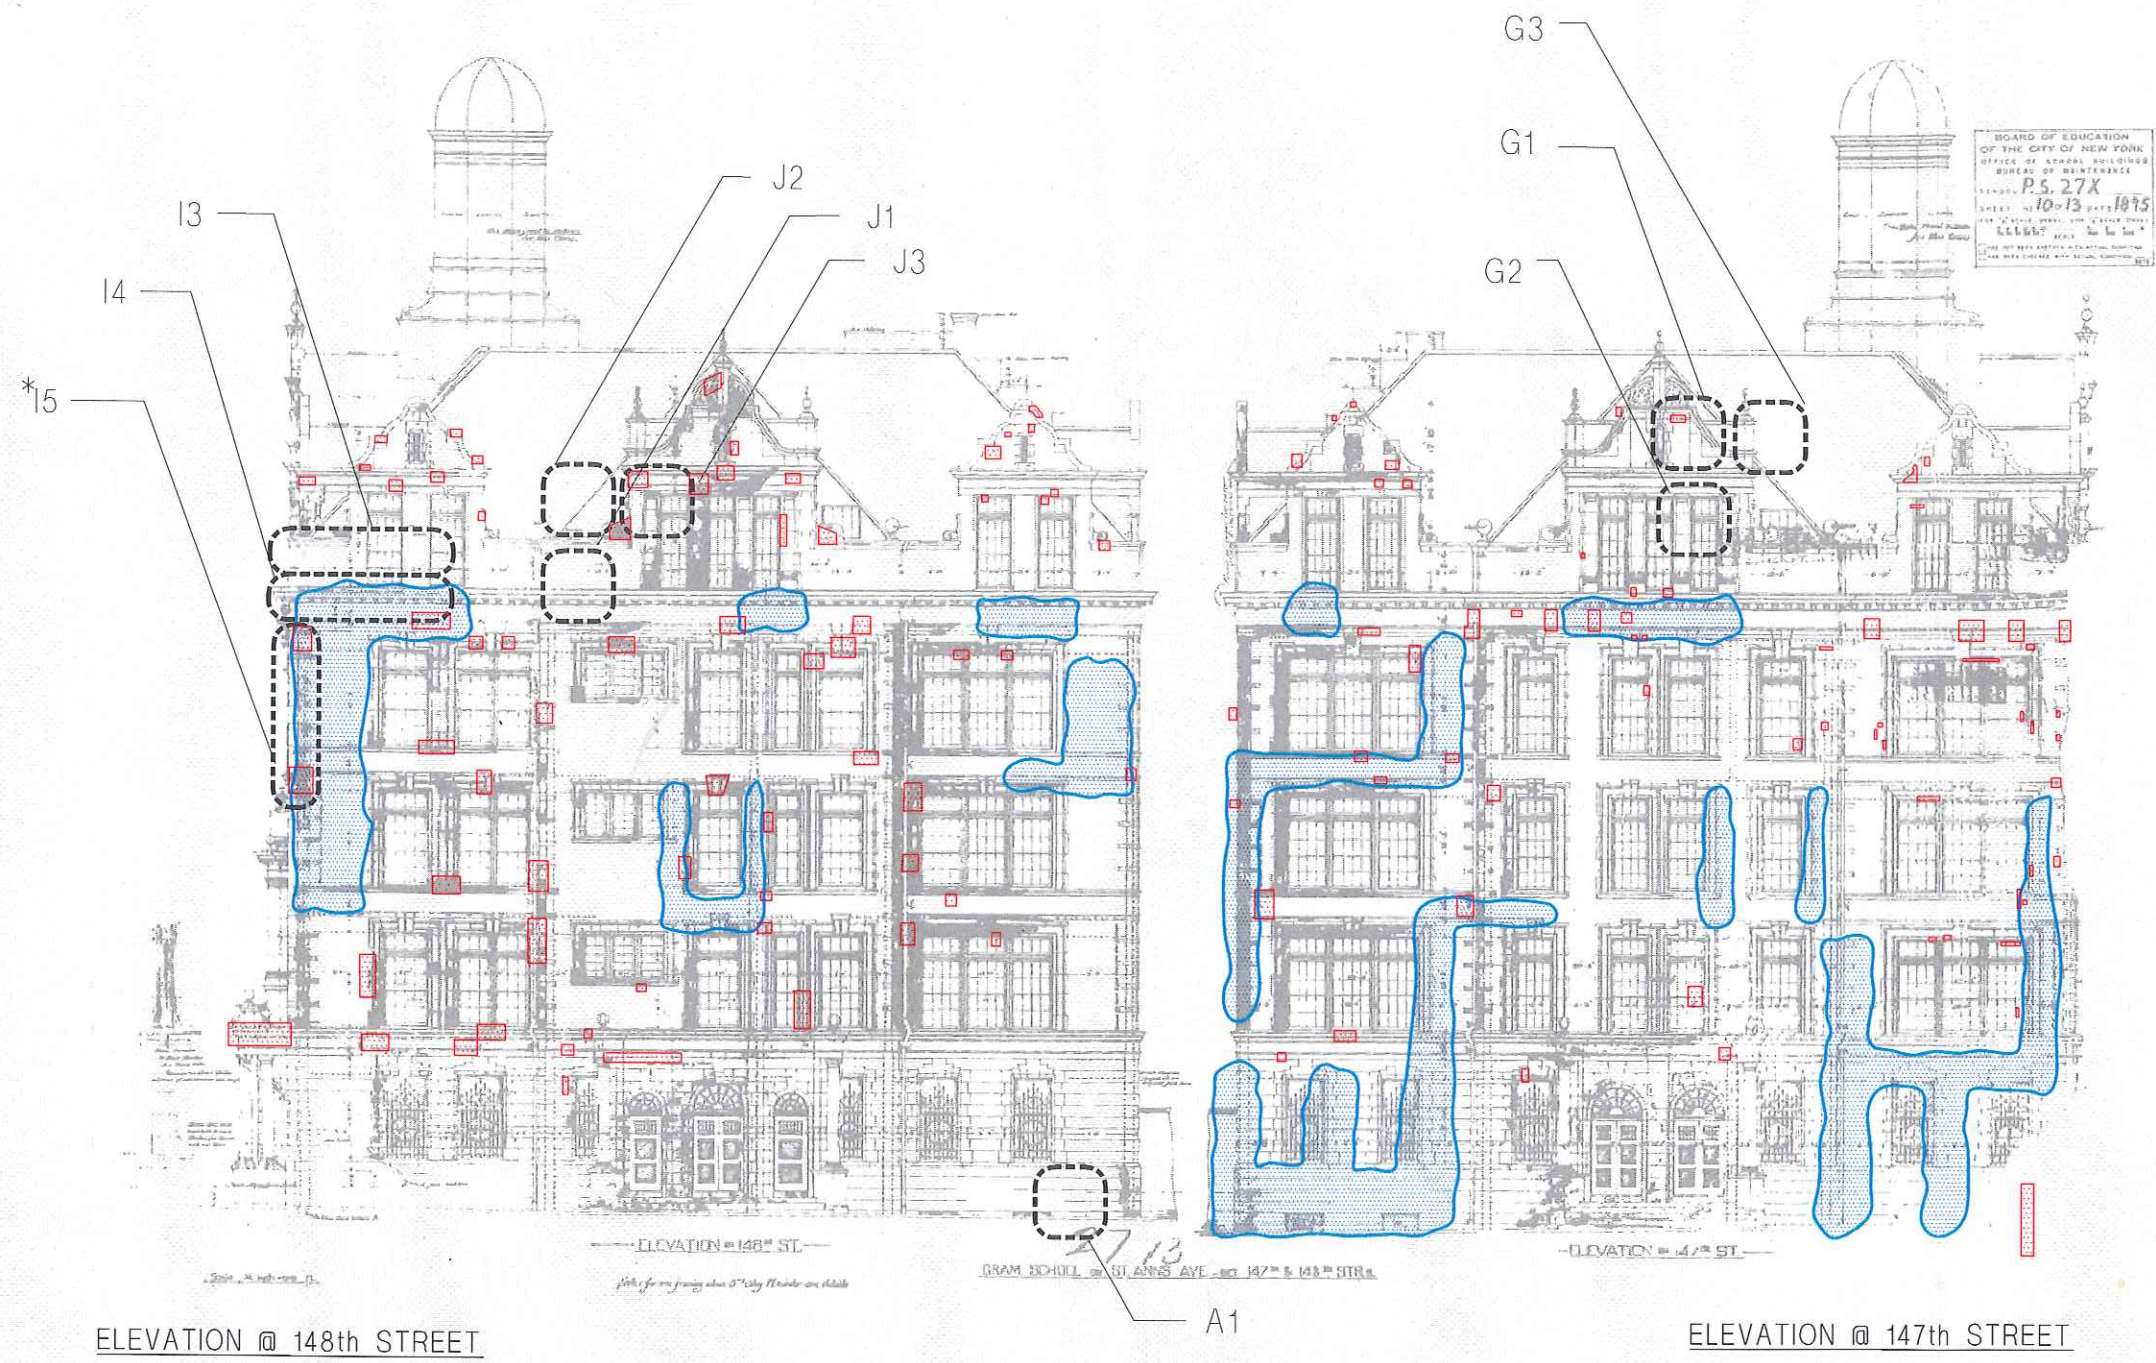
ELEVATION @ 148th STREET

ELEVATION @ 147th STREET

INTERIOR DAMAGE AT WALL

EXTERIOR MASONRY CRACK

\* NOTE: DETERIORATED CAULK JOINT WAS NOT TESTED AT THIS LOCATION

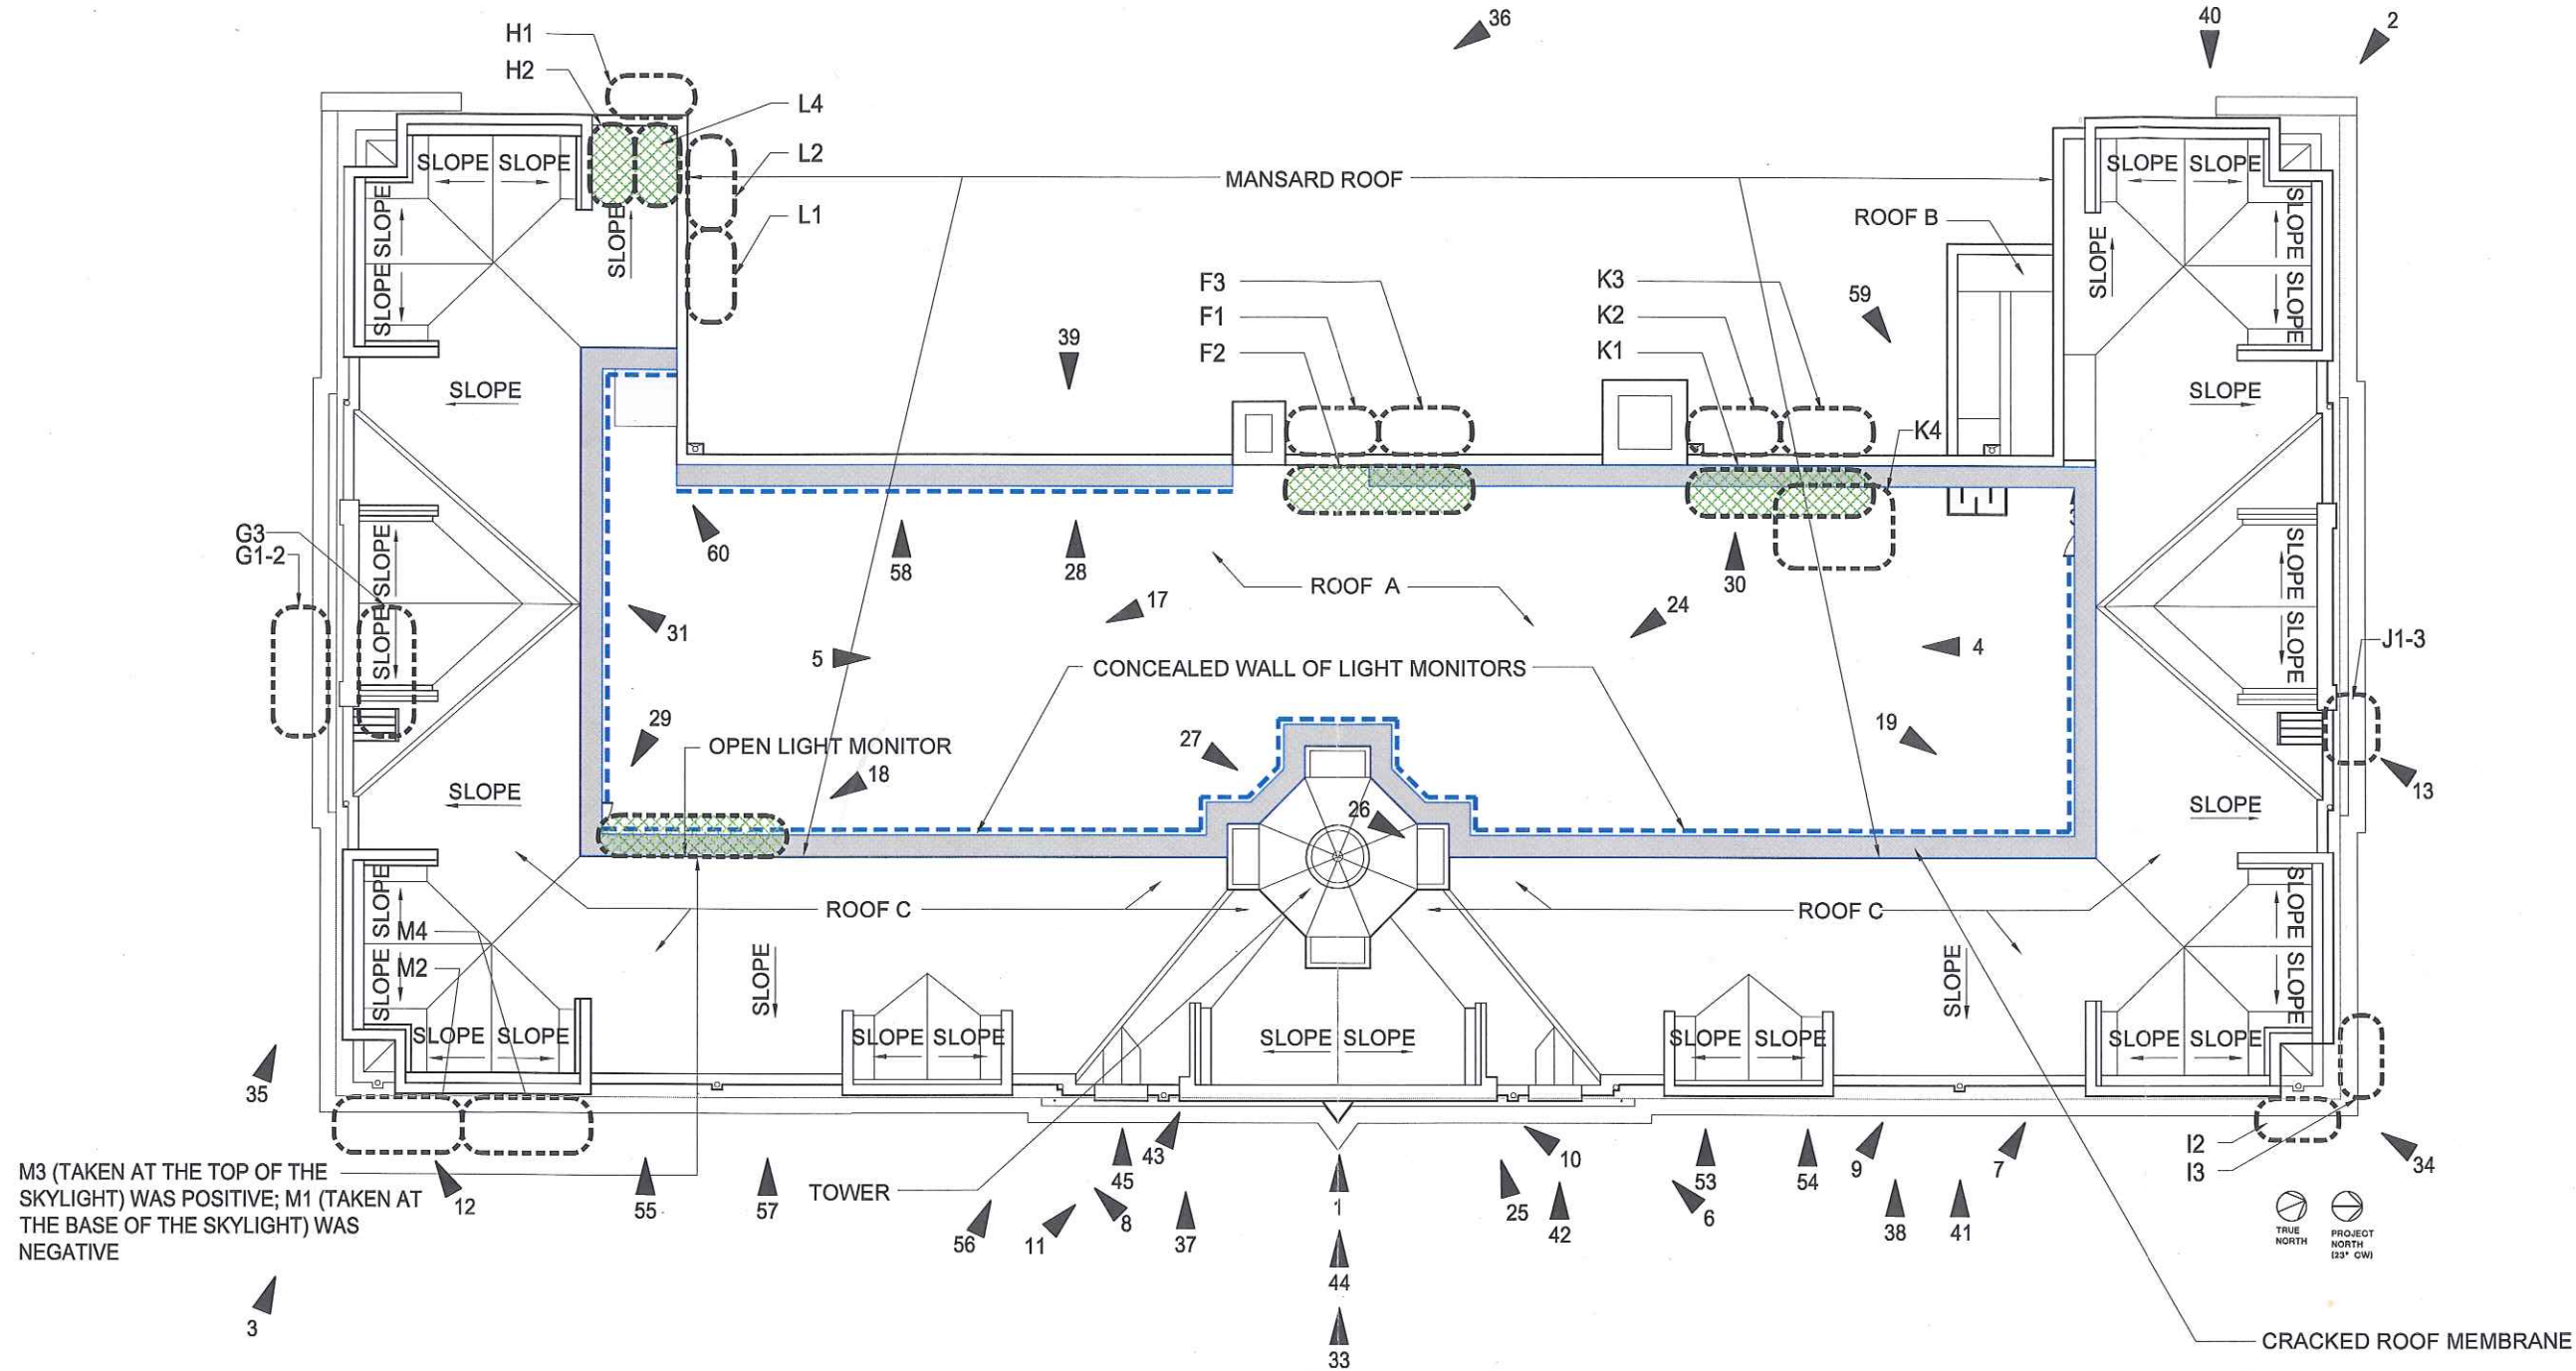
ROOF PLAN

LEGEND	
	INTERIOR DAMAGE AT FLOOR
	INTERIOR DAMAGE AT CEILING
	DAMAGE AT WALL AND FLASHING
	SPRAY TEST LOCATION NEGATIVE
	SPRAY TEST LOCATION POSITIVE
