## **BUILDING ENVELOPE SCOPING GUIDELINES**

#### **2.1. Introduction**

The following ‘Scoping Guidelines’ are provided to clarify the intended scope of assigned Capital Improvement Program (CIP) projects related to the Exterior Modernization/Building Envelope/Water Infiltration Work and provide direction on how to approach the investigation and scoping of the work for the ‘DOE Referred Items’ as well as ‘SCA Additional Recommended Items’ in Scope Reports. These guidelines are intended to supplement the General Scoping Guidelines and the requirements of the Scoping Process outlined in the CIP Project Manual.

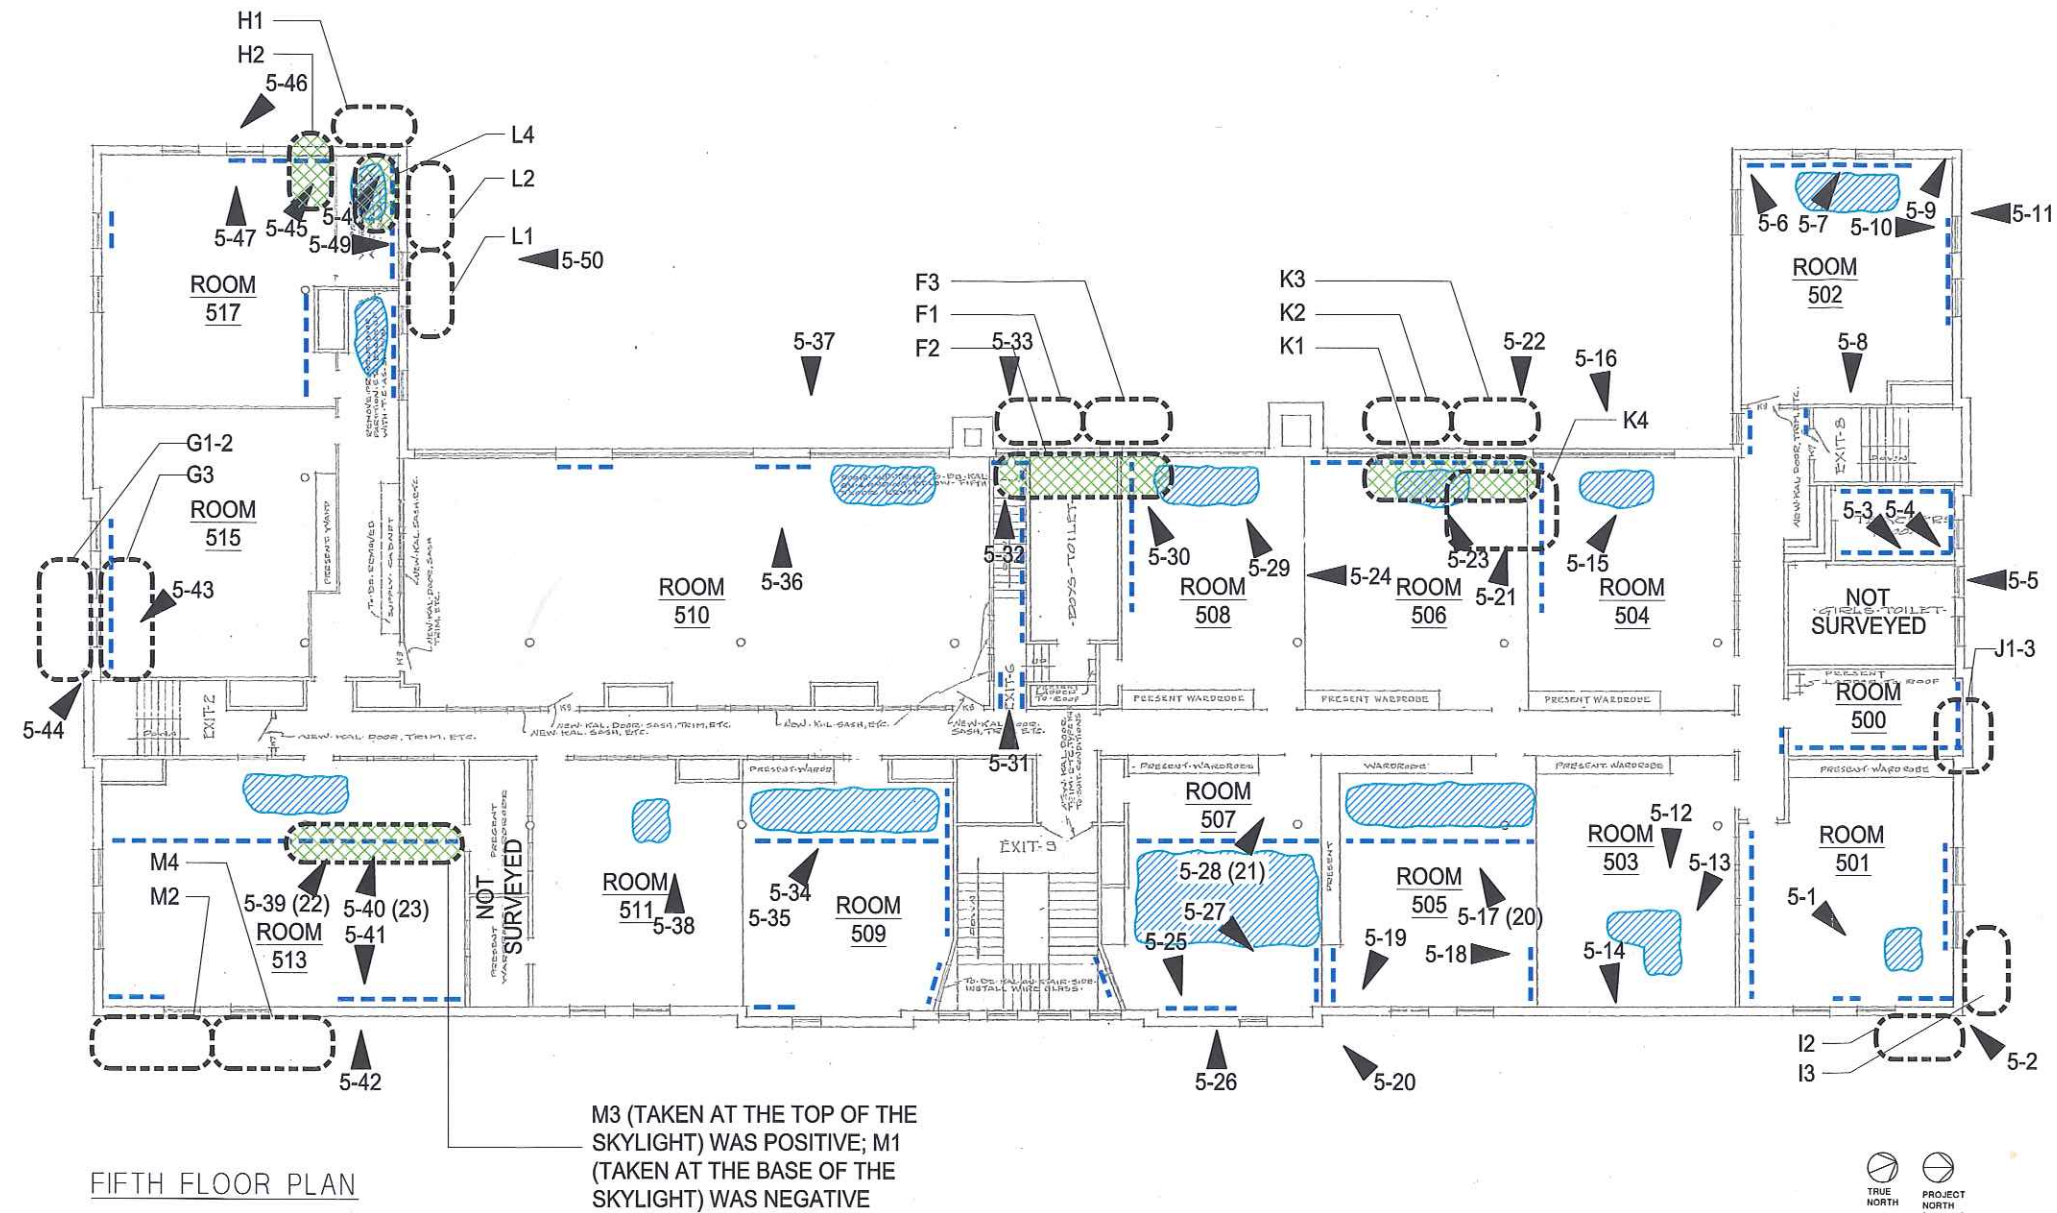
FIFTH FLOOR PLAN

M3 (TAKEN AT THE TOP OF THE SKYLIGHT) WAS POSITIVE; M1 (TAKEN AT THE BASE OF THE SKYLIGHT) WAS NEGATIVE

LEGEND	
	INTERIOR DAMAGE AT FLOOR
	INTERIOR DAMAGE AT CEILING
	INTERIOR DAMAGE AT WALL
	SPRAY TEST LOCATION NEGATIVE
	SPRAY TEST LOCATION POSITIVE

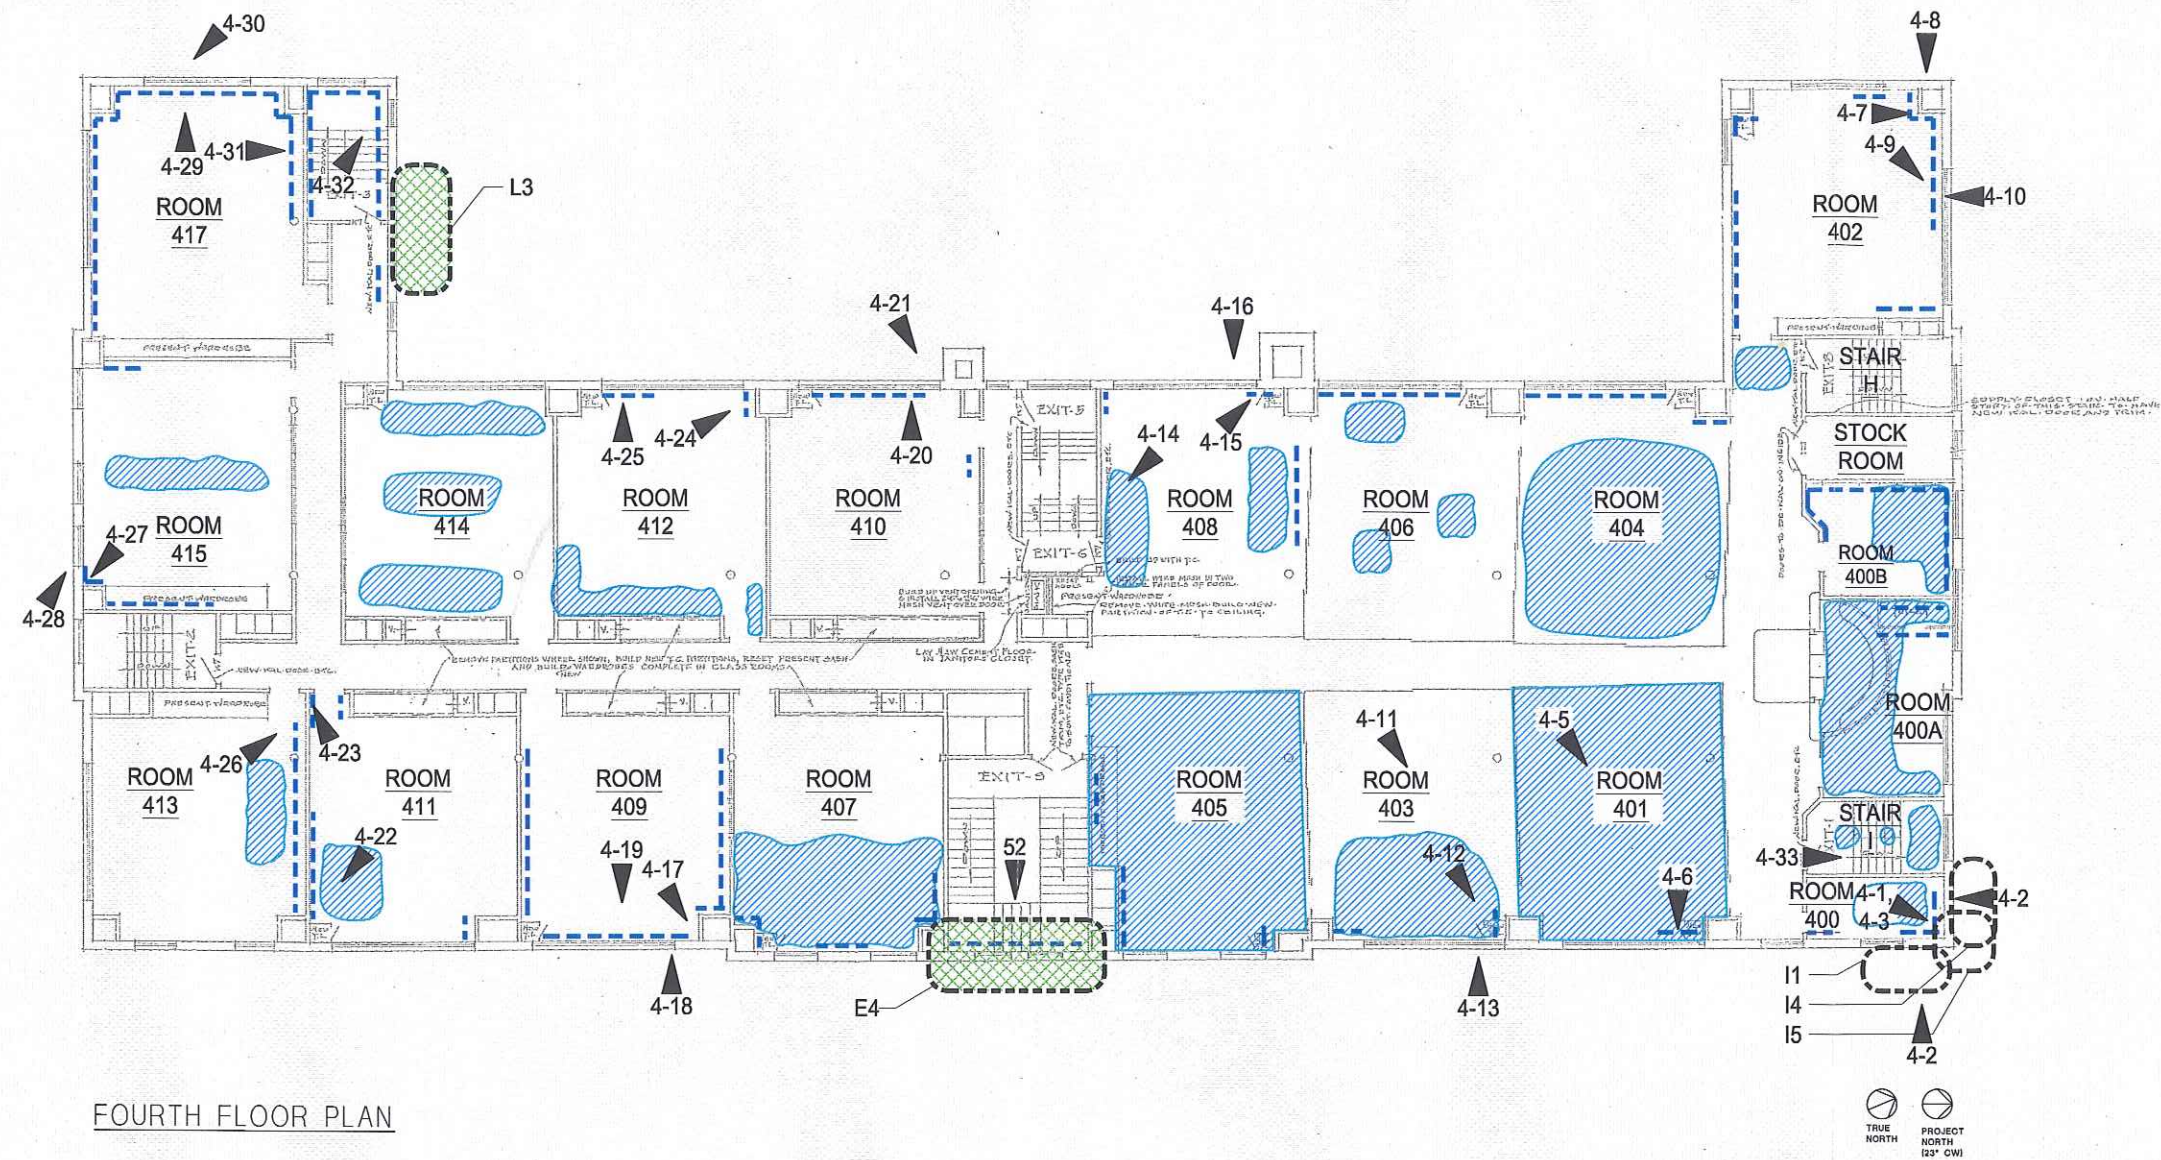
LEGEND	
	INTERIOR DAMAGE AT FLOOR
	INTERIOR DAMAGE AT CEILING
	INTERIOR DAMAGE AT WALL
	SPRAY TEST LOCATION NEGATIVE
	SPRAY TEST LOCATION POSITIVE

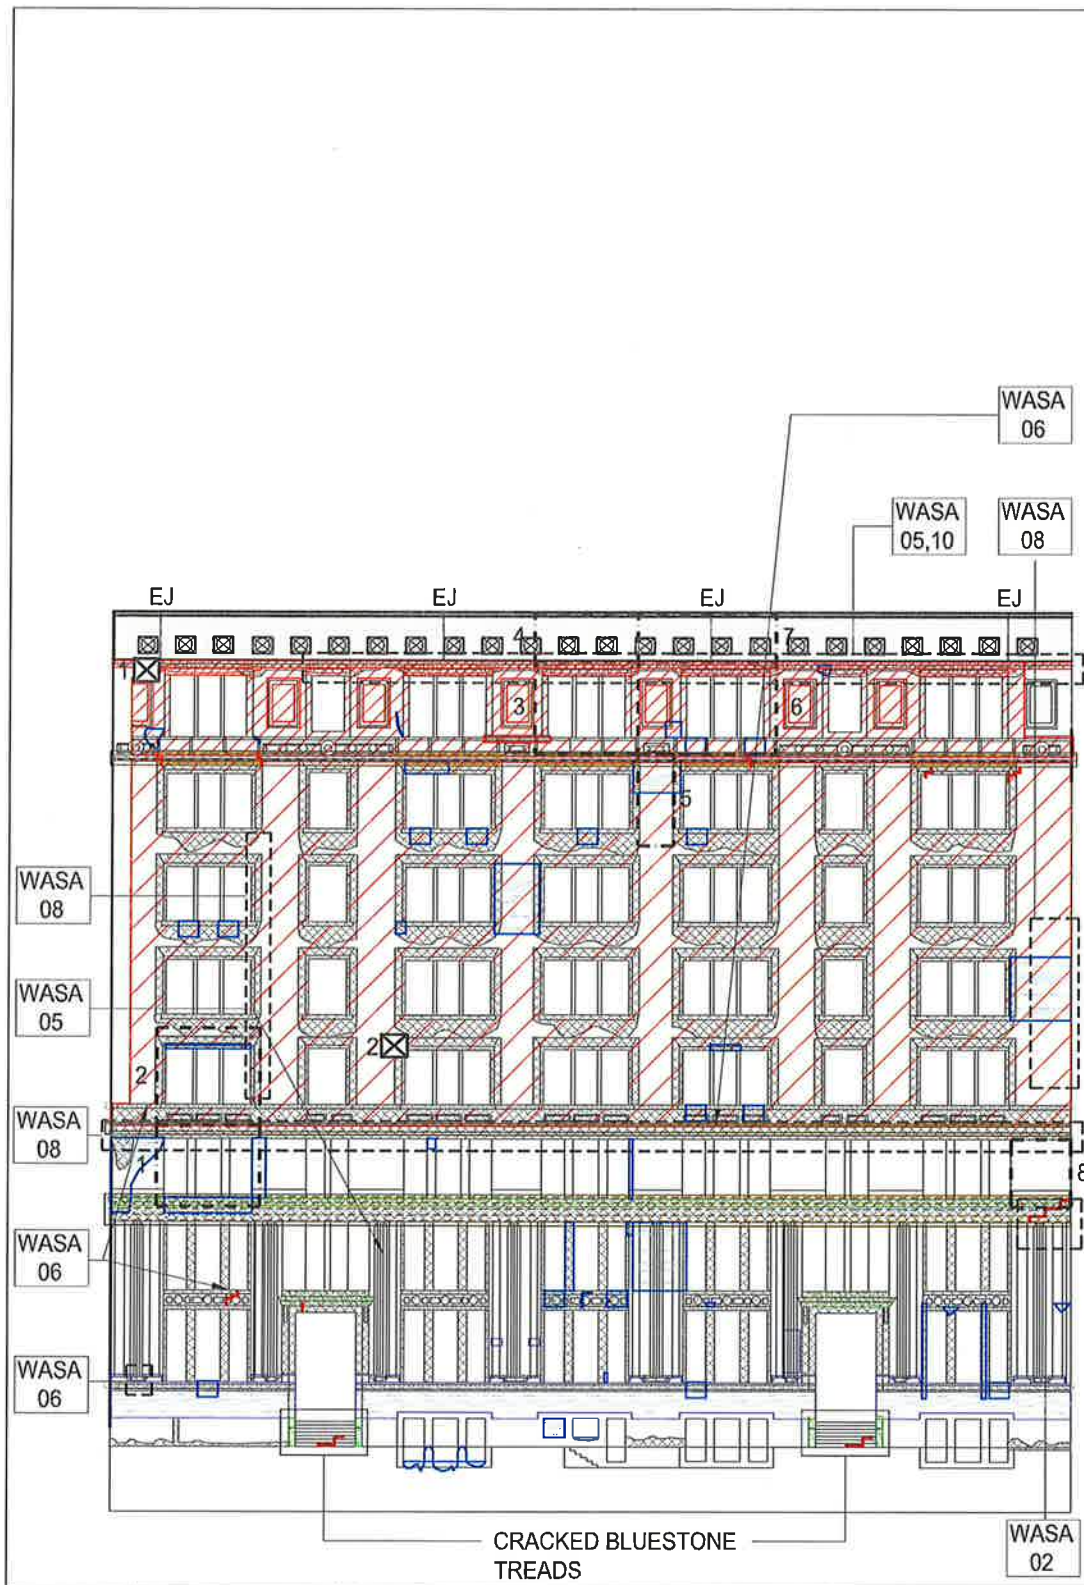
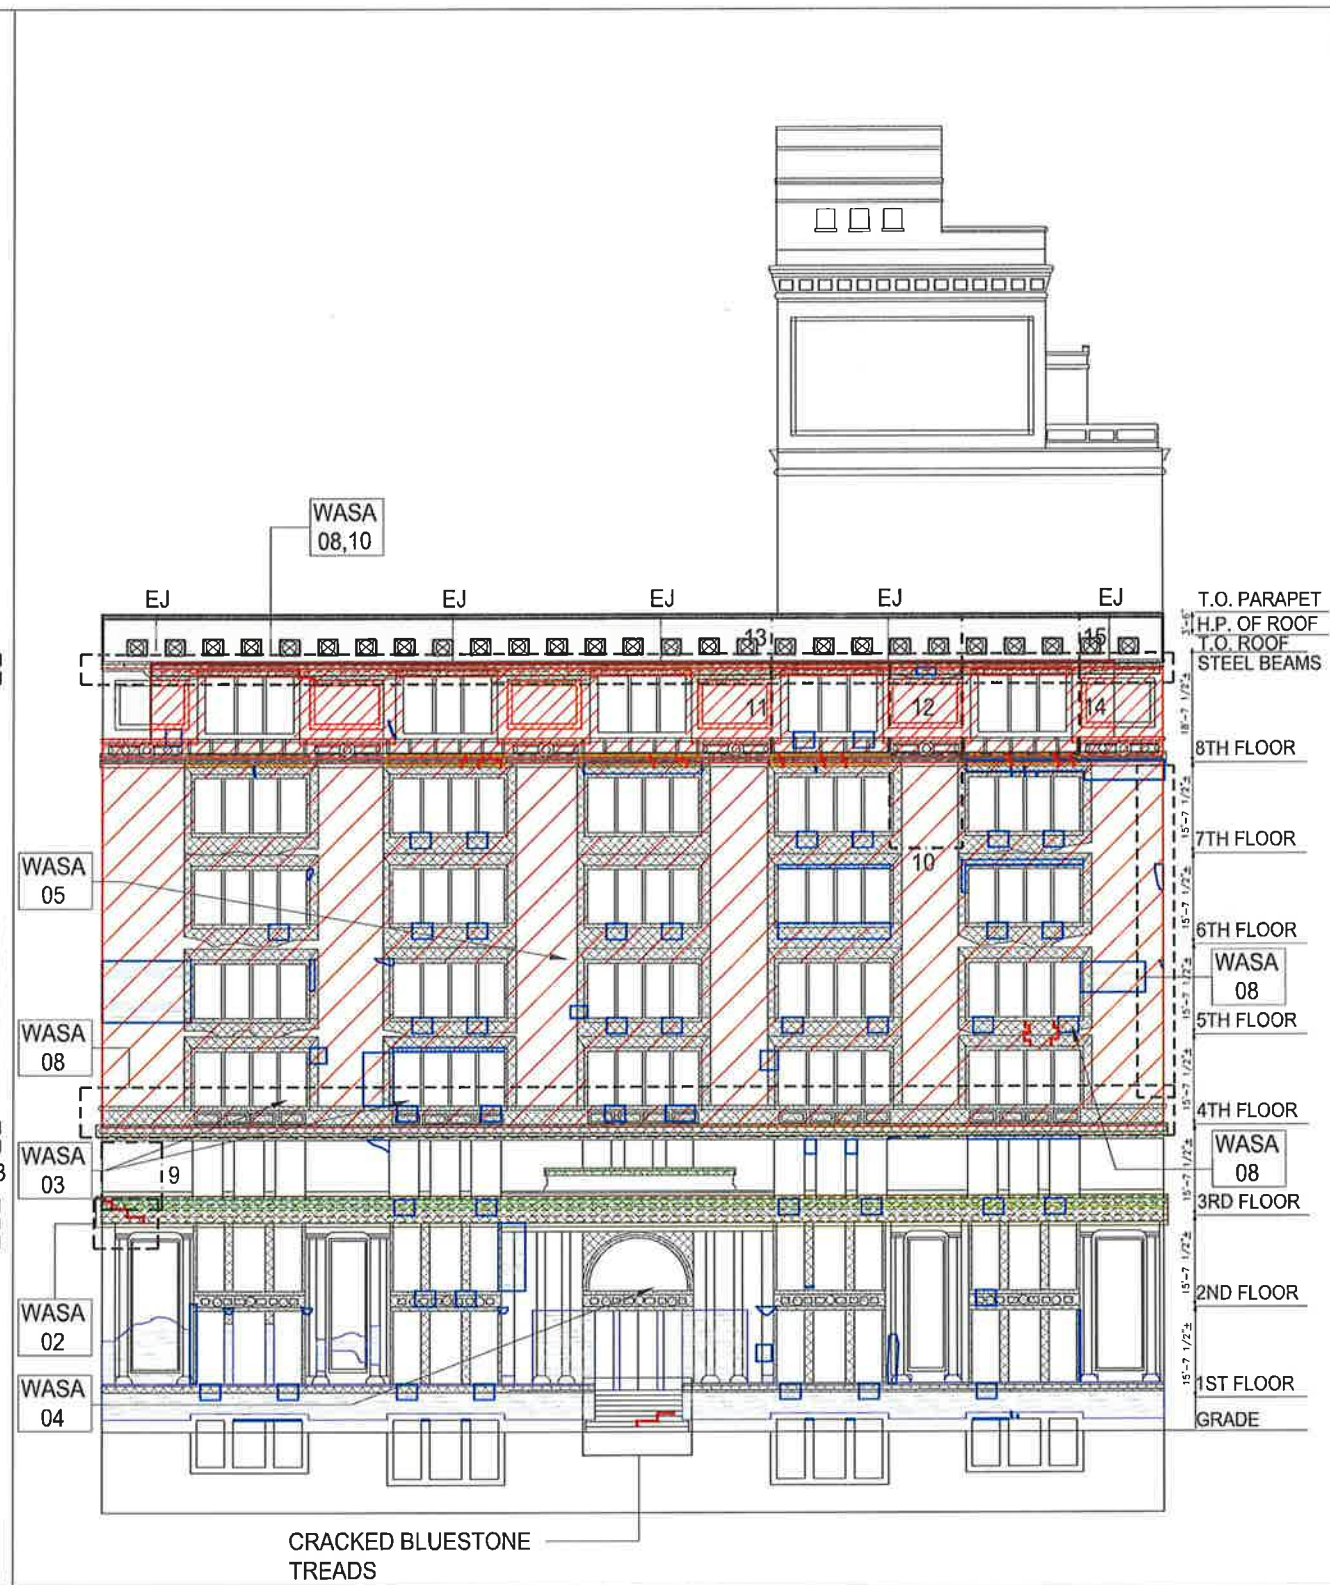
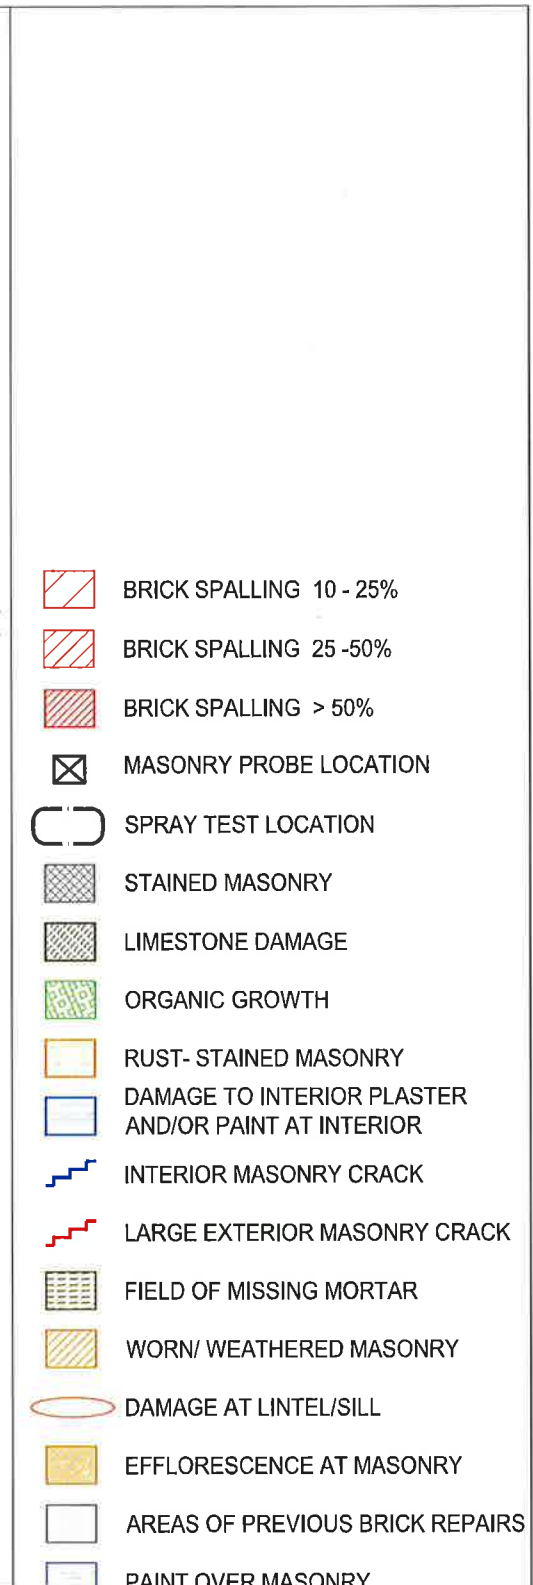
**A1 NORTH ELEVATION (E 17TH ST)**

**A2 WEST ELEVATION (IRVING PLACE)**
