# **EPL 21672 Monitoring Report April 2024**

Sydney Metro - Western Sydney Airport, Station Boxes and Tunnelling Works

Project number	SSI 10051
Document number	SMWSASBT-CPG-SWD-SW000-EN-RPT-295399
Revision date	24 May 2024
Revision	01

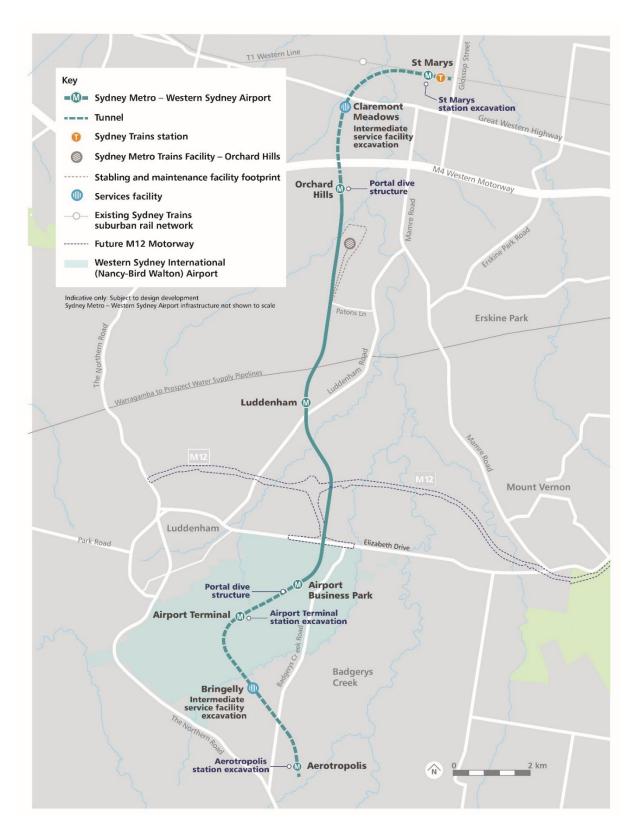
Figure 1: Overview of the Project

The Project forms part of the broader Sydney Metro network. It involves the construction and operation of a 23km new metro rail line that extends from the existing Sydney Trains suburban T1 Western Line (at St Marys) in the north and the Aerotropolis (at Bringelly) in the south. The alignment includes a combination of tunnels and civil structures, including viaduct, bridges, surface and open-cut troughs between the two tunnel sections (Figure 1).

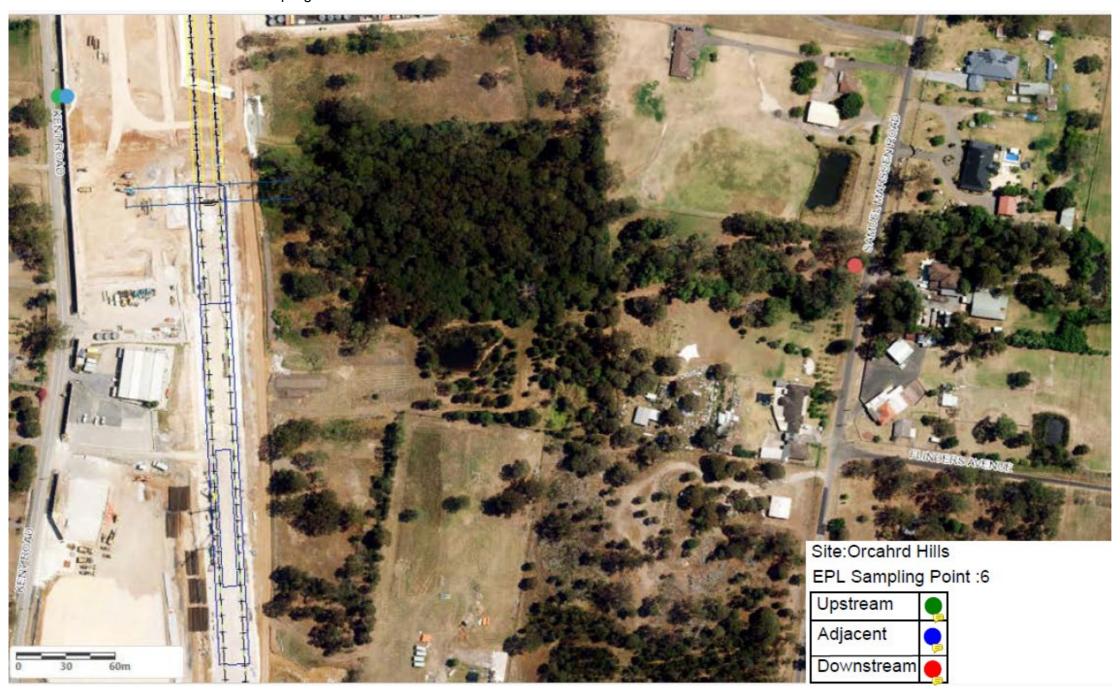
Figure 10: SBT-6 Sampling Locations

- SBT-6 is in a semi-rural setting with vegetated swales up and downstream of the sampling location.
- SBT-7 is a drainage line that may collect water off road surfaces from Gipps Street and the Great Western Highway.
- SBT-9 is downstream of the Western Sydney Airport water and farmlands which would contribute runoff to the waterway.
